Action Effectiveness Monitoring for the Lower Columbia River Estuary Habitat Restoration Program

Project Number: 2003-007-00

Action Effectiveness Monitoring for the Lower Columbia River Estuary Habitat Restoration Program Annual Report for Year 11 (October 2014 to September 2015)

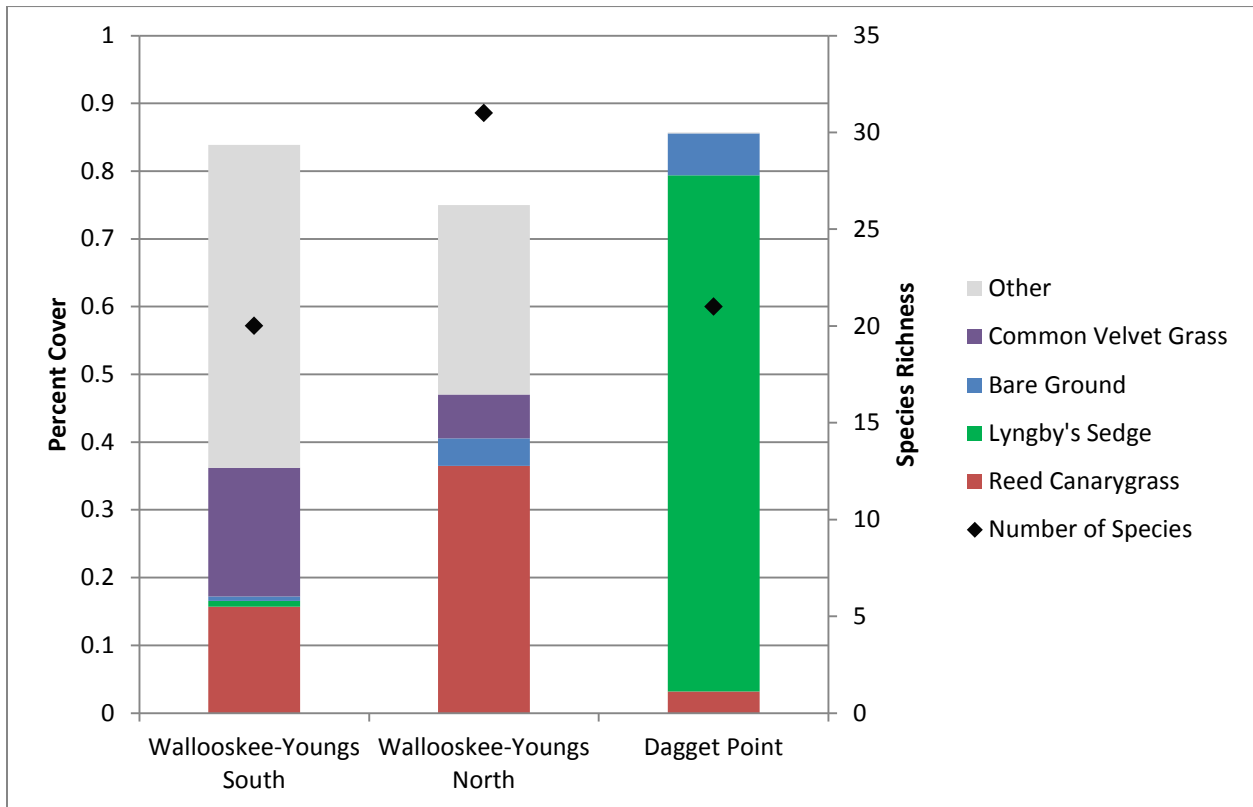
Figure 4. Vegetation cover and composition for Wallooskee-Youngs and Dagget Point Reference site

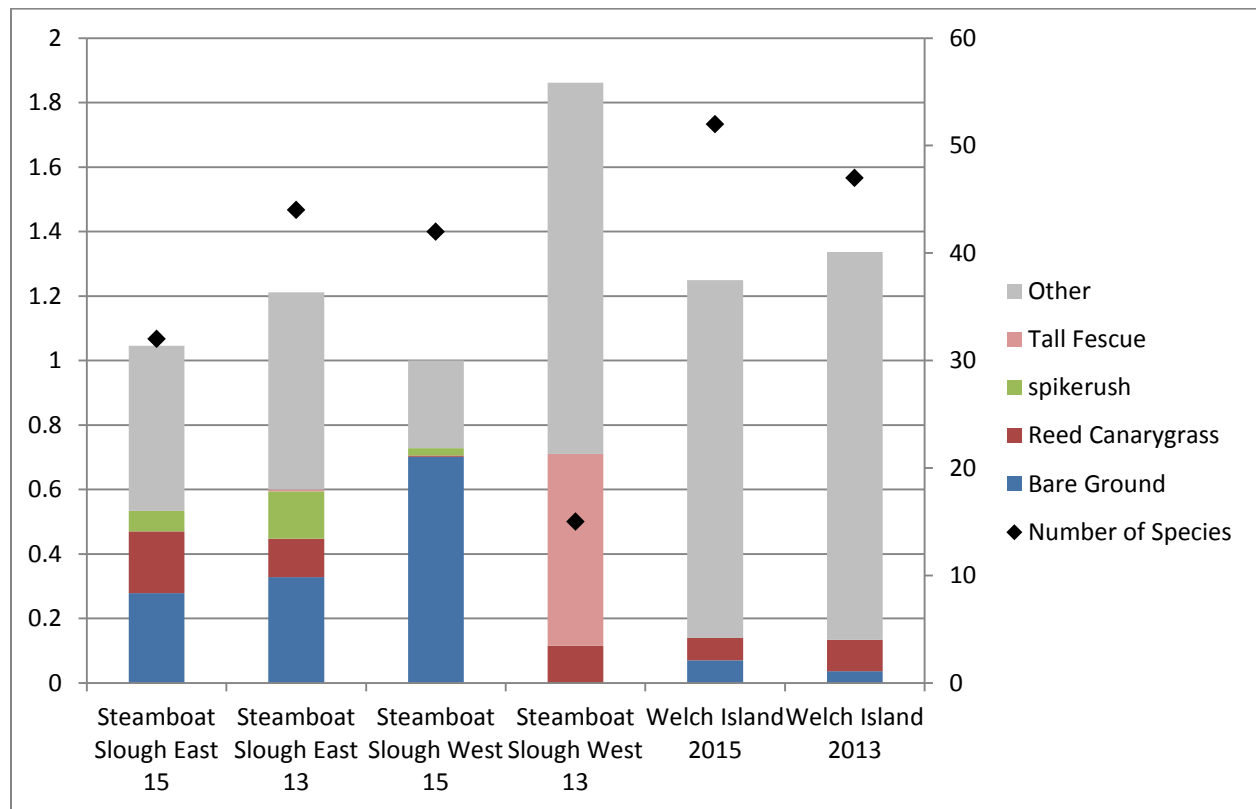
Figure 5. Vegetation cover and composition pre- and post-restoration at Steamboat Slough and Welch Island reference site

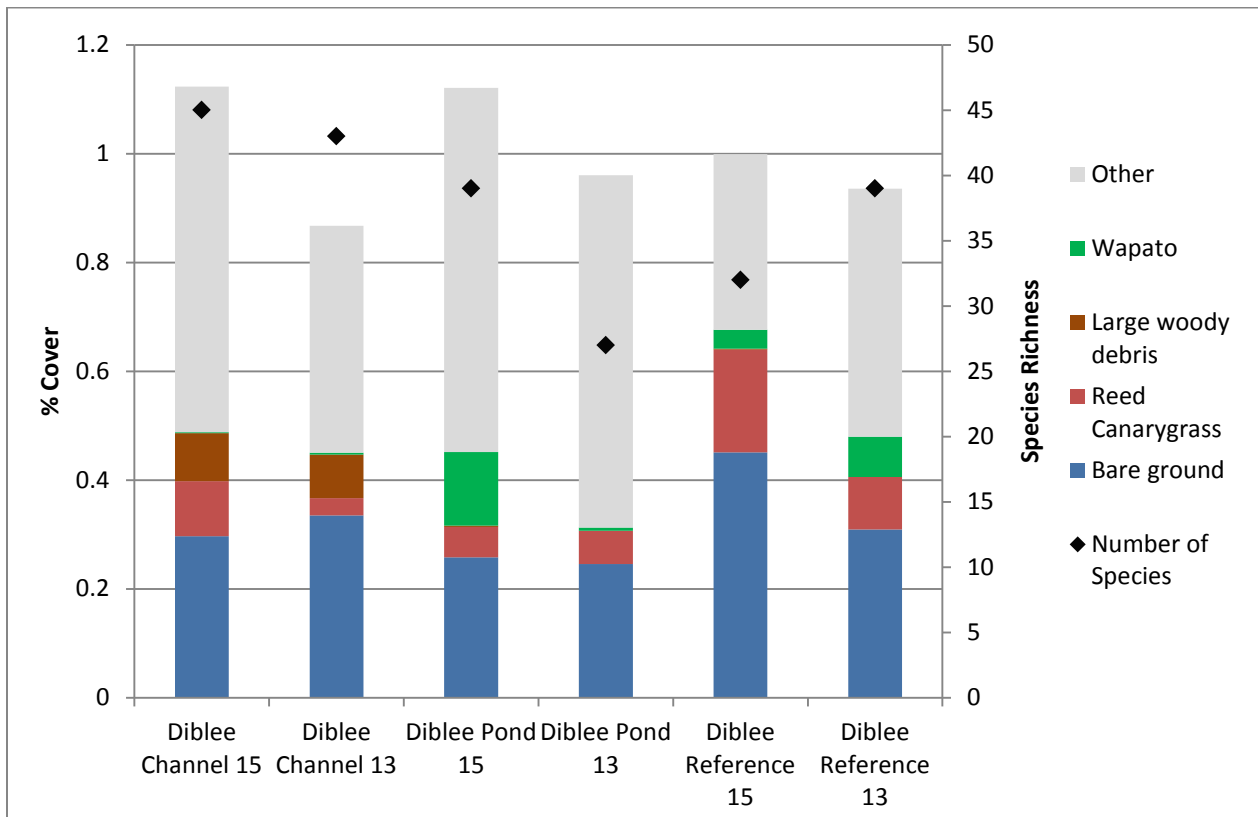
Figure 6. Vegetation cover and composition pre- and post-restoration at Dibblee Slough and reference site

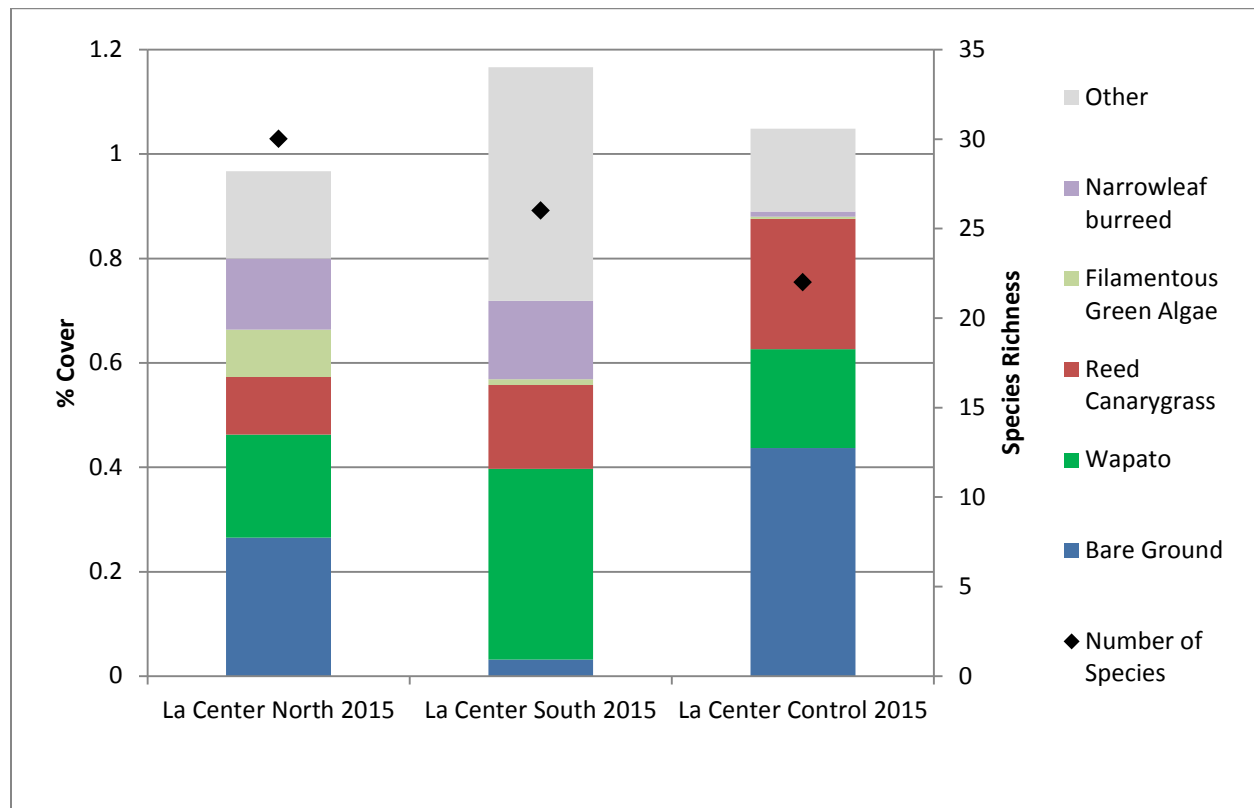
Figure 10. Vegetation cover and composition pre- and post-restoration at La Center Wetland and control site

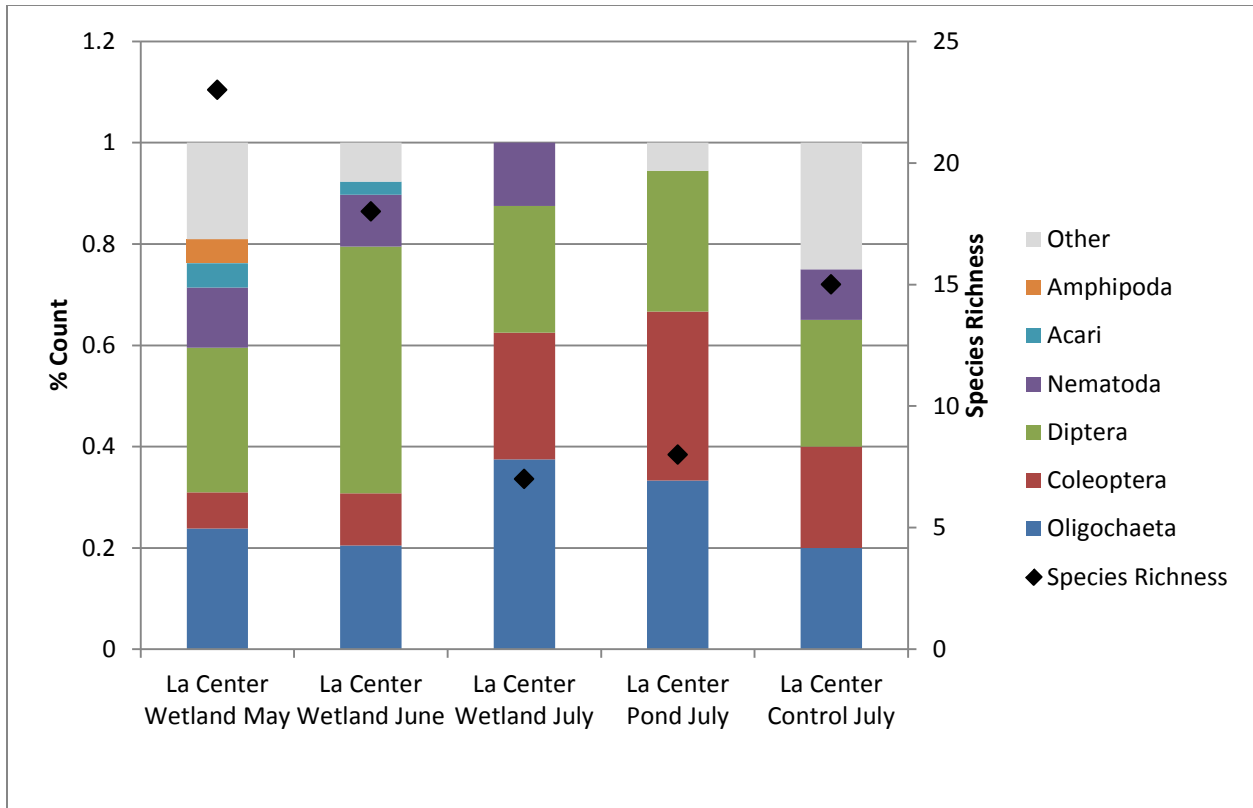
Figure 12. Percent portion of species in benthic samples at La Center Wetlands and control site

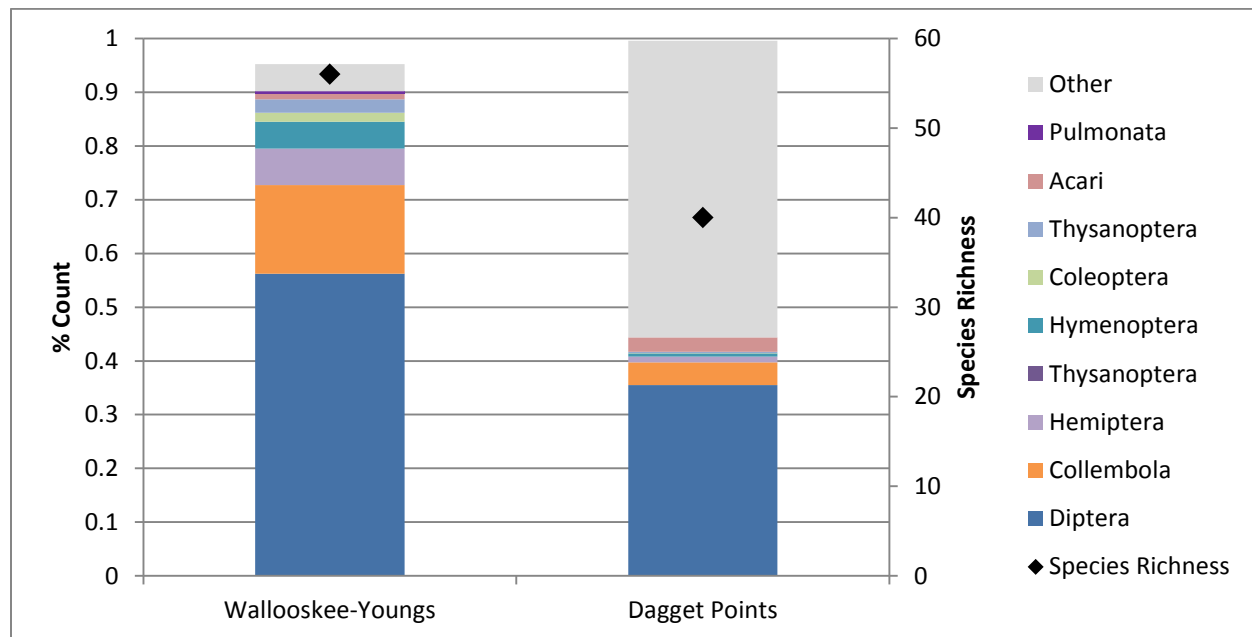
Figure 13. Percent portion of terrestrial macroinvertebrates species at Wallooskee-Youngs and reference site.

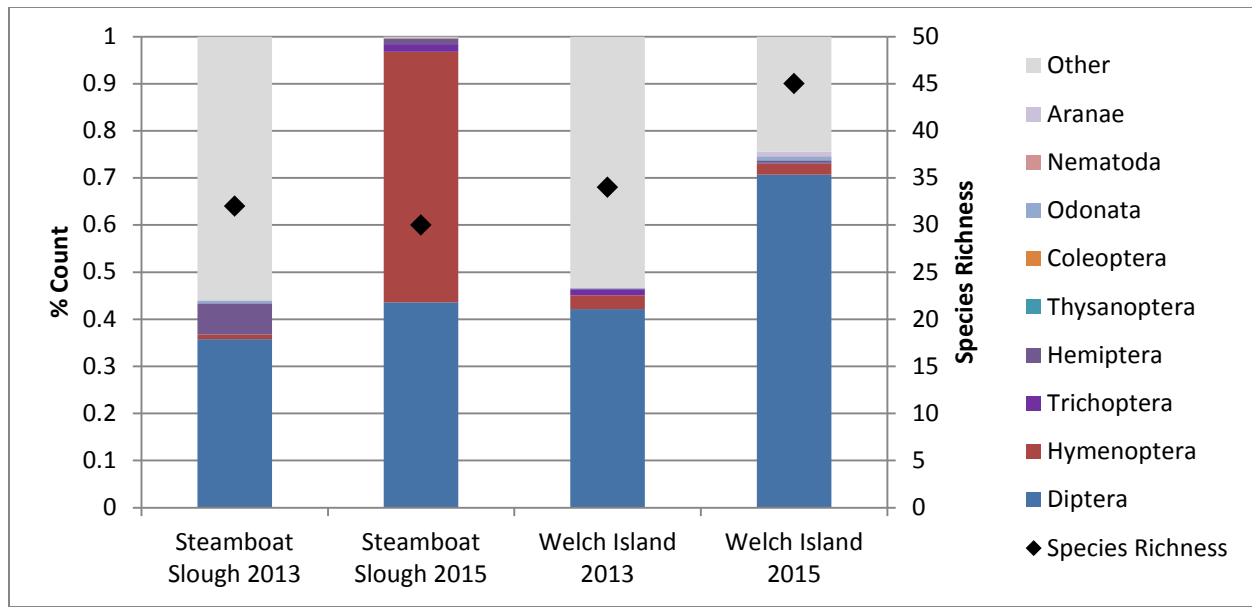
Figure 14. Percent portion of terrestrial macroinvertebrates species pre- and post-restoration at Steamboat Slough and reference site

At Steamboat Slough species richness was similar between pre- and post-restoration condition with a decrease in species diversity. At the reference site, there was an increase in species richness between 2013 and 2015, but a decrease in species richness (Table 21). Dipteran abundance was slightly higher post-restoration as Steamboat Slough, but the abundance of hymenoptera increased dramatically. At the reference site, dipteran abundance was higher in 2015 than in 2013 and hymenoptera abundance was the same between years (Figure 14).

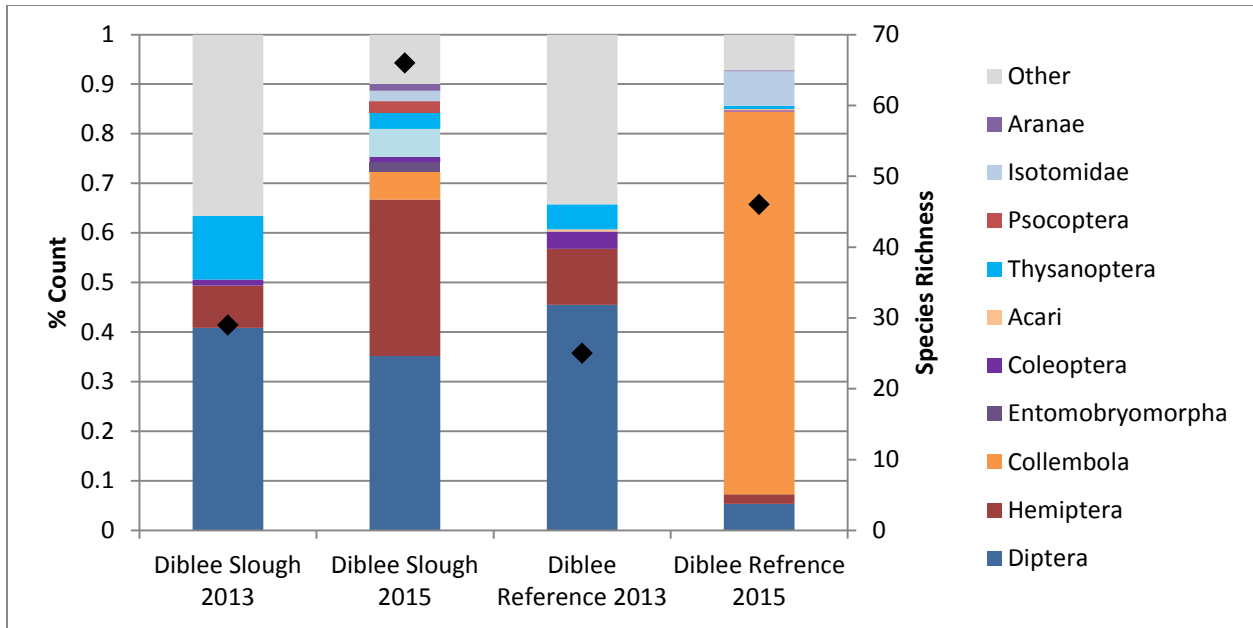
Figure 15. Percent portion of terrestrial macroinvertebrates species pre- and post-restoration at Diblee Slough and reference site

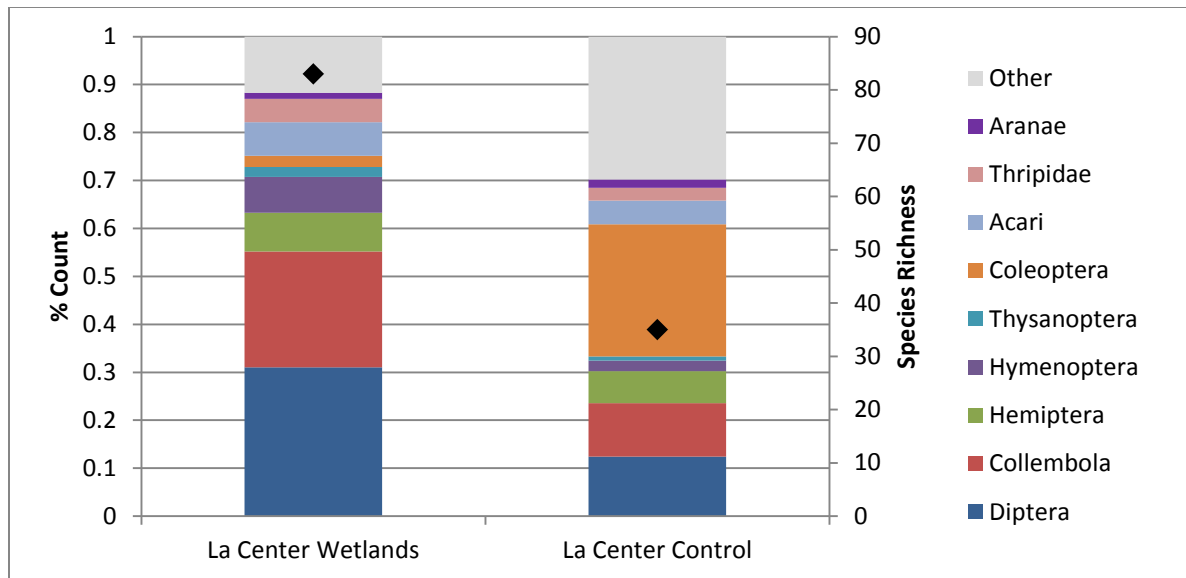
Figure 17. Percent portion of terrestrial macroinvertebrates species at La Center Wetlands and reference sites

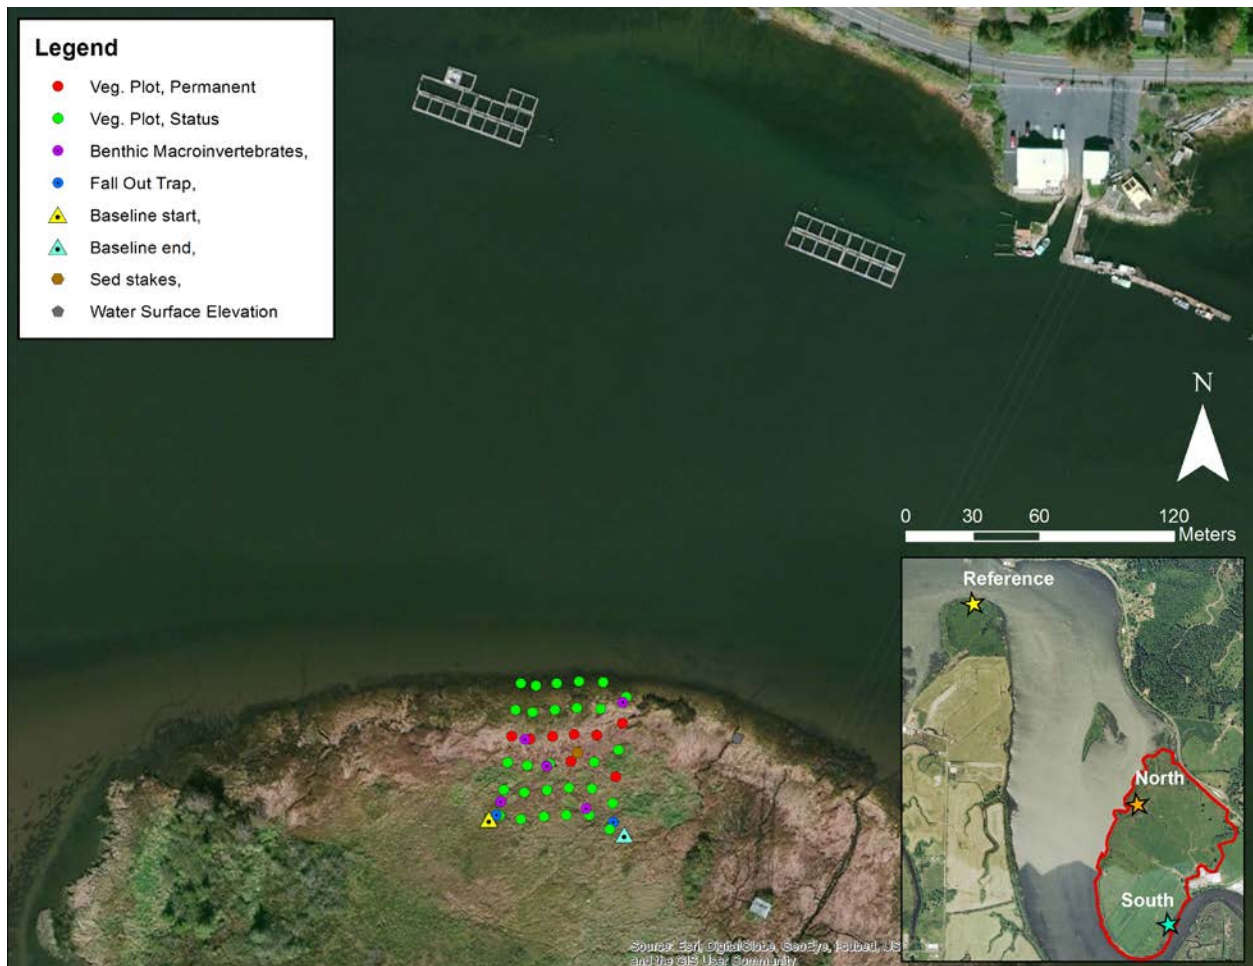
Figure 19. Vegetation and macroinvertebrate sampling locations at the Wallooskee-Youngs reference site

Veg Sample area (Figure 19)

- 60 m x 70 m, with 36 quadrat locations
- Baseline azimuth: 81° magnetic
- Transect azimuth: 351° magnetic
- Transect spacing: 10m, random start: 4
- Quadrat spacing: 10 m, random starts: 2, 2, 4, 6, 7, 1
- 8 permanent quadrats, randomly selected, systematically to ensure coverage on all transects

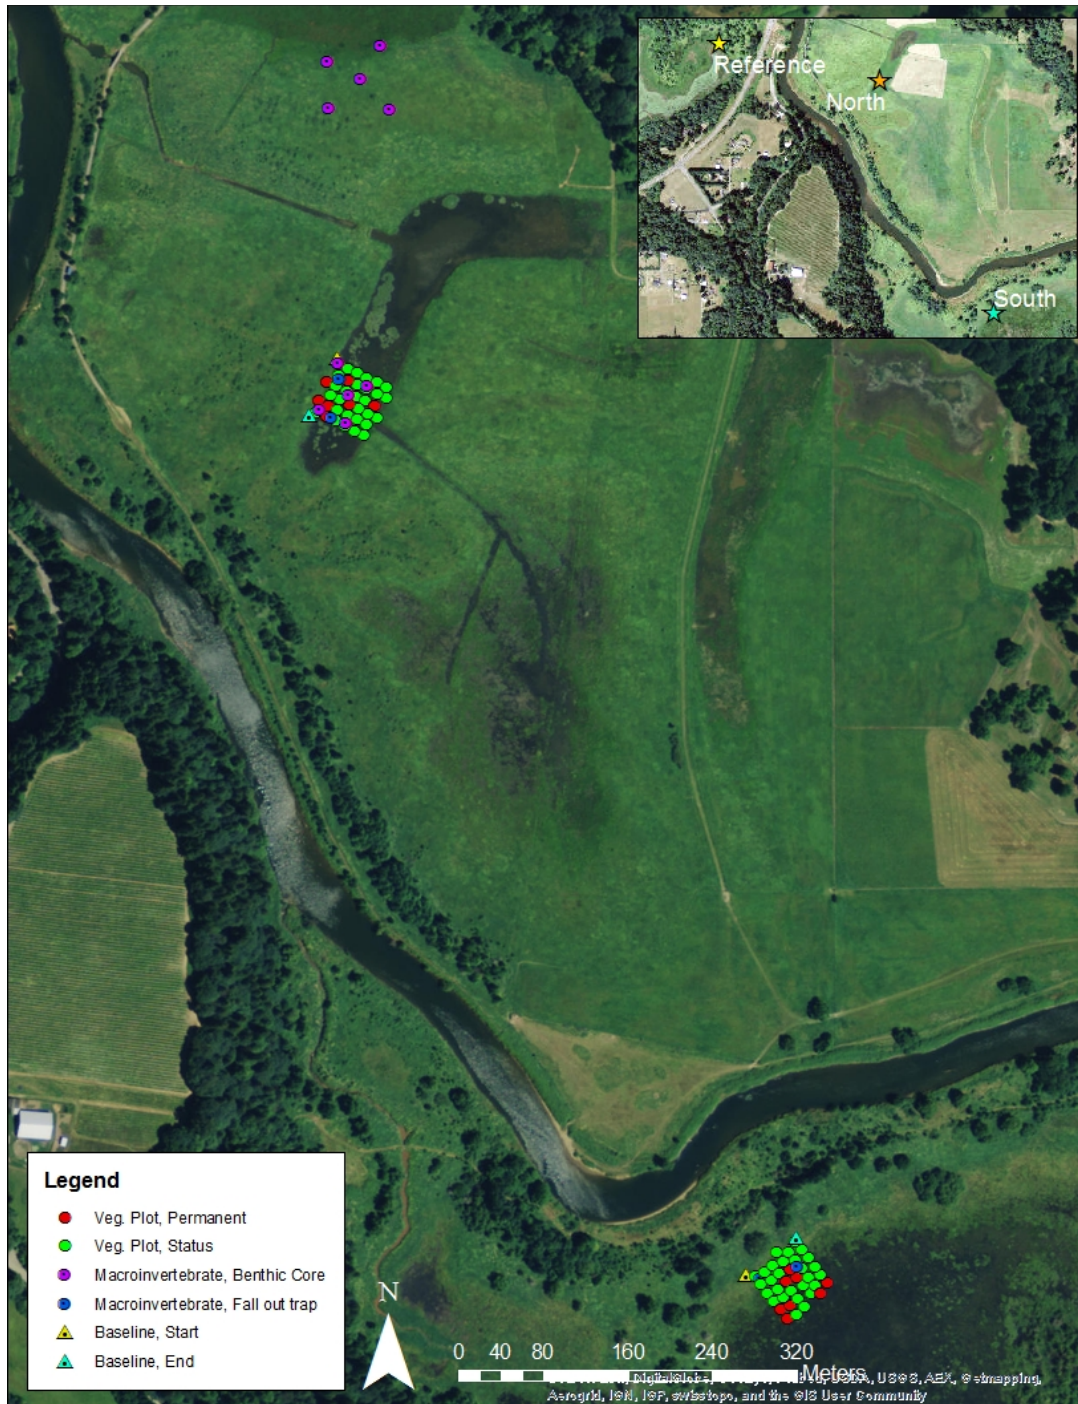
Figure 23. Vegetation and macroinvertebrate sampling locations at the La Center Wetlands restoration site.

- Located on the south side of the East Fork Lewis River.
- 60m x 60m, with 36 quadrat location
- Baseline azimuth: 39° magnetic
- Transect azimuth: 129° magnetic
- Transect spacing: 10 m, random start: 7
- Quadrat spacing: 10m, random starts: 5, 8, 7, 0, 6, 2
- 8 permanent quadrats, randomly selected, systematically to ensure coverage on all transects
