Lessons Learned for the Columbia from Puget Sound Estuary Restoration

*Dan Elefant PE, Environmental Science Associates, delefant@esassoc.com **

zis a ba Estuary Restoration

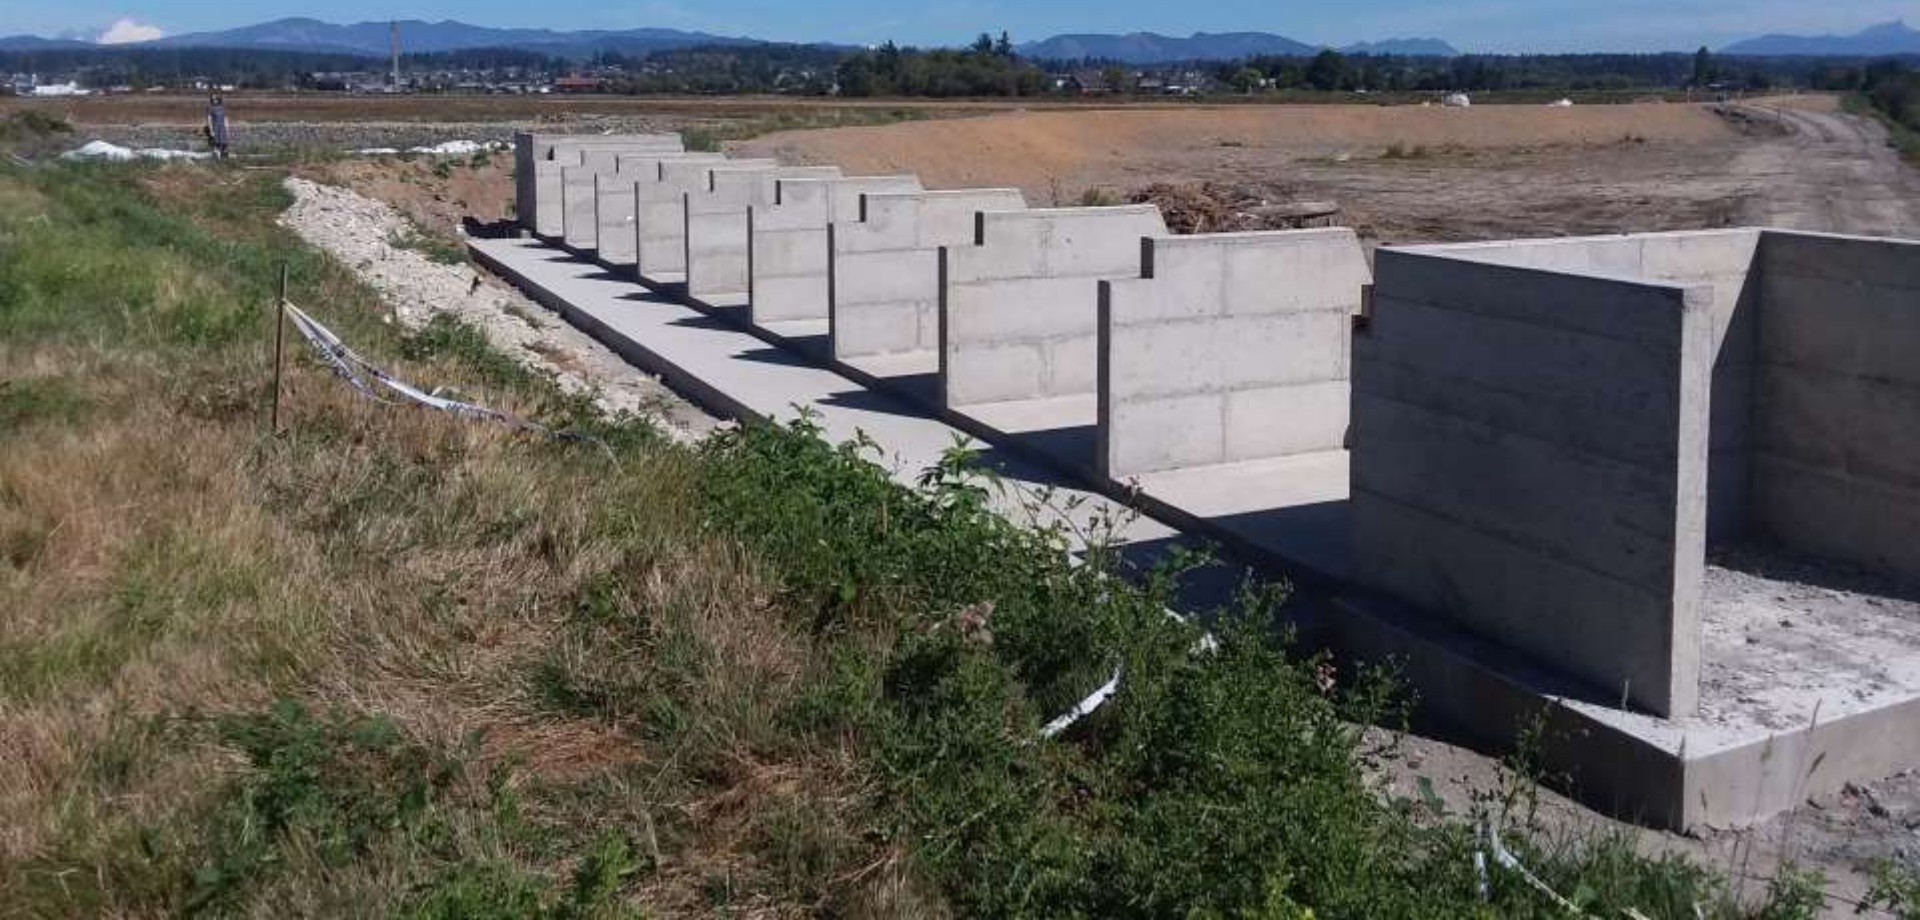
Lesson: Address Stakeholder Concerns early and thoroughly

- New Floodgate: 3000 CFS when Florence Island Inundates
- New Cross-dike
- Main channel sedimentation analysis
- Avulsion prevention
- Pipeline protection

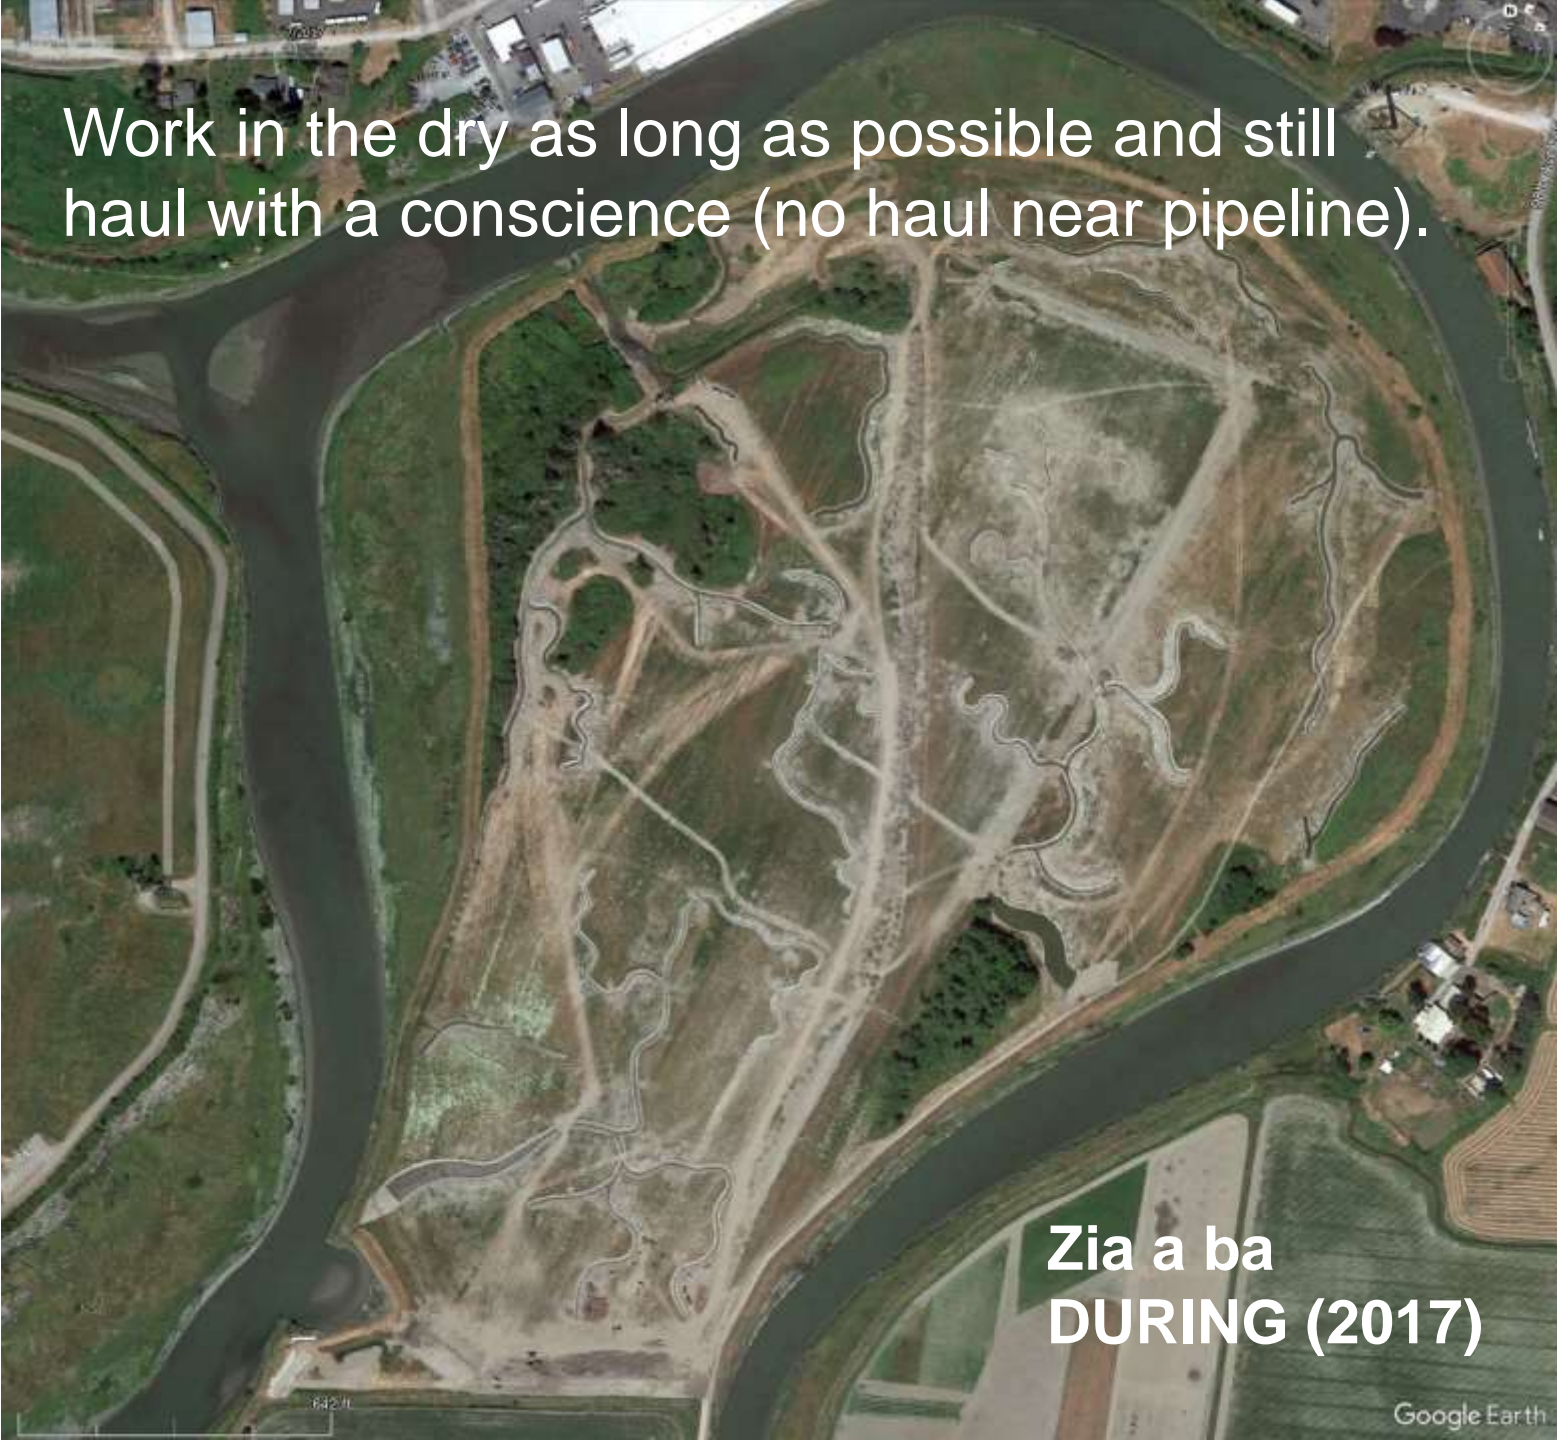
Zia a ba
DURING (2017)

Minimize construction impacts ...

- Require “Morooookas!” (tracked hauling equipment, 7psig max)
- Site haul routes along channel alignments and dike removals only
- Work in the dry.
 - TNC’s 2012 restoration created 2 breaches and insufficient dike removal ... now we’re in the wet to fix it

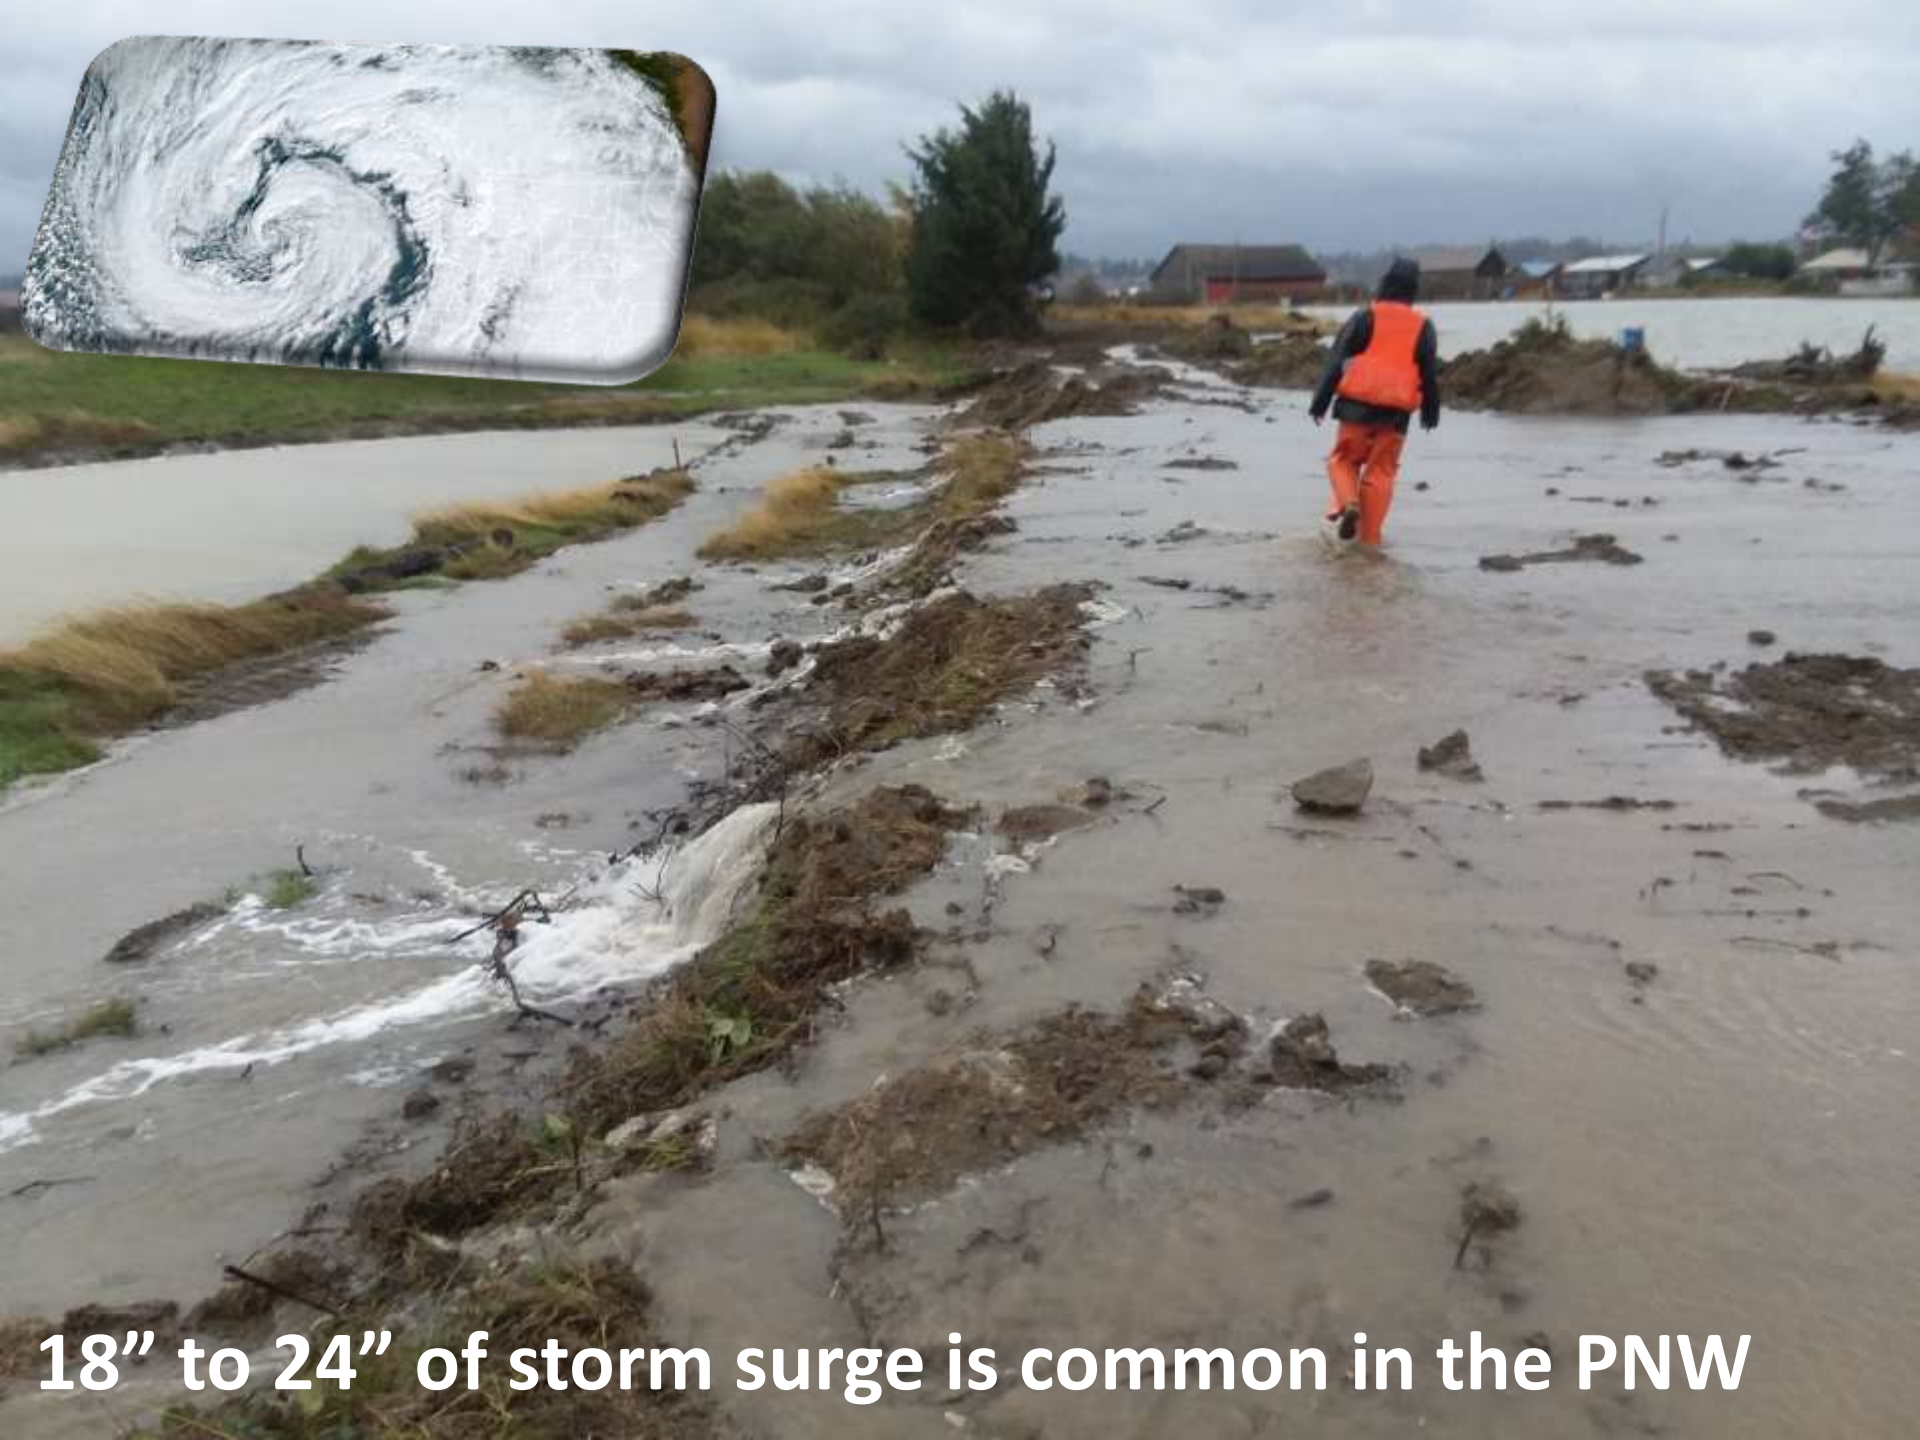
18" to 24" of storm surge is common in the PNW

zis a ba: hydraulics risk assessment → cross dike, floodgate, spur dike, and habitat/infrastructure protection berm

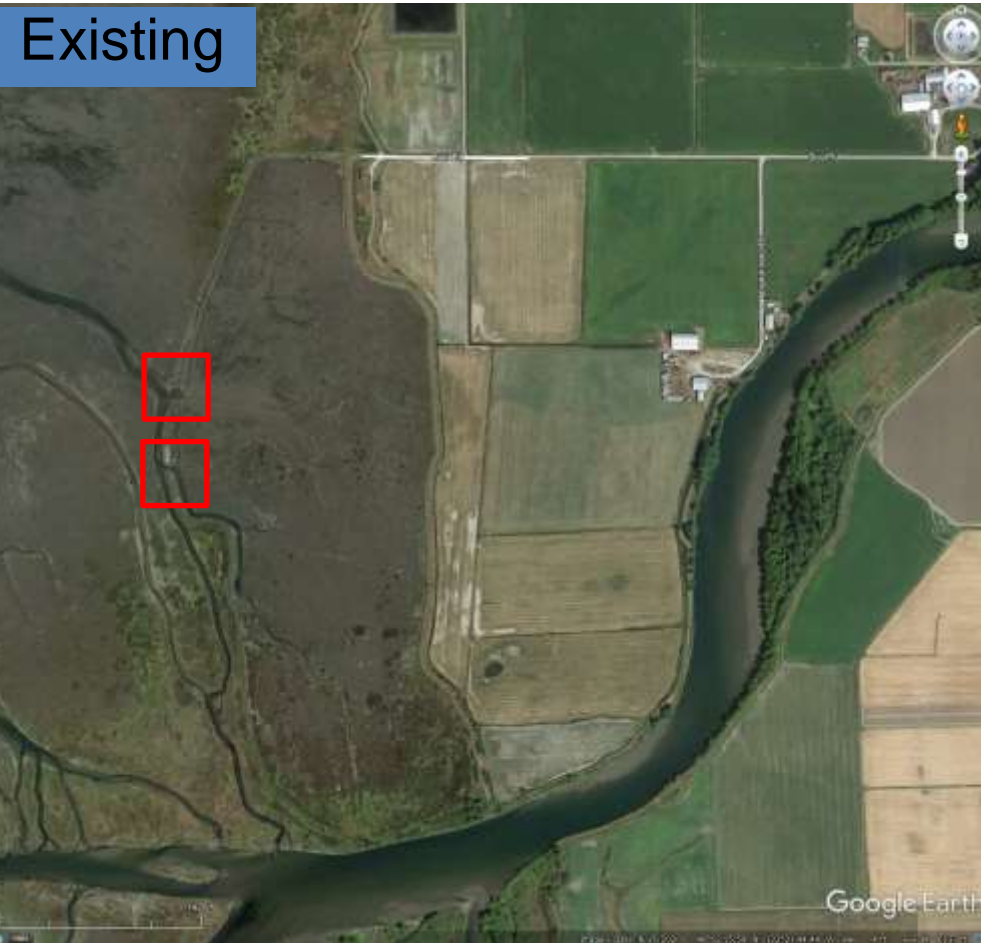
Existing

TNC's Port Susan Bay Preserve – Adaptive Management in the wet ...

Lessons: tide channels will not form on their own, create oversized breaches, strategize levee removals, & plan for subsidence, marsh evolution, and SLR.

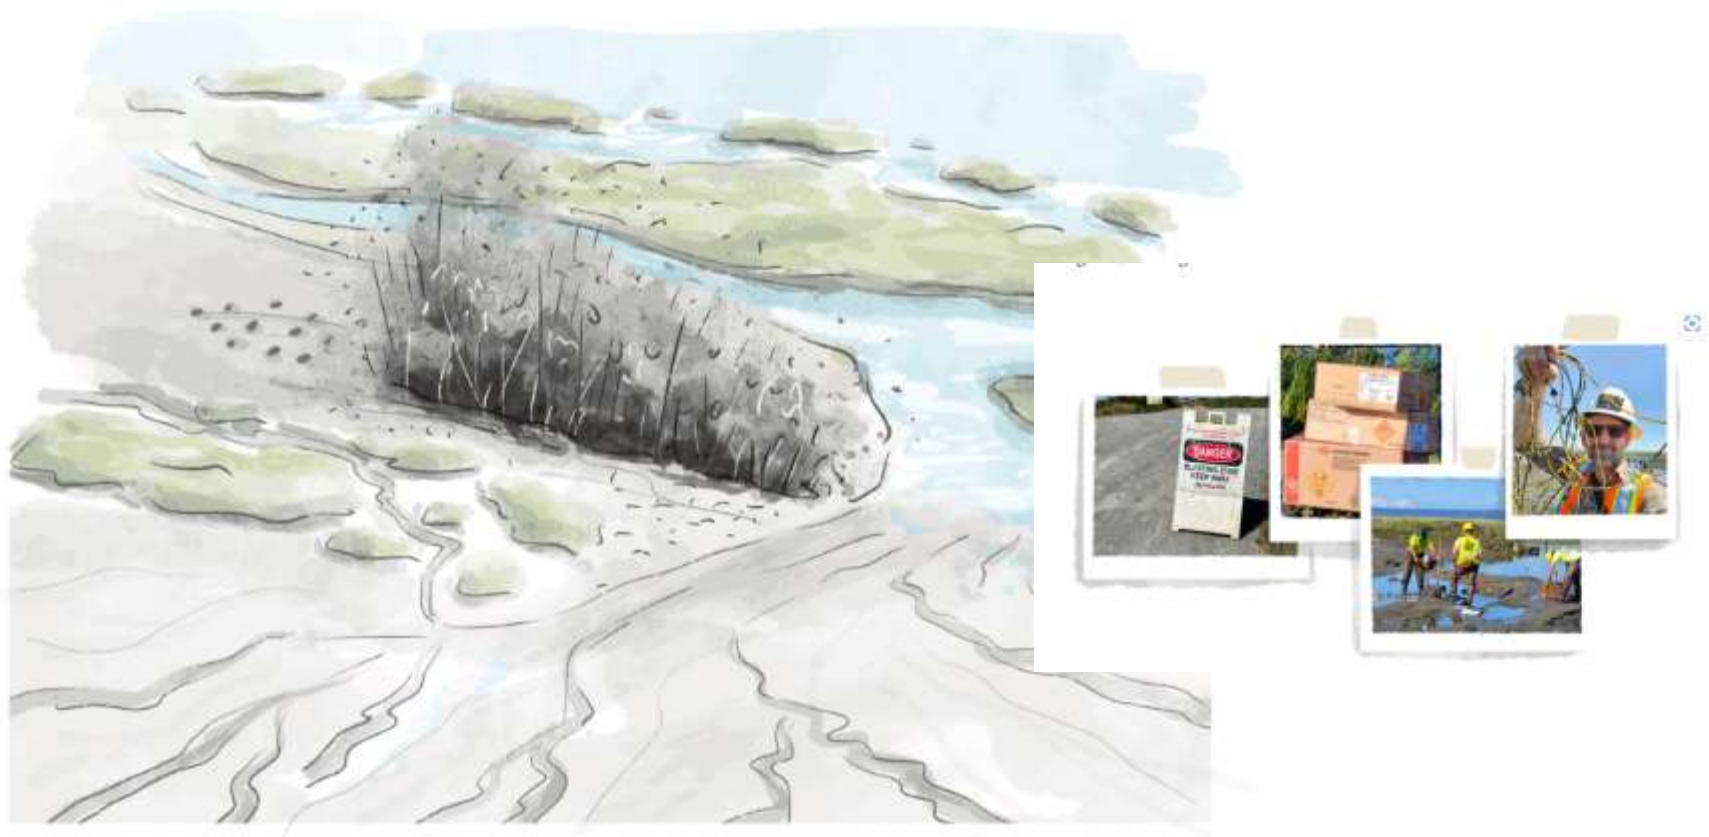
Simulation of the Port Susan Bay blast on August, 11, 2022. Illustration by Erica Simek Sloniker / The Nature Conservancy.

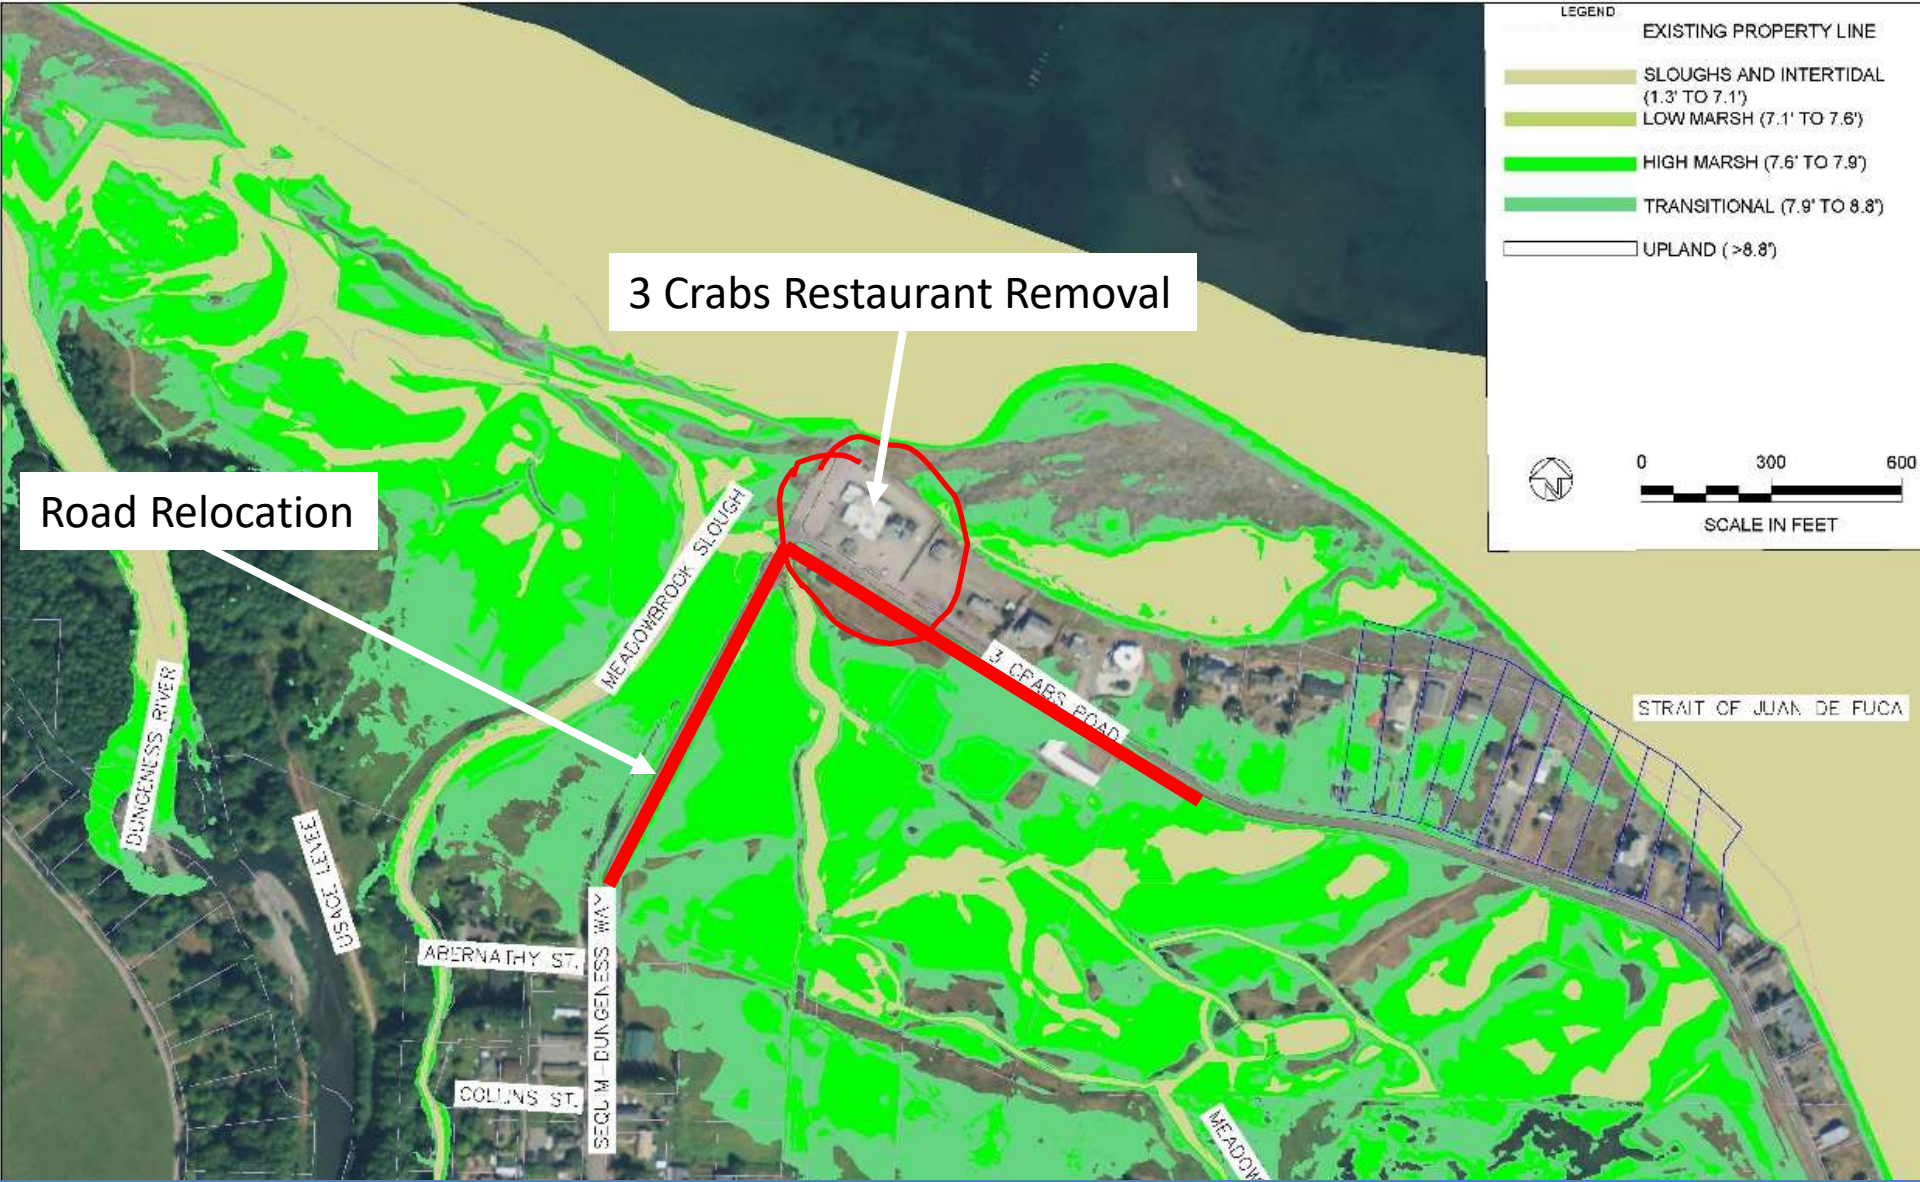
3 Crabs existing conditions before restoration

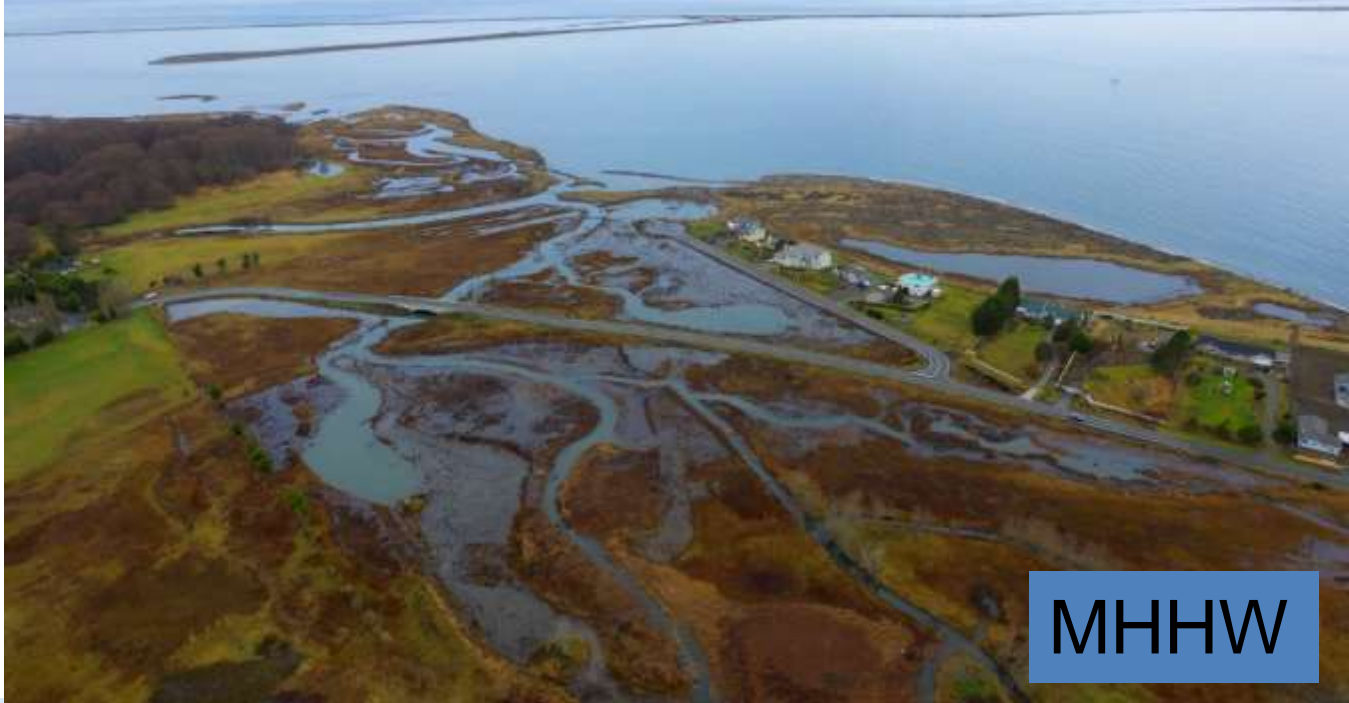
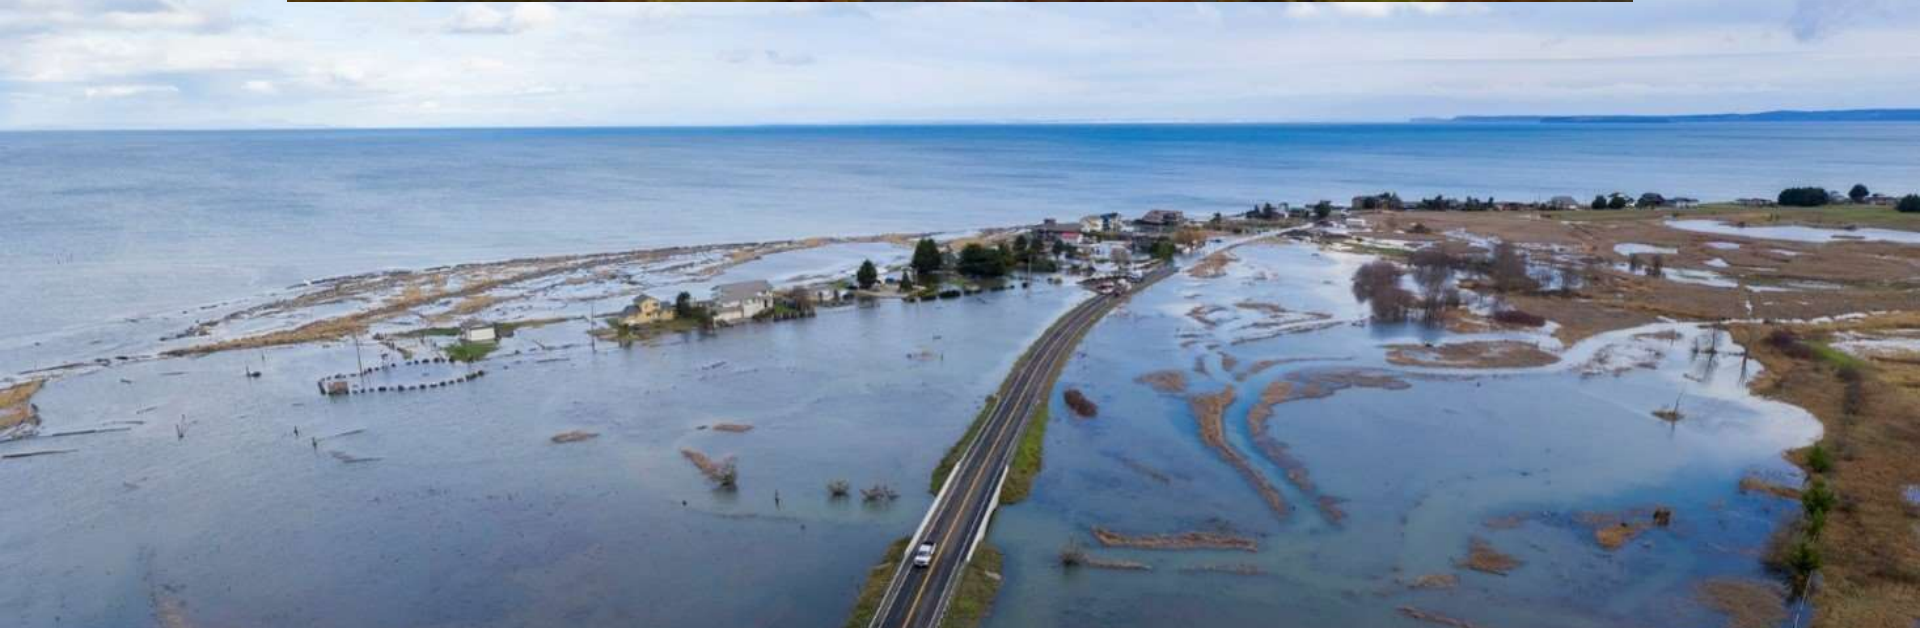
Lesson: communicate existing conditions flooding ...

So that project conditions with king tides don't surprise folks.

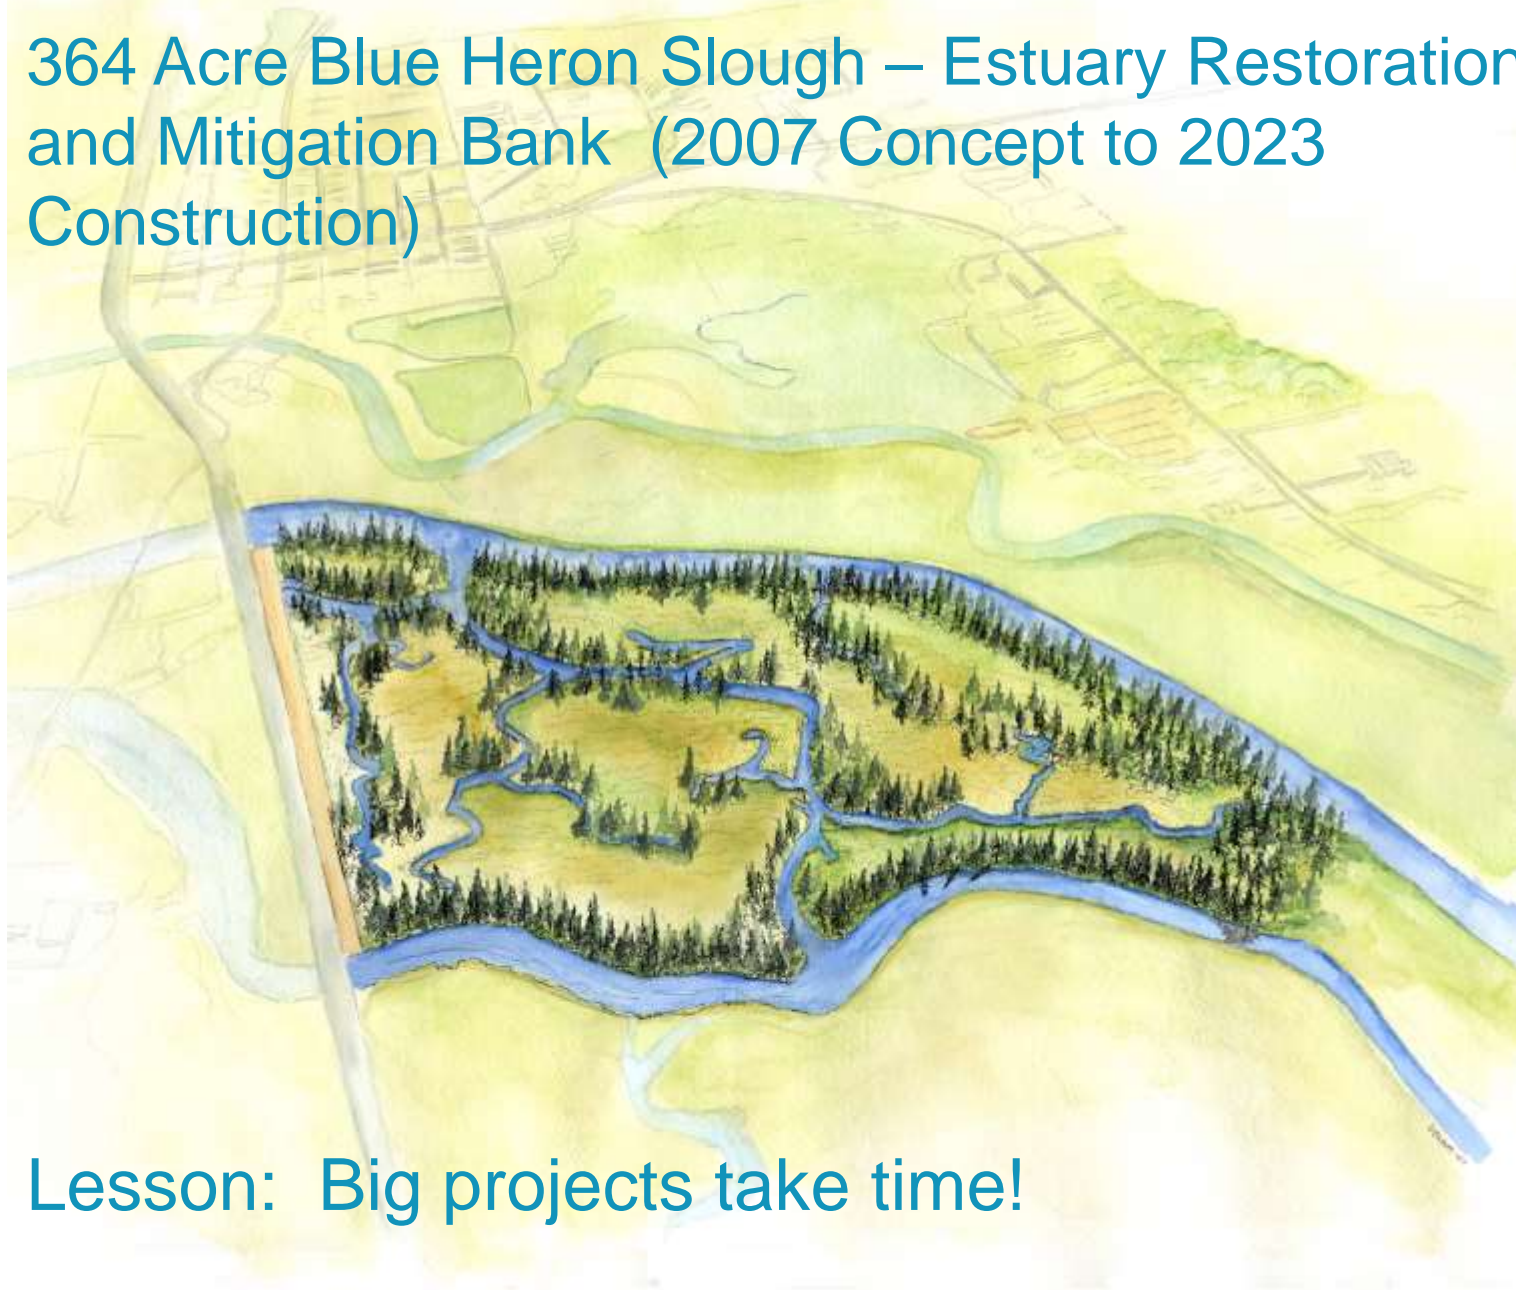
364 Acre Blue Heron Slough – Estuary Restoration and Mitigation Bank (2007 Concept to 2023 Construction)

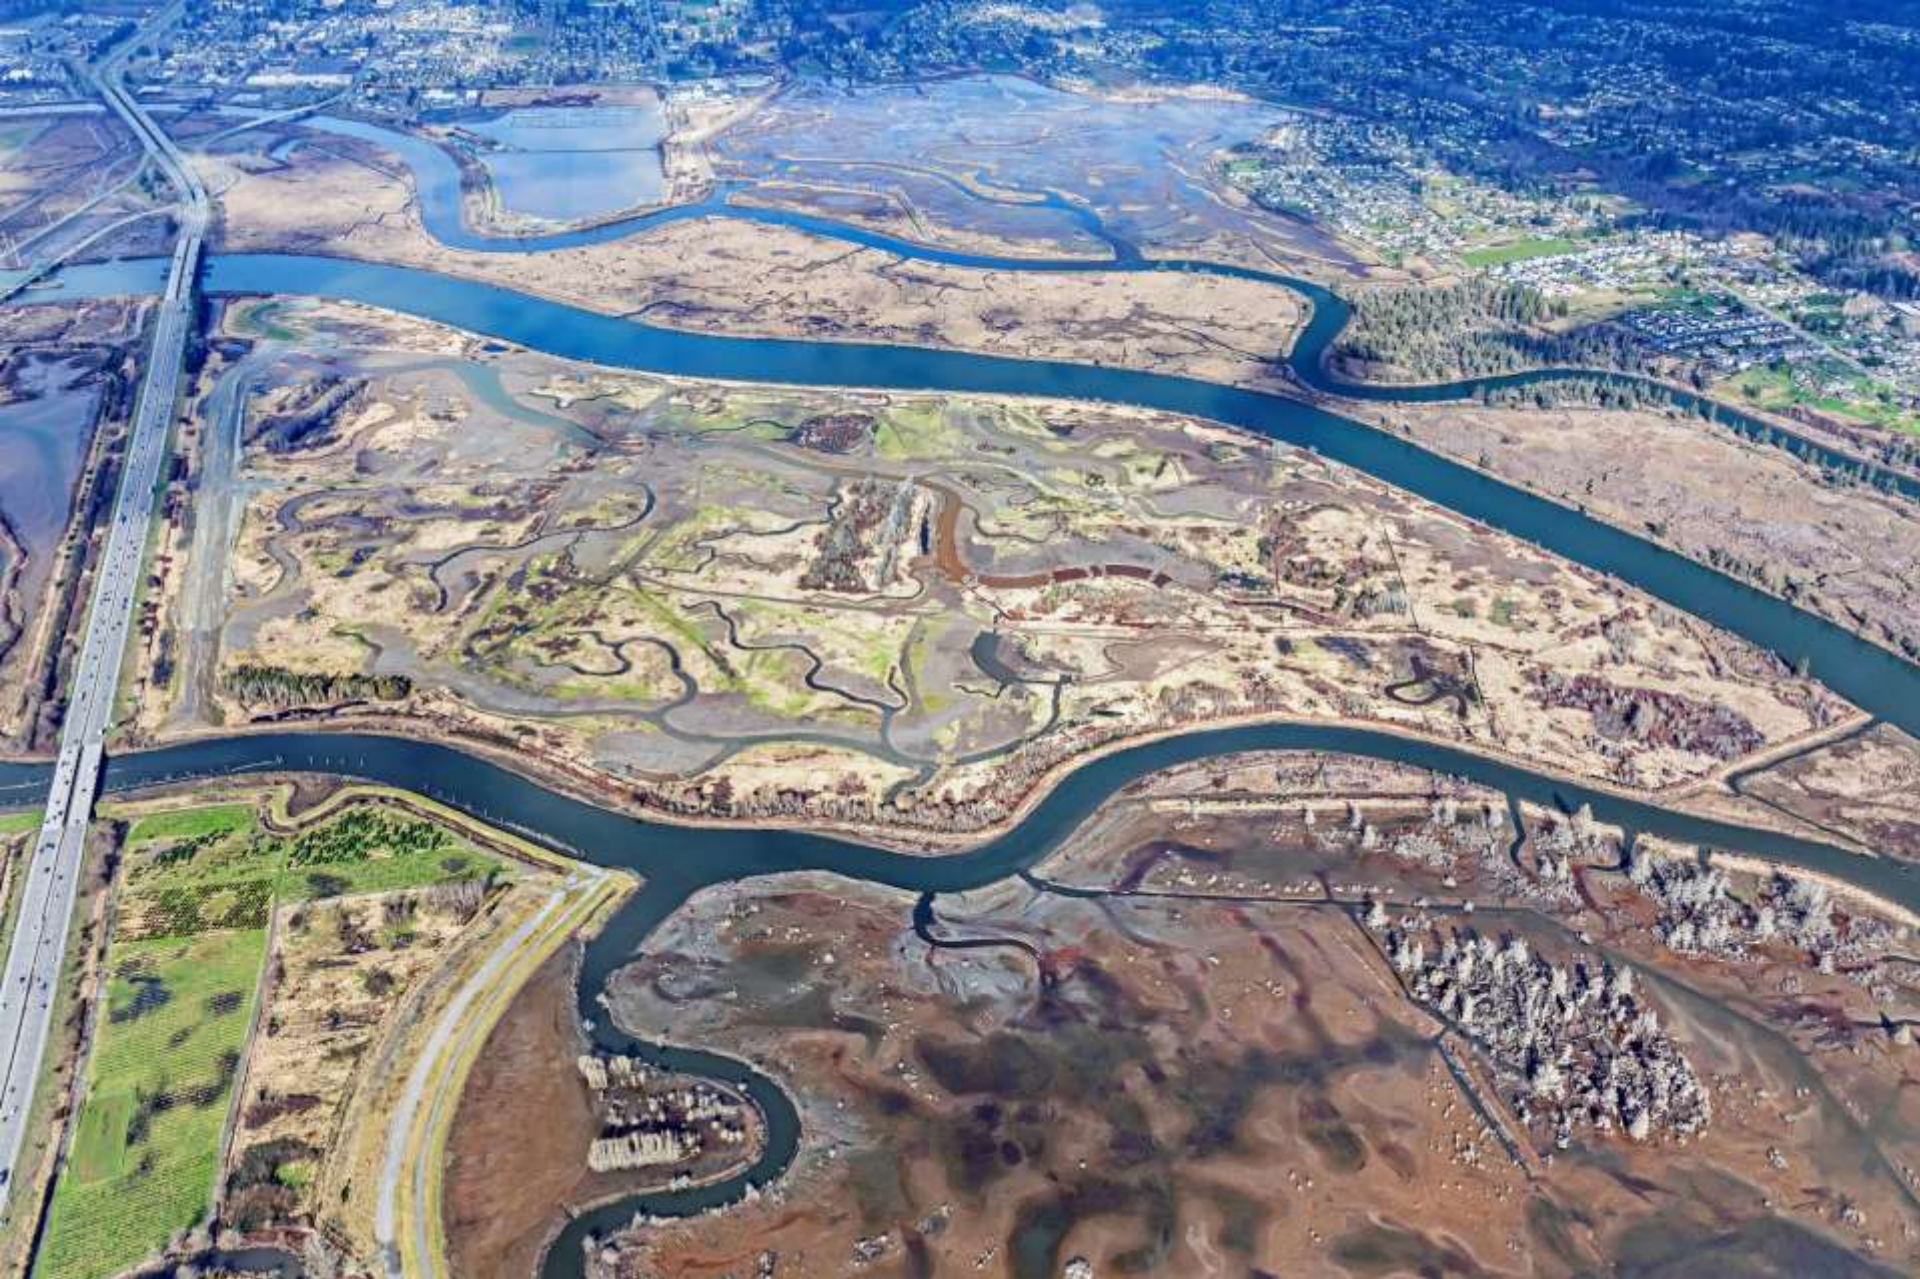
Lesson: Expect levee failures

- Construction delays & difficult conditions
 - Flooding/overtopping levee during construction
 - Extremely soft sediments – stuck equipment
- Breach timing, in-water work windows
- Working in the dry vs wet
- Achieving/verification of grades after breach
 - Seasonal tide constraints (wintertime low tides) – safety
- Construction access after breaching

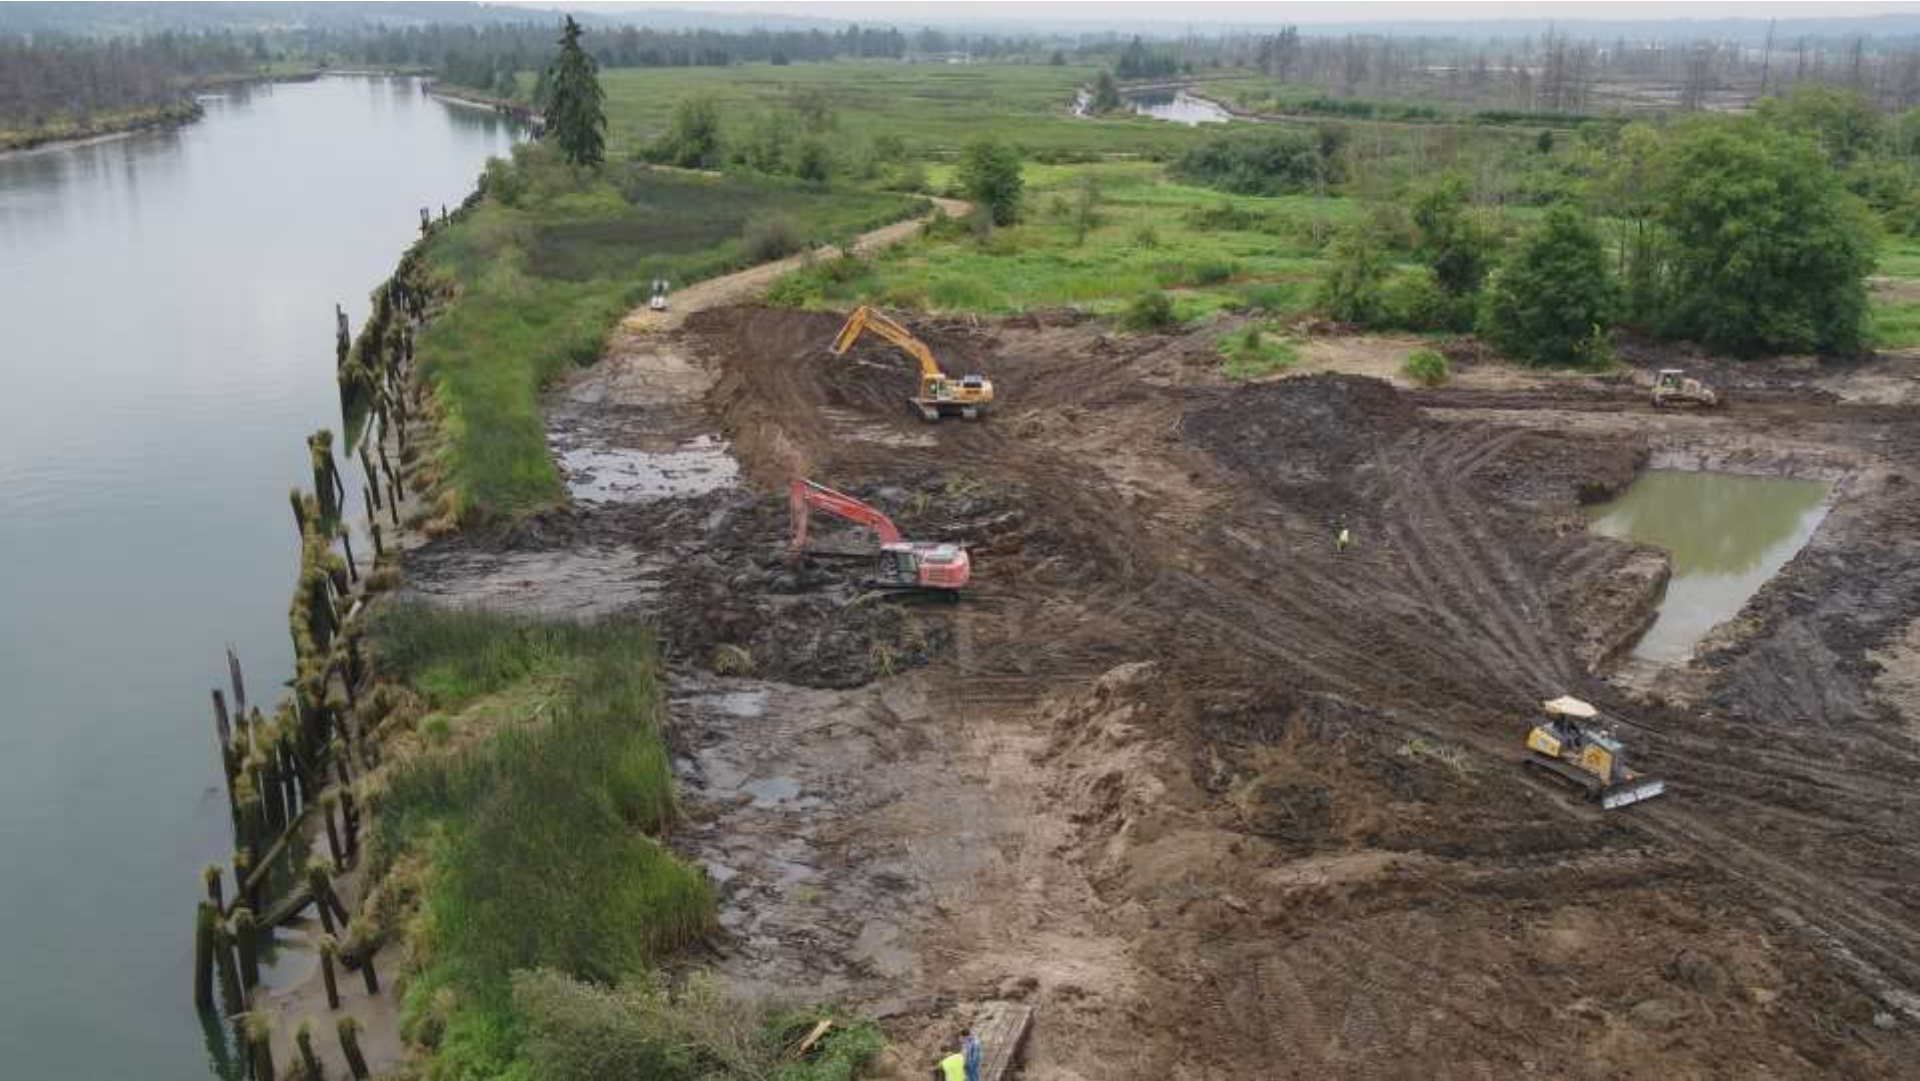
Lesson: Excavators sink quickly, know the site

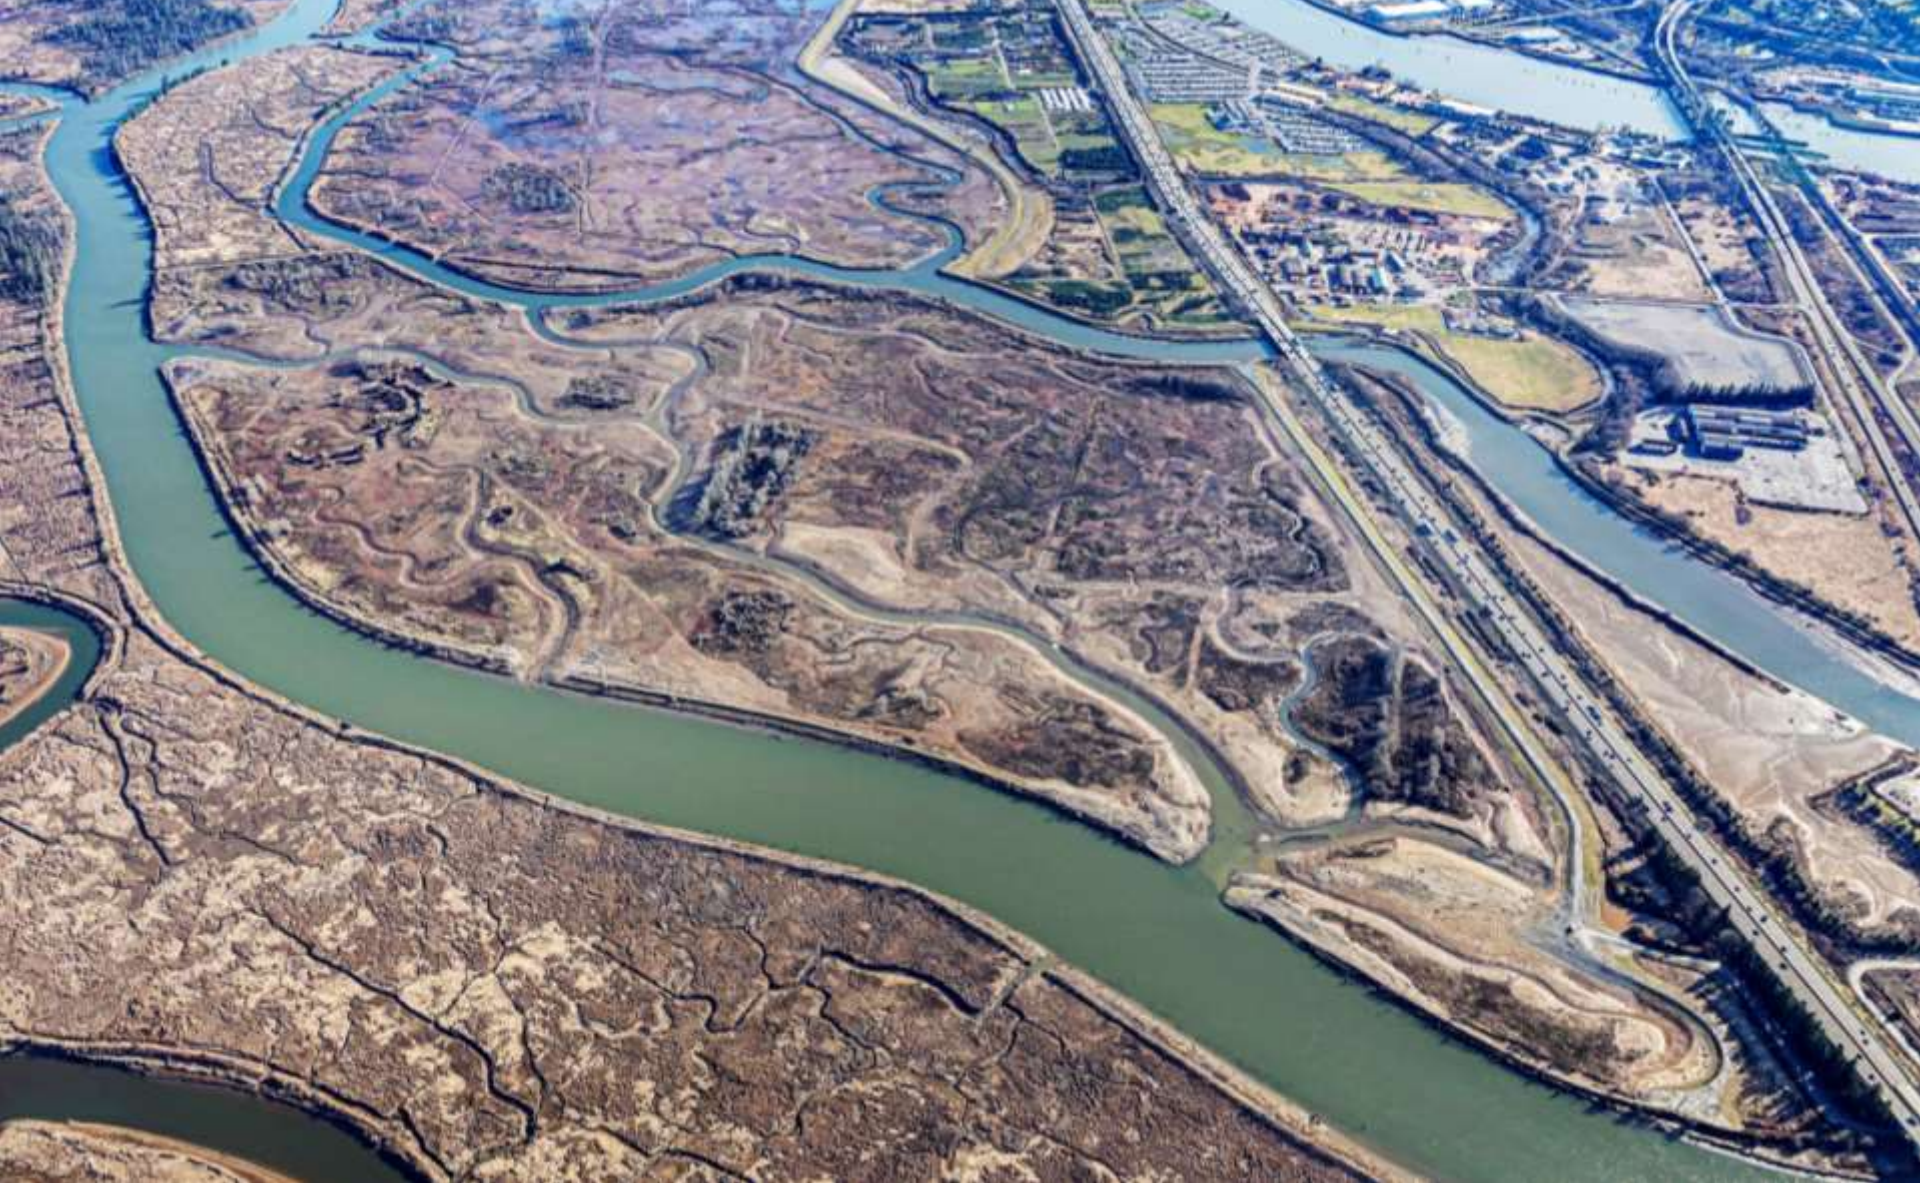
Lesson: Use amphib where applicable?
