Lessons Learned for the Columbia from Puget Sound Estuary Restoration

*Dan Elefant PE, Environmental Science Associates, delefant@esassoc.com **

zis a ba Estuary Restoration

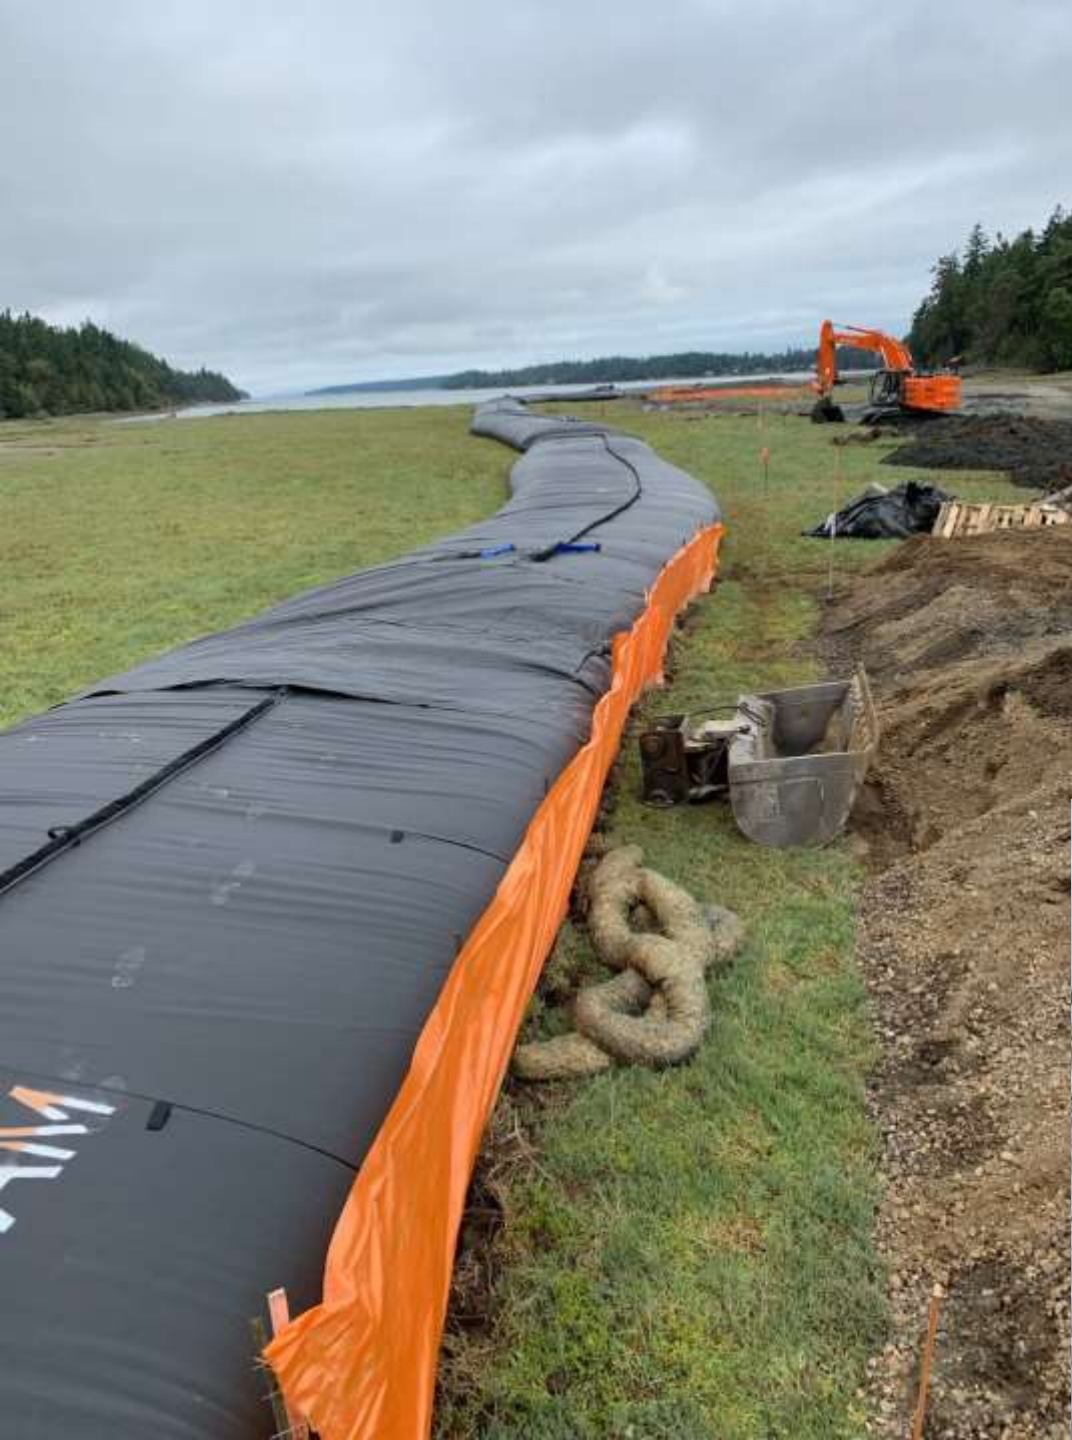
Flood Tide

Want to save \$\$, protect native marsh, and use water-filled coffer dams (aka Aquadams)?

Kilisut water dam example ... contractor neglected to pull dam 2 months into fall season. Storm surge failure.

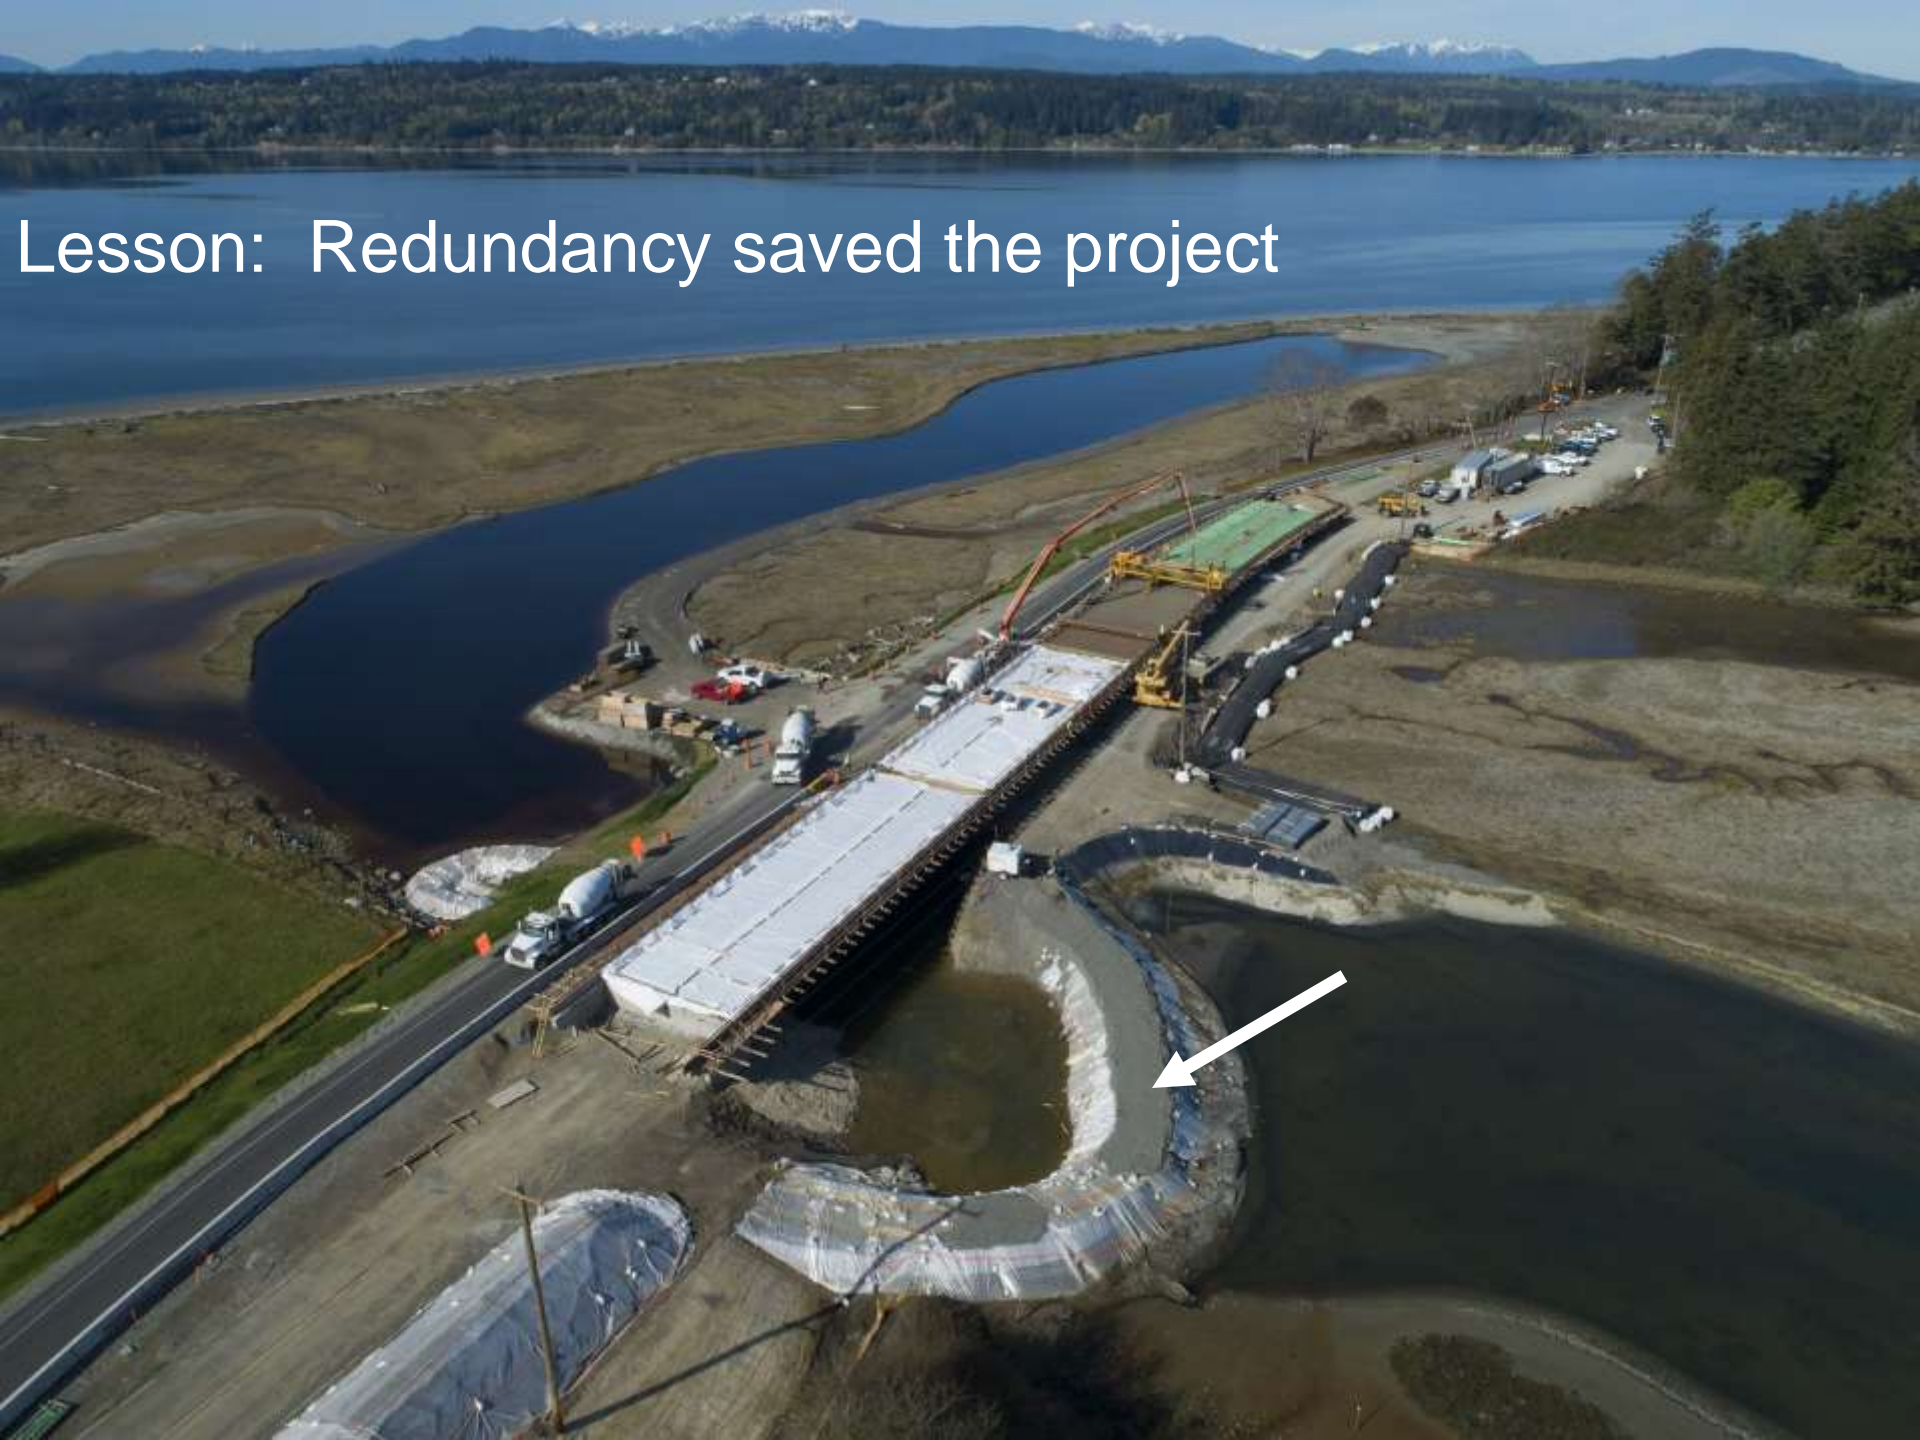
Lesson: Redundancy saved the project

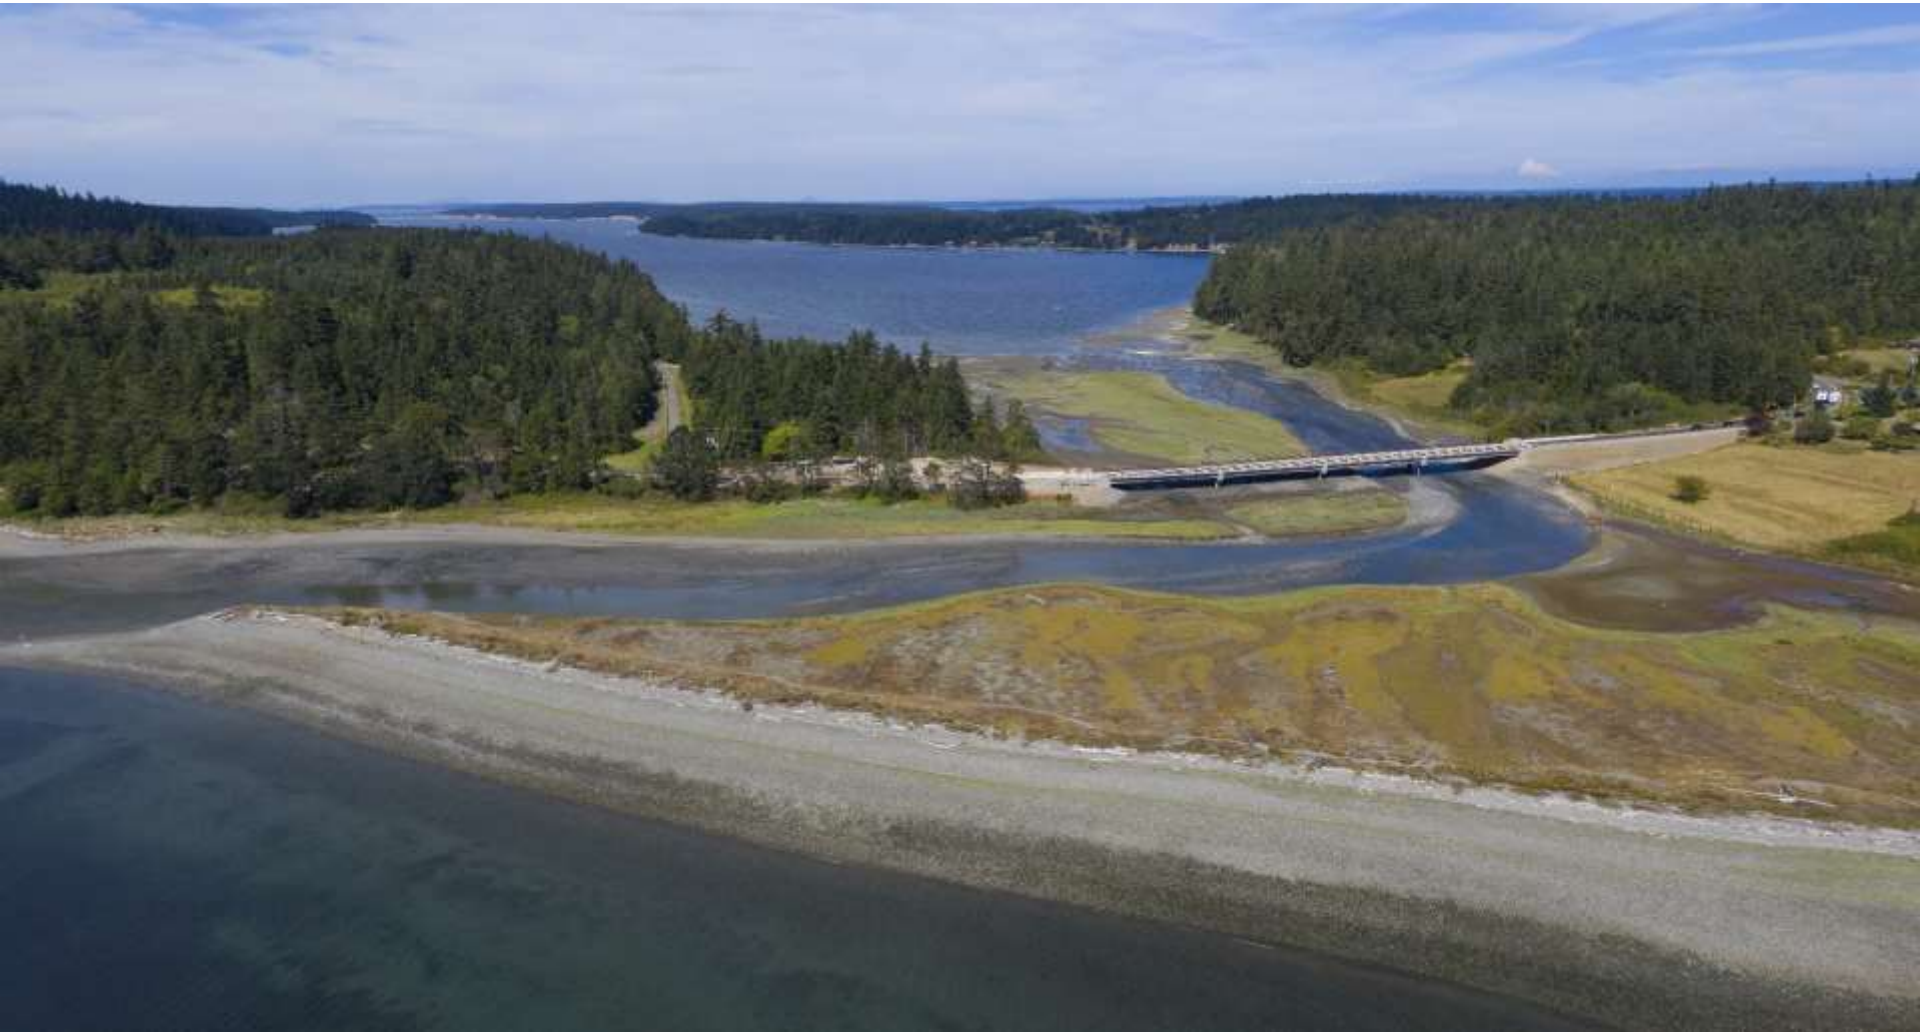
Kilisut after construction

Lesson: Plan for channel migration through full
Span of the bridge (3500 CFS at max flood tide)

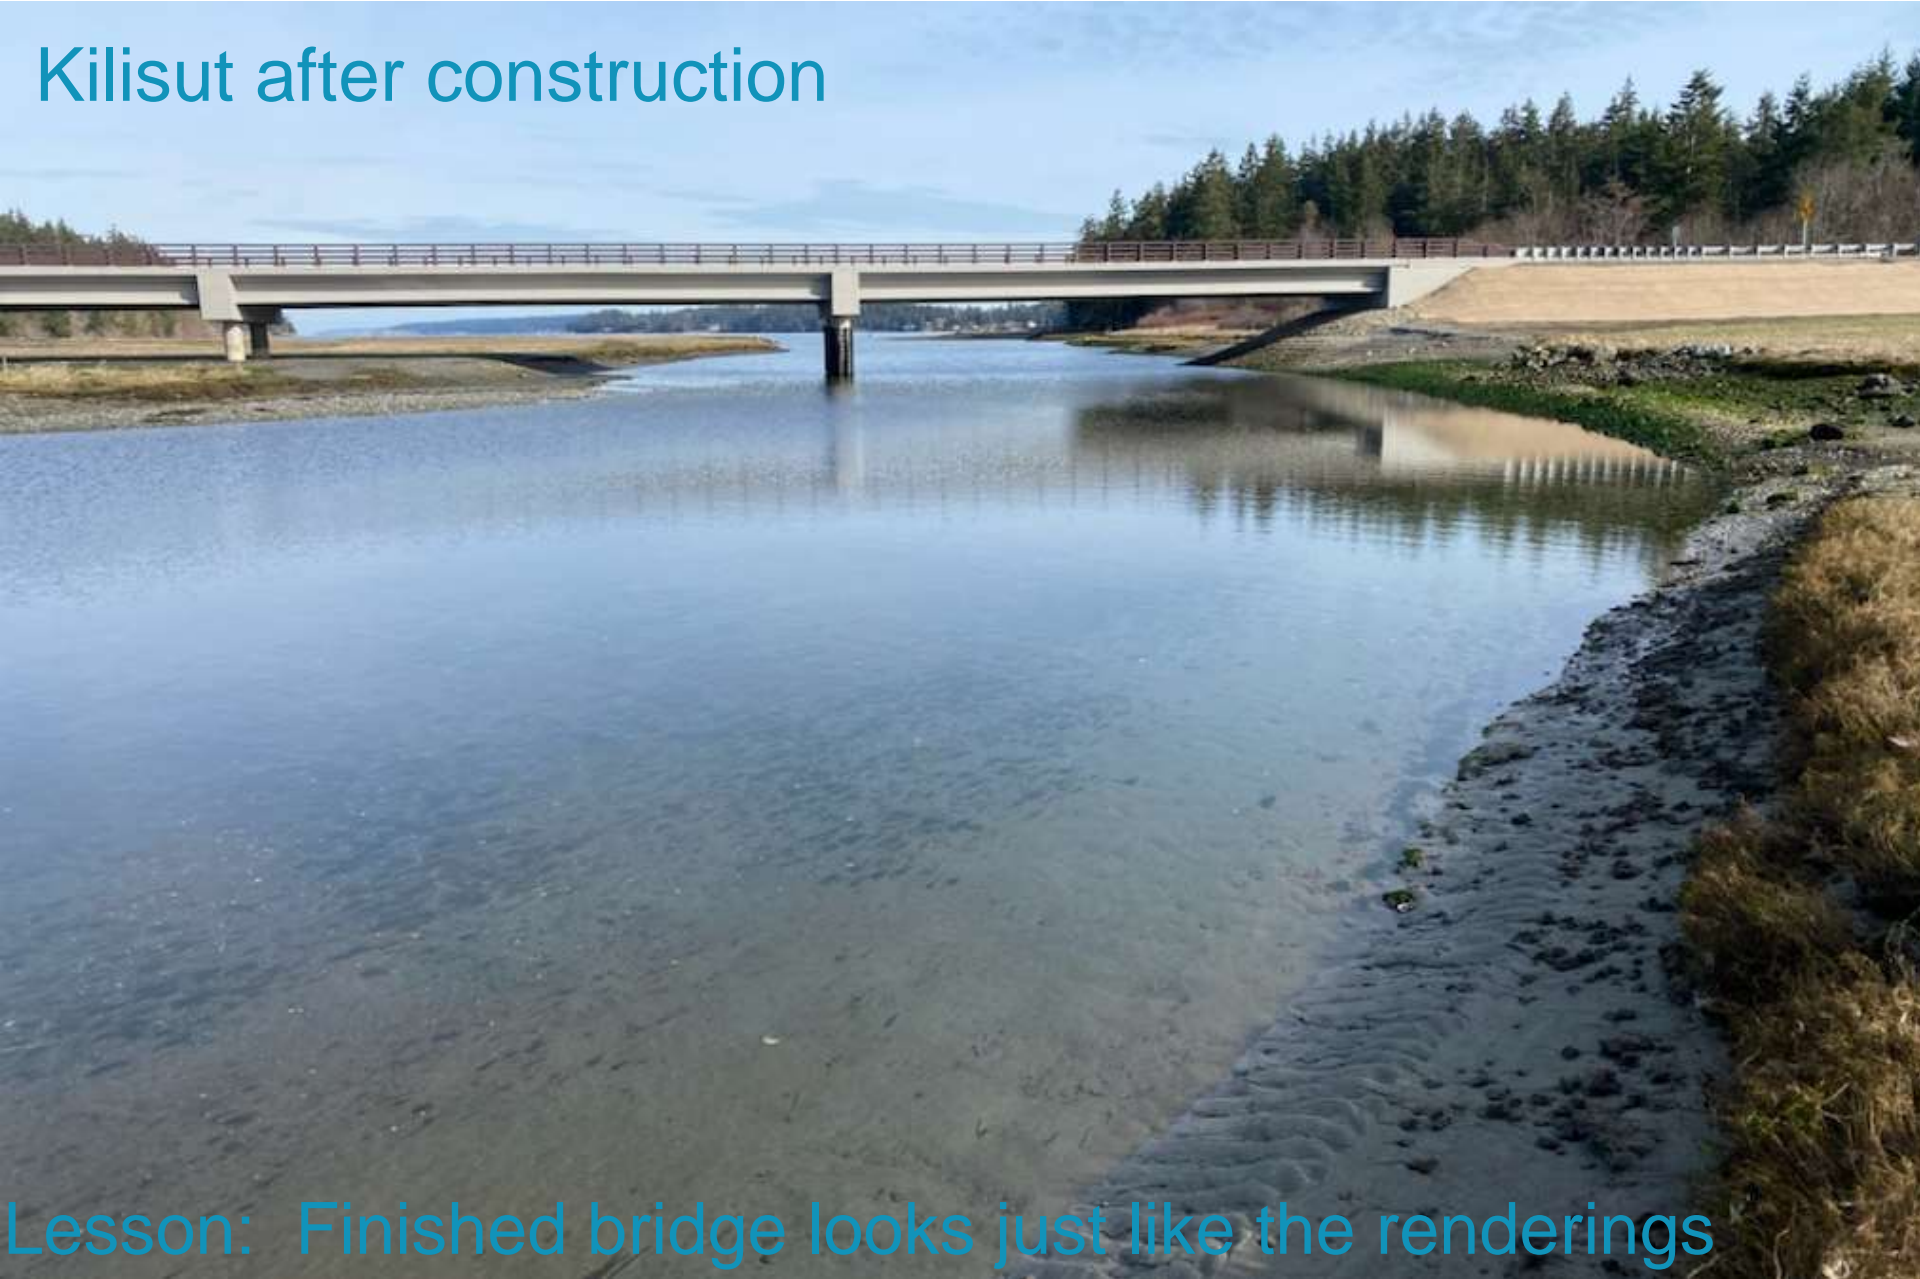
Kilisut after construction

Lesson: Finished bridge looks just like the renderings
