Changes in Tidal Hydraulics at Crims Island in Response to Restoration Activities

2014 Columbia River Estuary Workshop:
Forging Links in the Columbia River Estuary

- 1) Highlight Implementation of Crims Island Restoration.**
- 2) Summarize AdH model development at Crims Island**
- 3) Investigate Changes in tidal hydraulics due to Restoration**

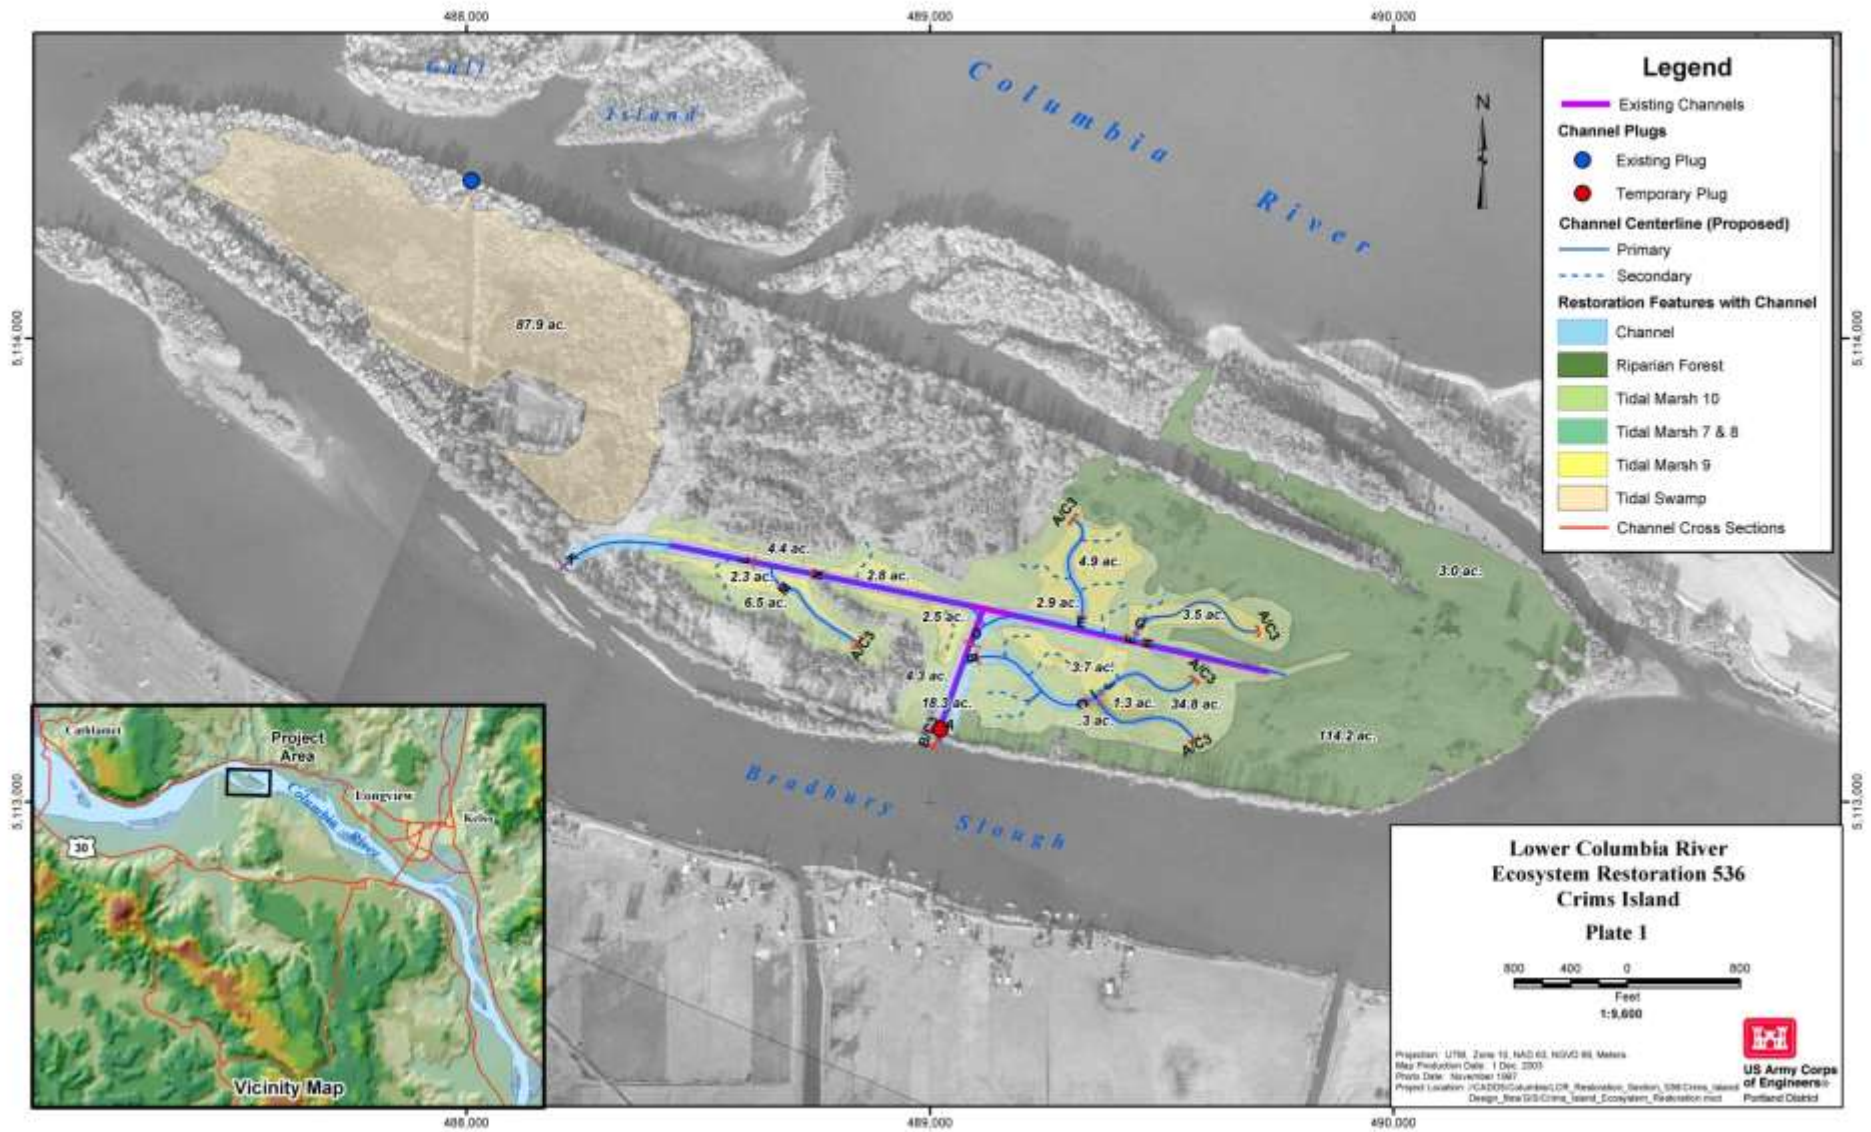
Excavation plan and tidal channel layout for Crims Island restoration, USACE.
 Restoration design developed through Chris Nygaard et al in EC-HY

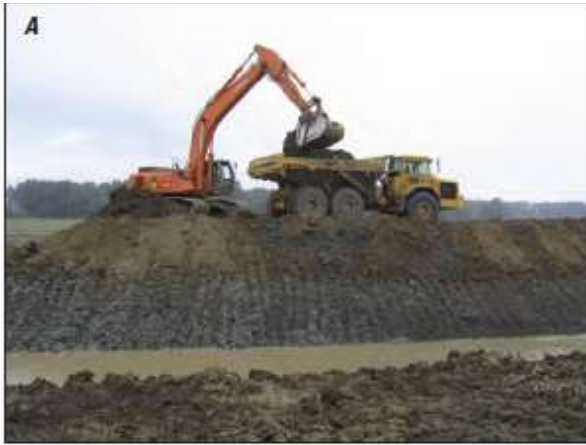
Cut deeper channels initially---

To allow post-construction adjustment .

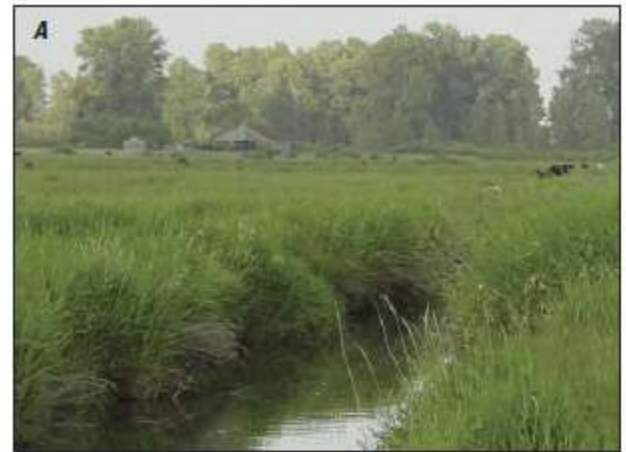
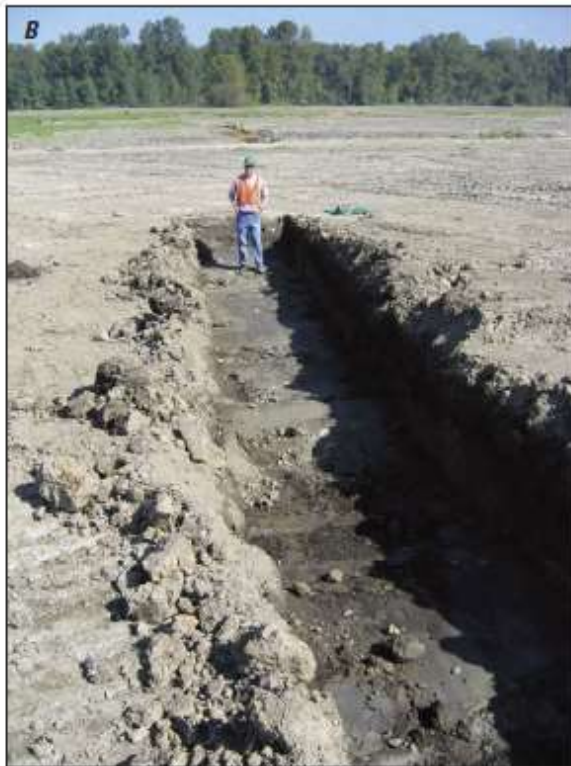
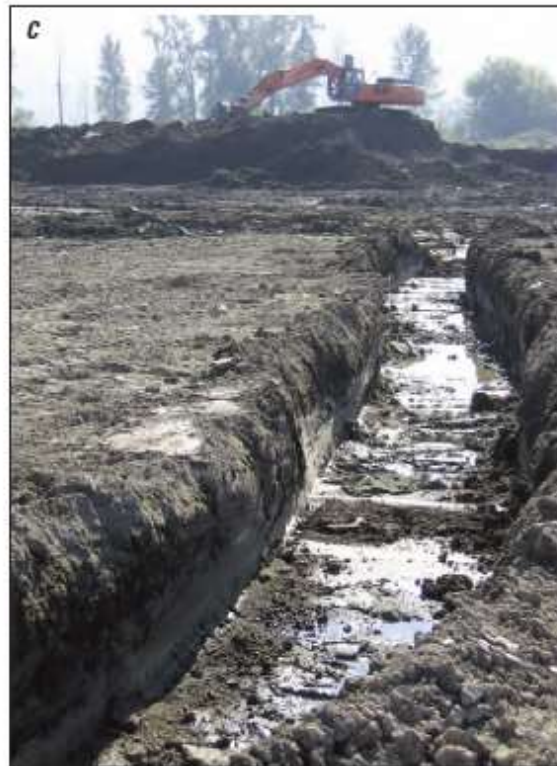
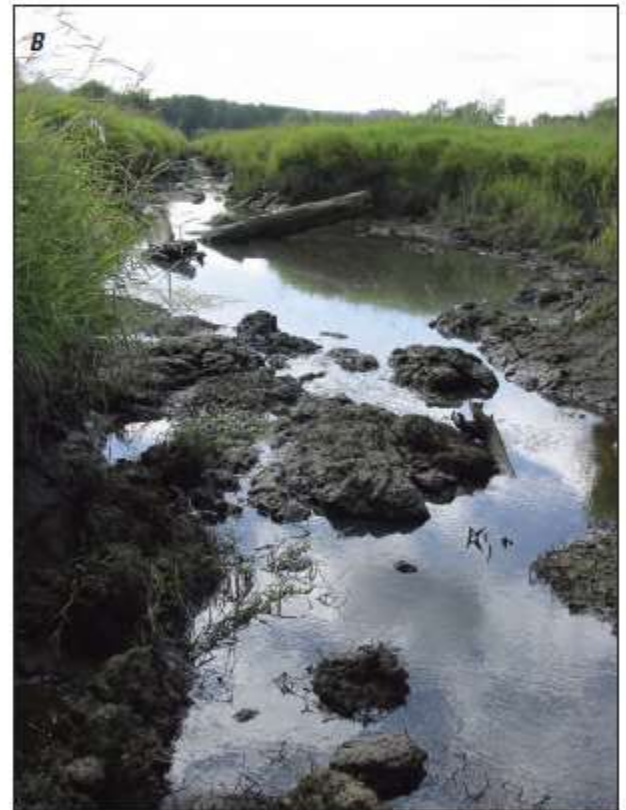
Figure 3. Excavation at Crims Island, Columbia River, Oregon, 2005. (Photographs taken by Craig Haskell and Ken Tiffan, U.S. Geological Survey, October 17, 2005).

Figure 2. Habitat at Crims Island in 2004 prior to restoration, Columbia River estuary, Oregon. (Photographs taken by Craig Haskell, U.S. Geological Survey, January 16, 2004)

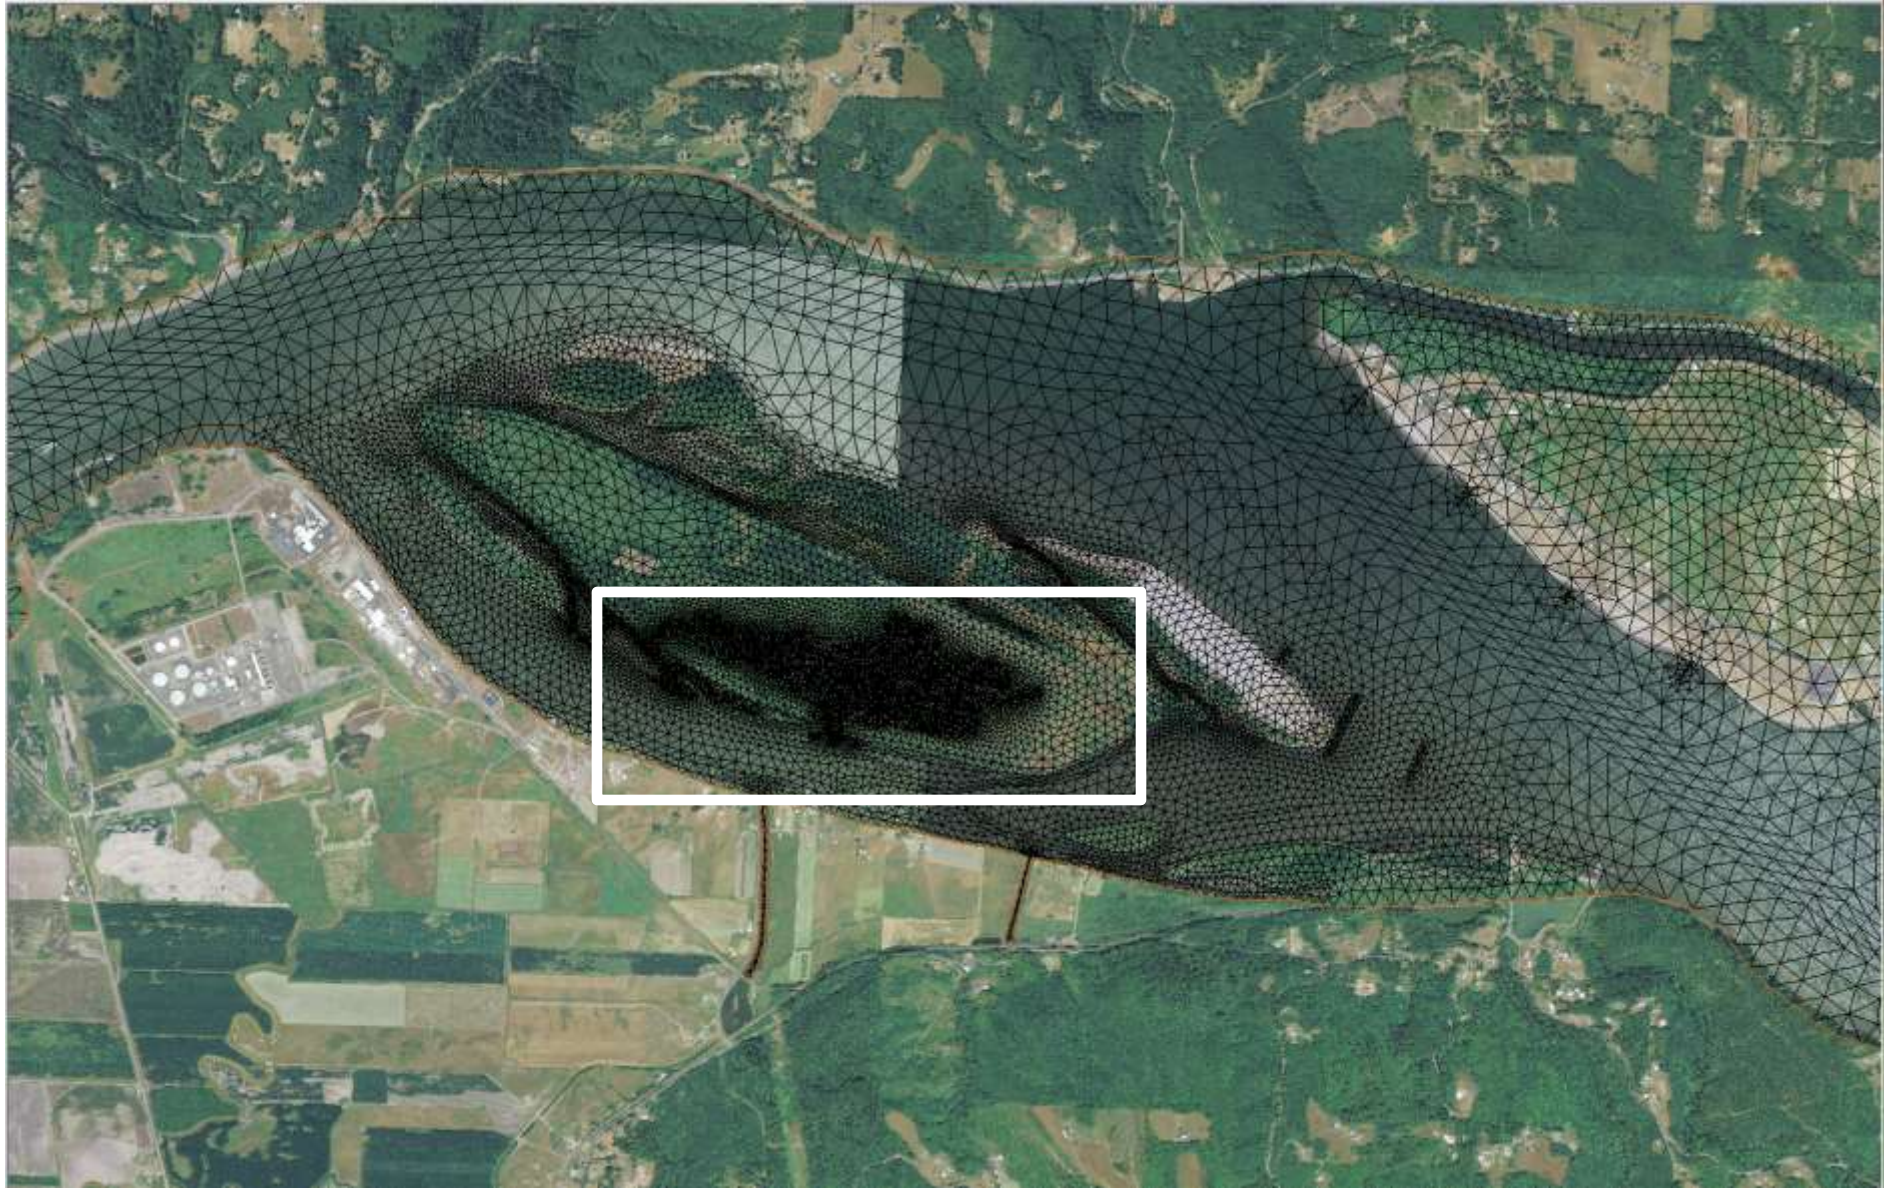
Finite element mesh used to emulate Crims Island within a 2-dimensional hydrodynamic model (AdH). The model was used to compare the tidal hydraulics for pre-restoration condition to post-restoration conditions. Habitat improvement associated with the post-restoration condition was assessed using the AdH hydraulic forcing within the framework of the Habitat Evaluation Model.

Detailed resolution (in conformance with morphology) is required to properly model small-scale features like tidal channels....unstructured grid meets the need.

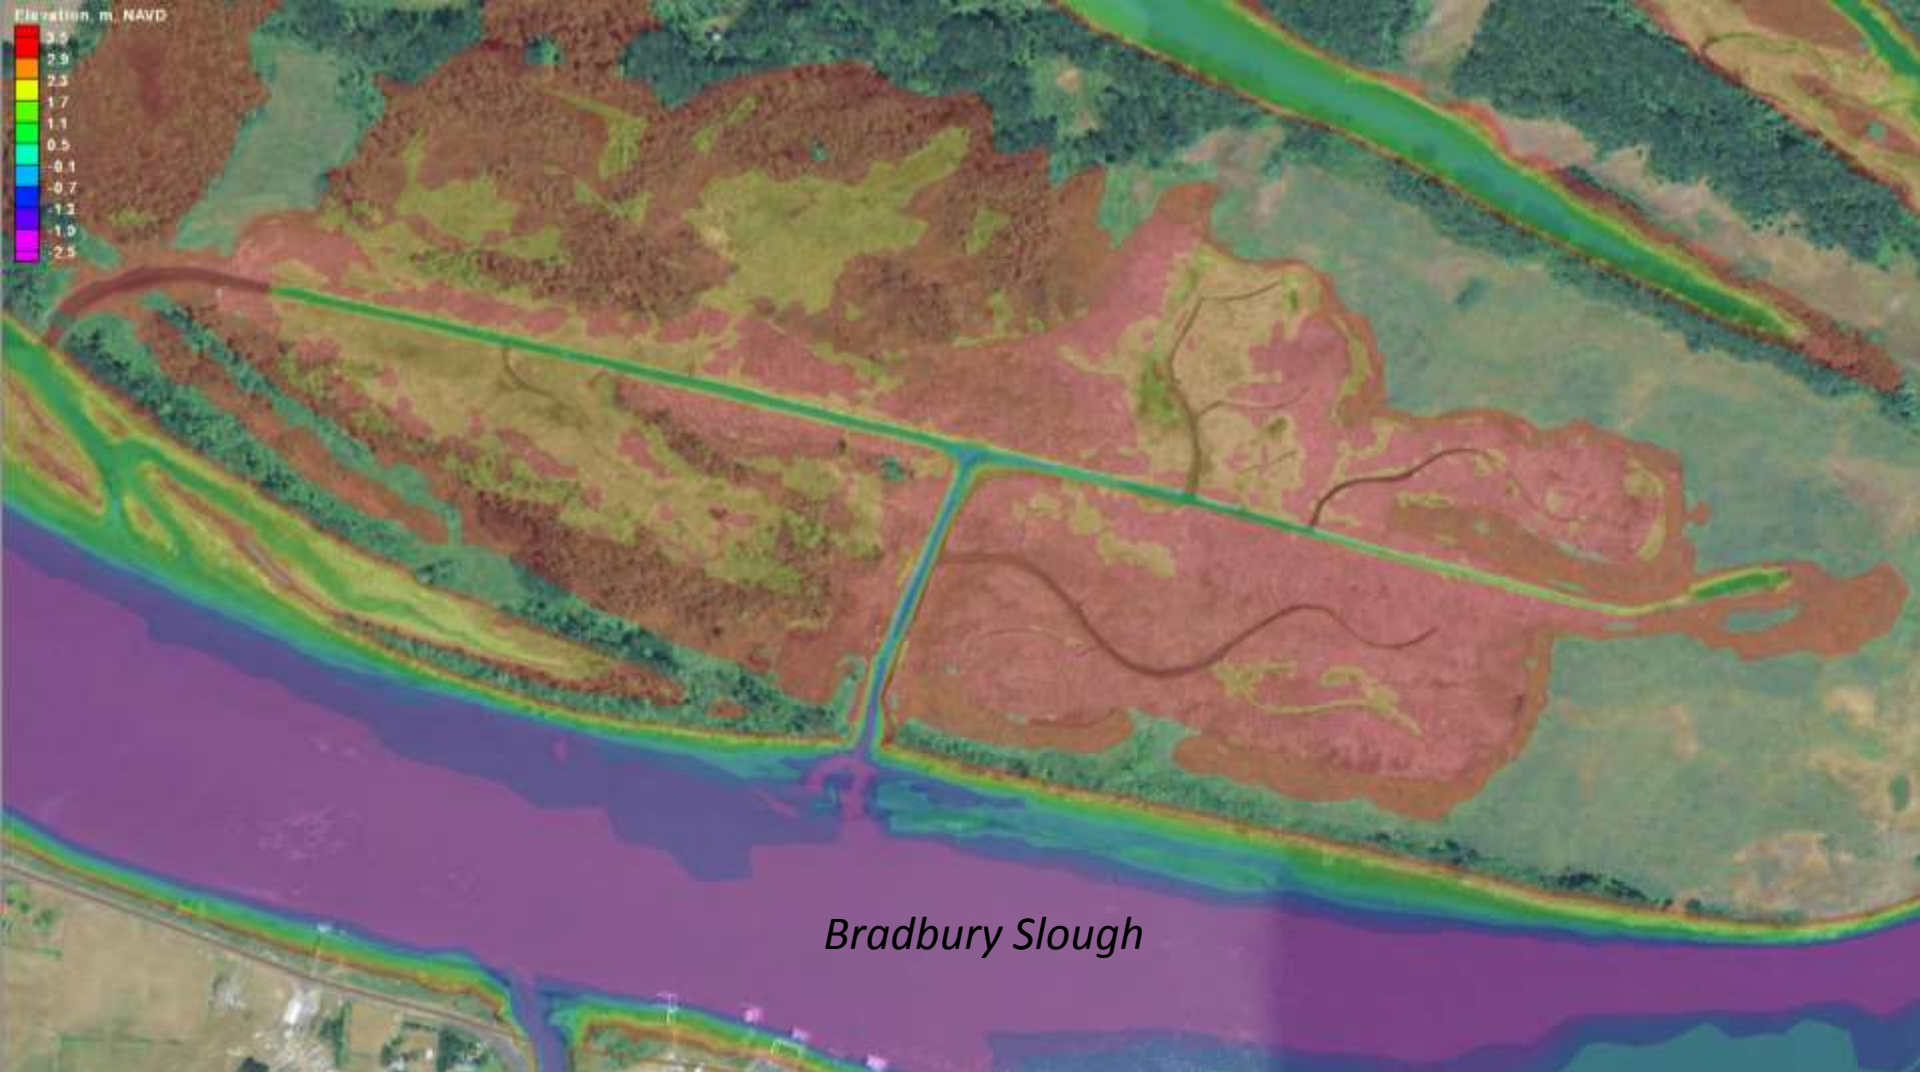
PRE-restoration topographic condition for Crims Island as represented by the composition of LIDAR and conventional topographic/bathymetric surveys, restoration area is outlined by the “box”. The above morphology was reproduced in a hydrodynamic model (AdH).

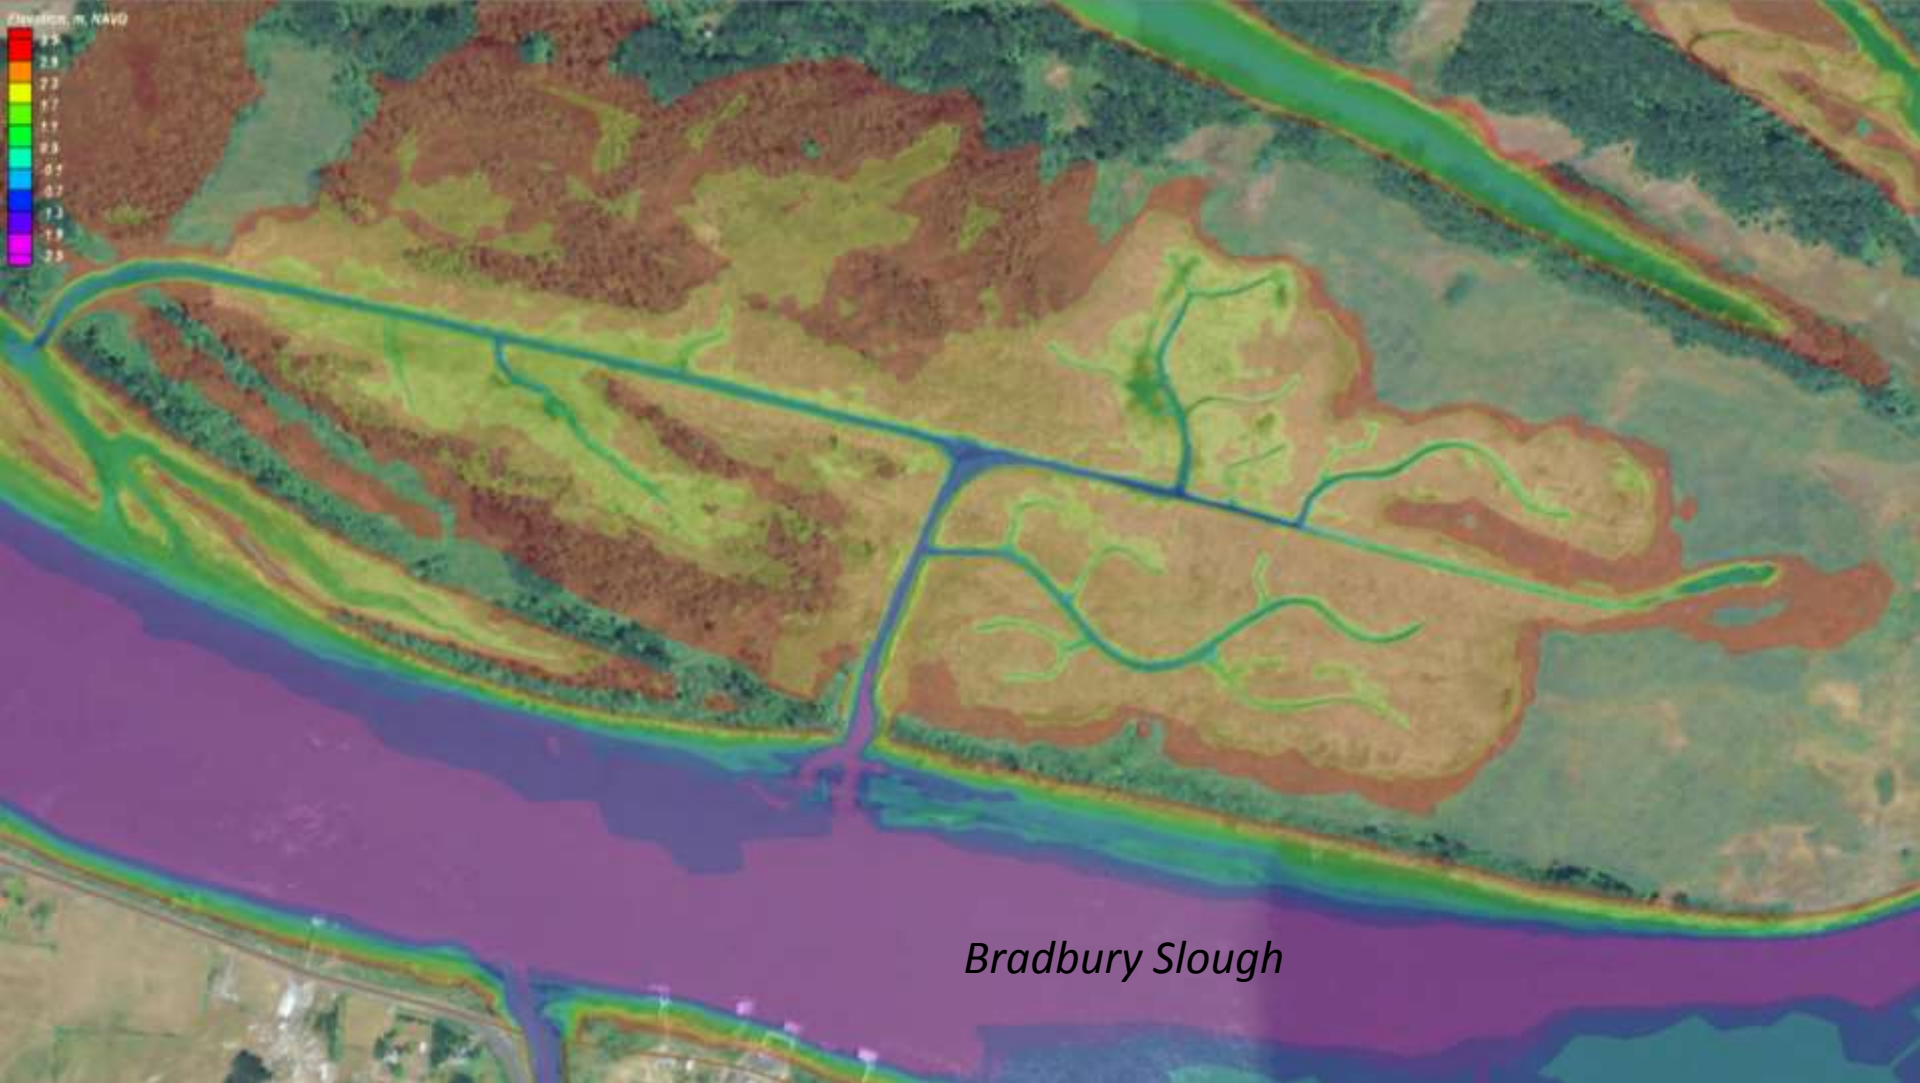
POST restoration topographic condition for Crims Island as represented by the composition of LIDAR and conventional topographic/bathymetric surveys, restoration area is outlined by the “box”. The above morphology was reproduced in a hydrodynamic model (AdH).

Smart move to lower terrain by 0.6 m (establish marsh-like terrain) and implement many primary and secondary tidal channels, accounting for channel evolution.

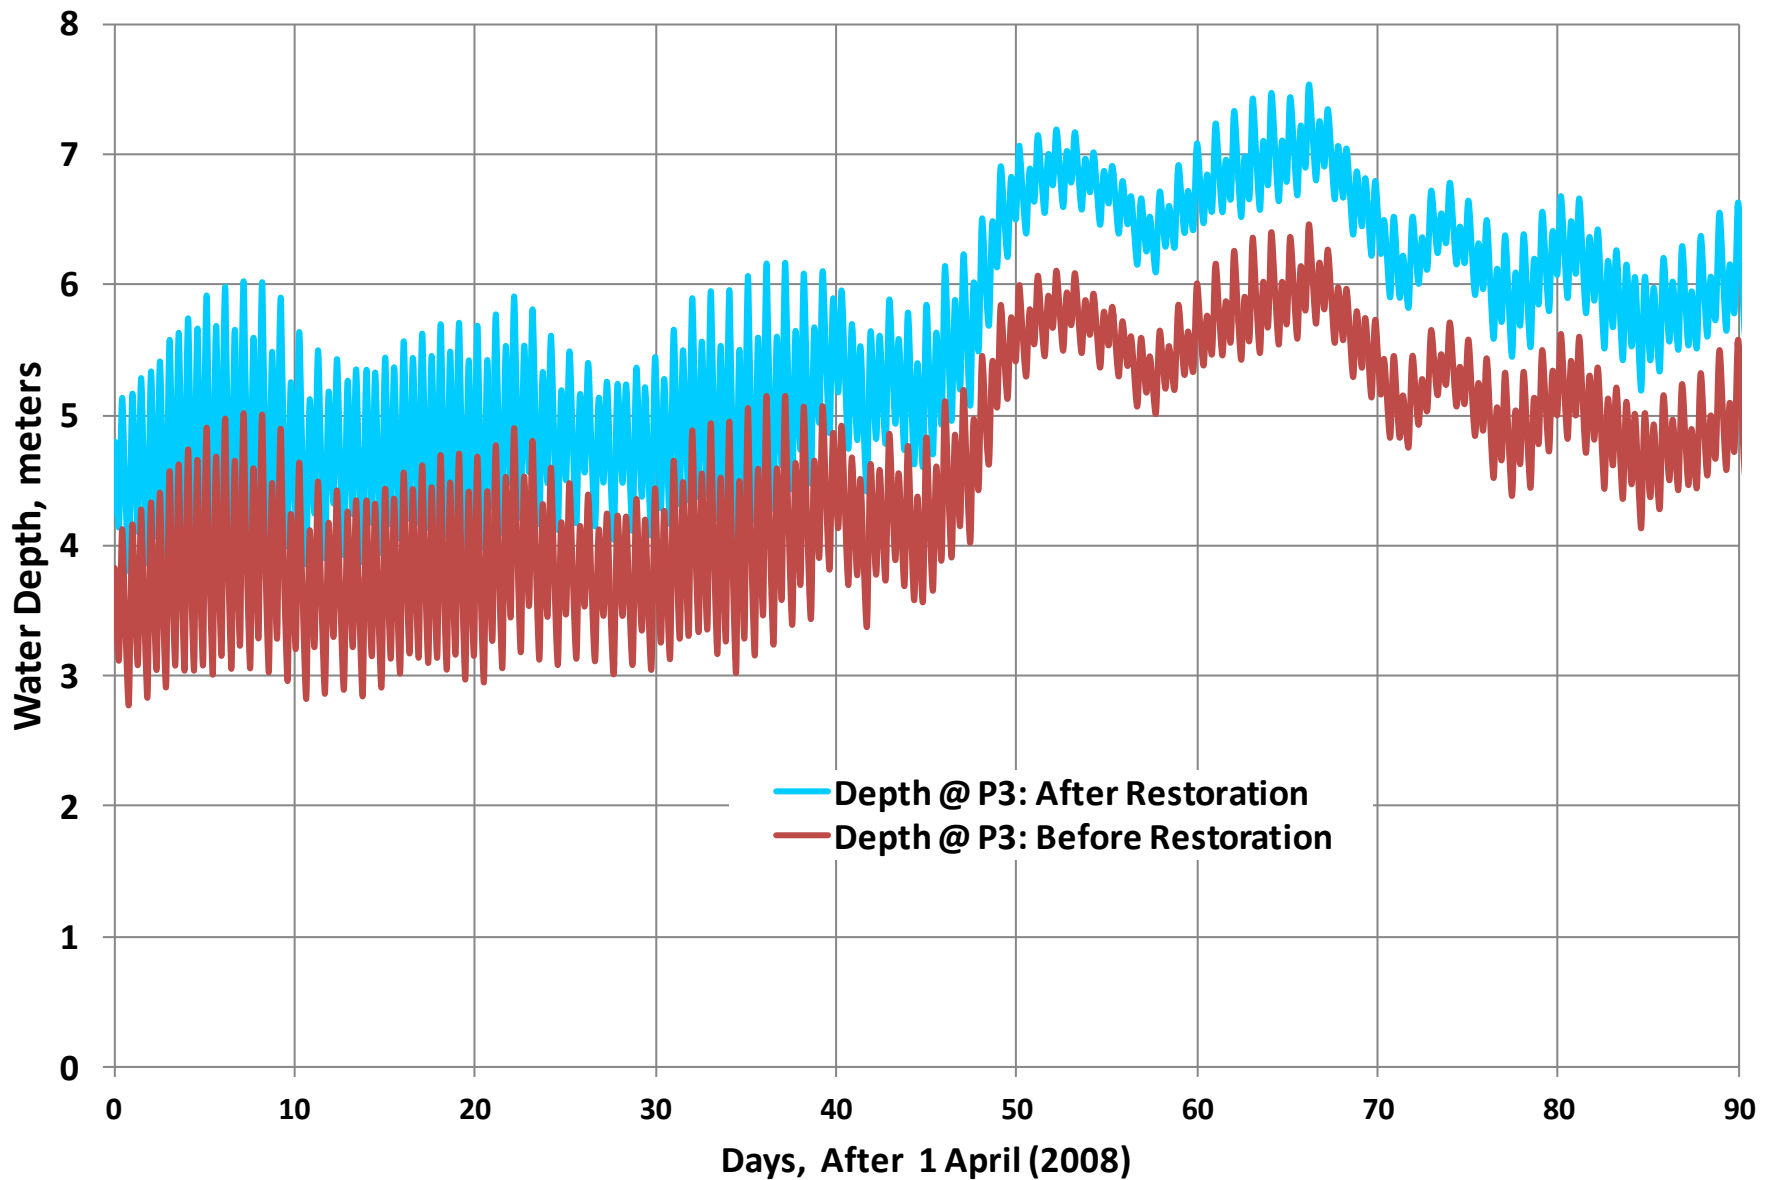
Water Depth at Crims Island- Comparison Before vs. After Restoration @ Point 3

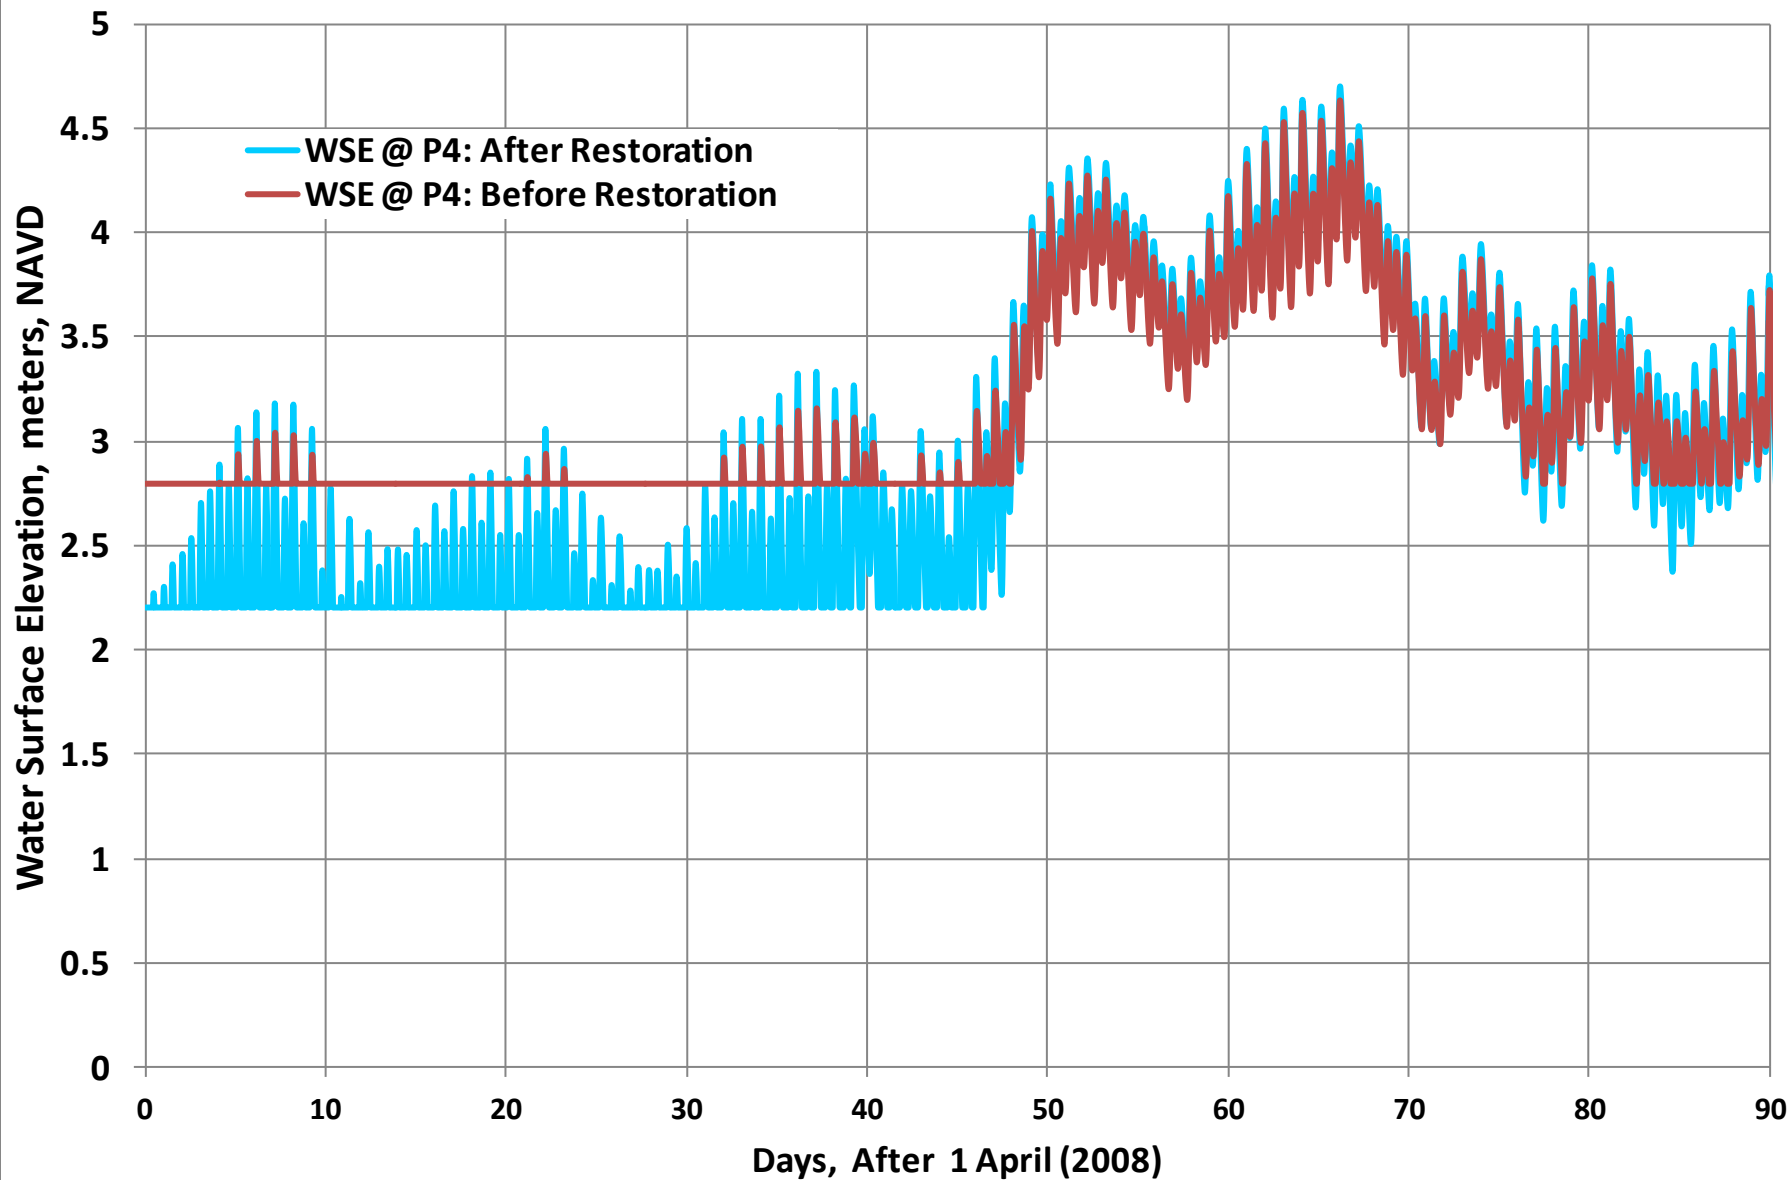
WSE at Crims Island- Comparison Before vs. After Restoration @ Point 4

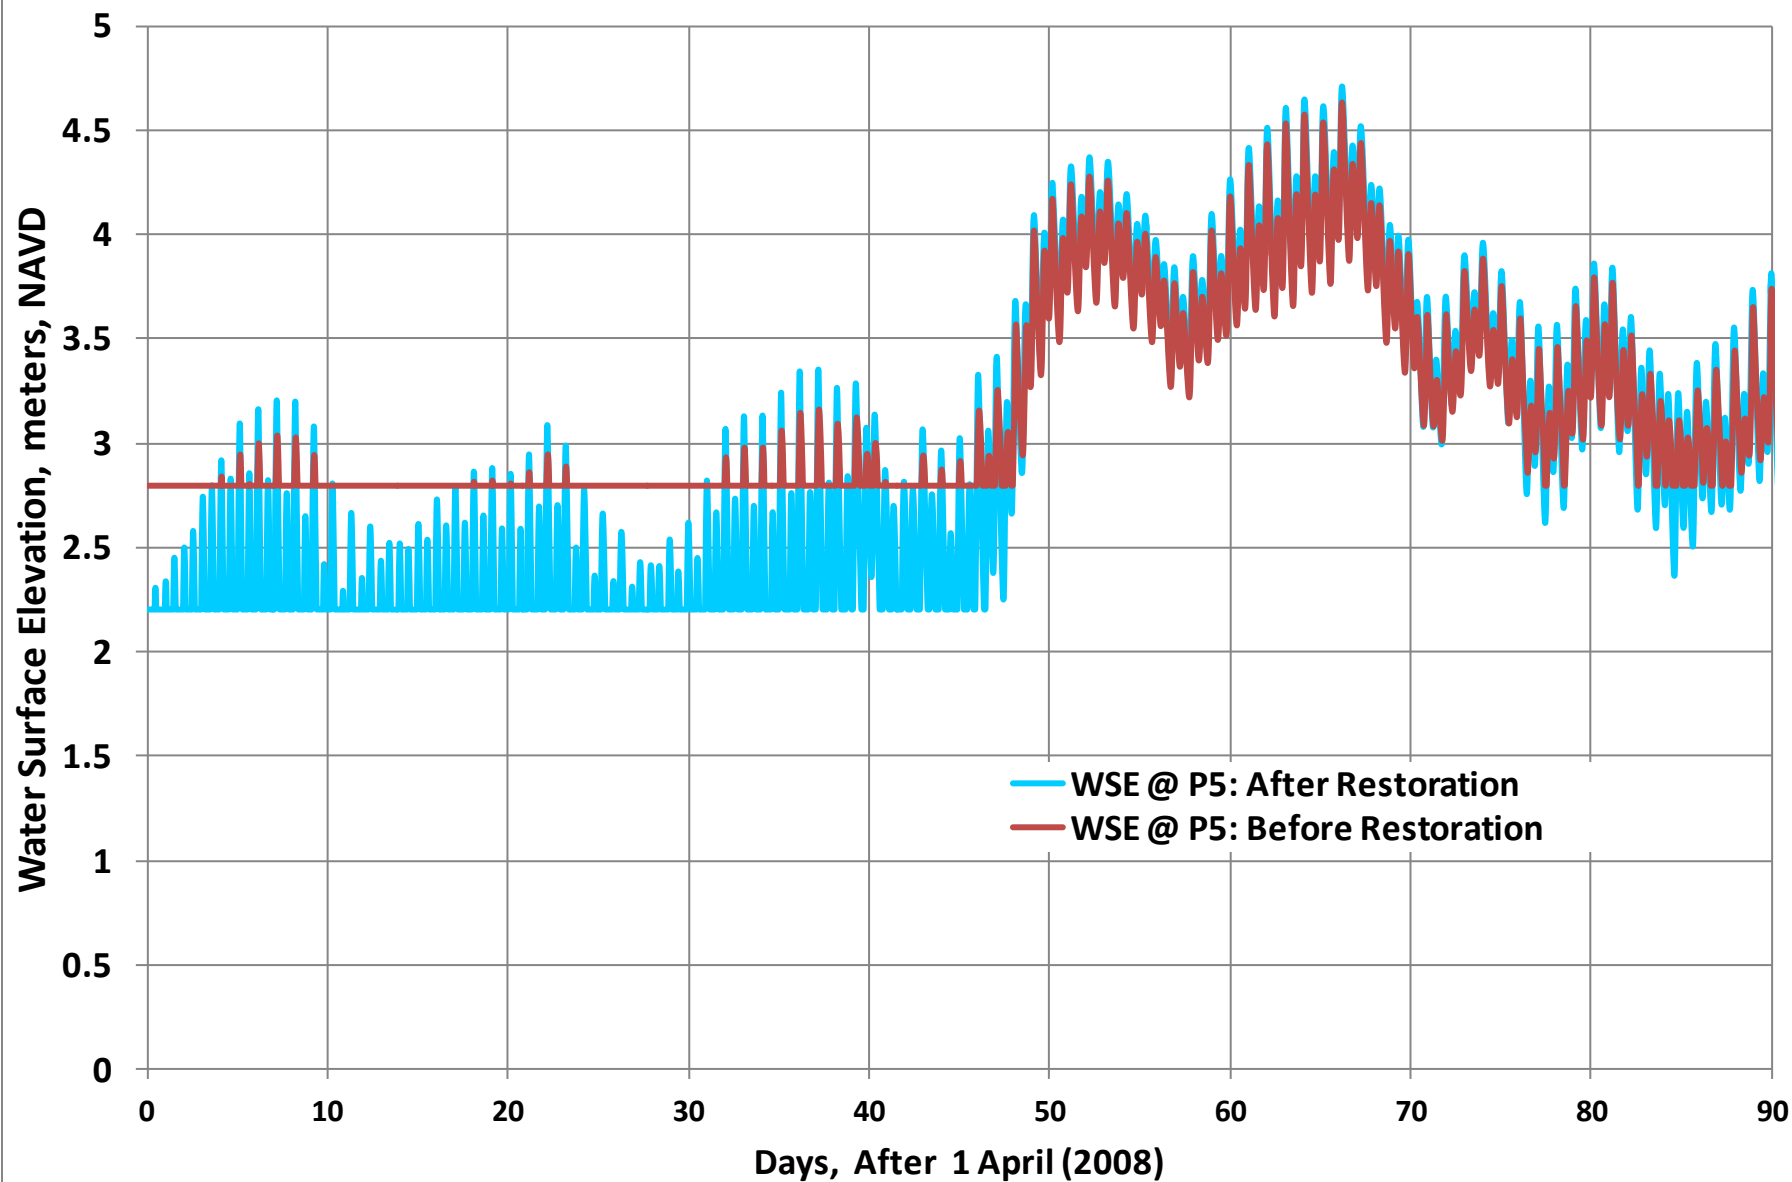
WSE at Crims Island- Comparison Before vs. After Restoration @ Point 5

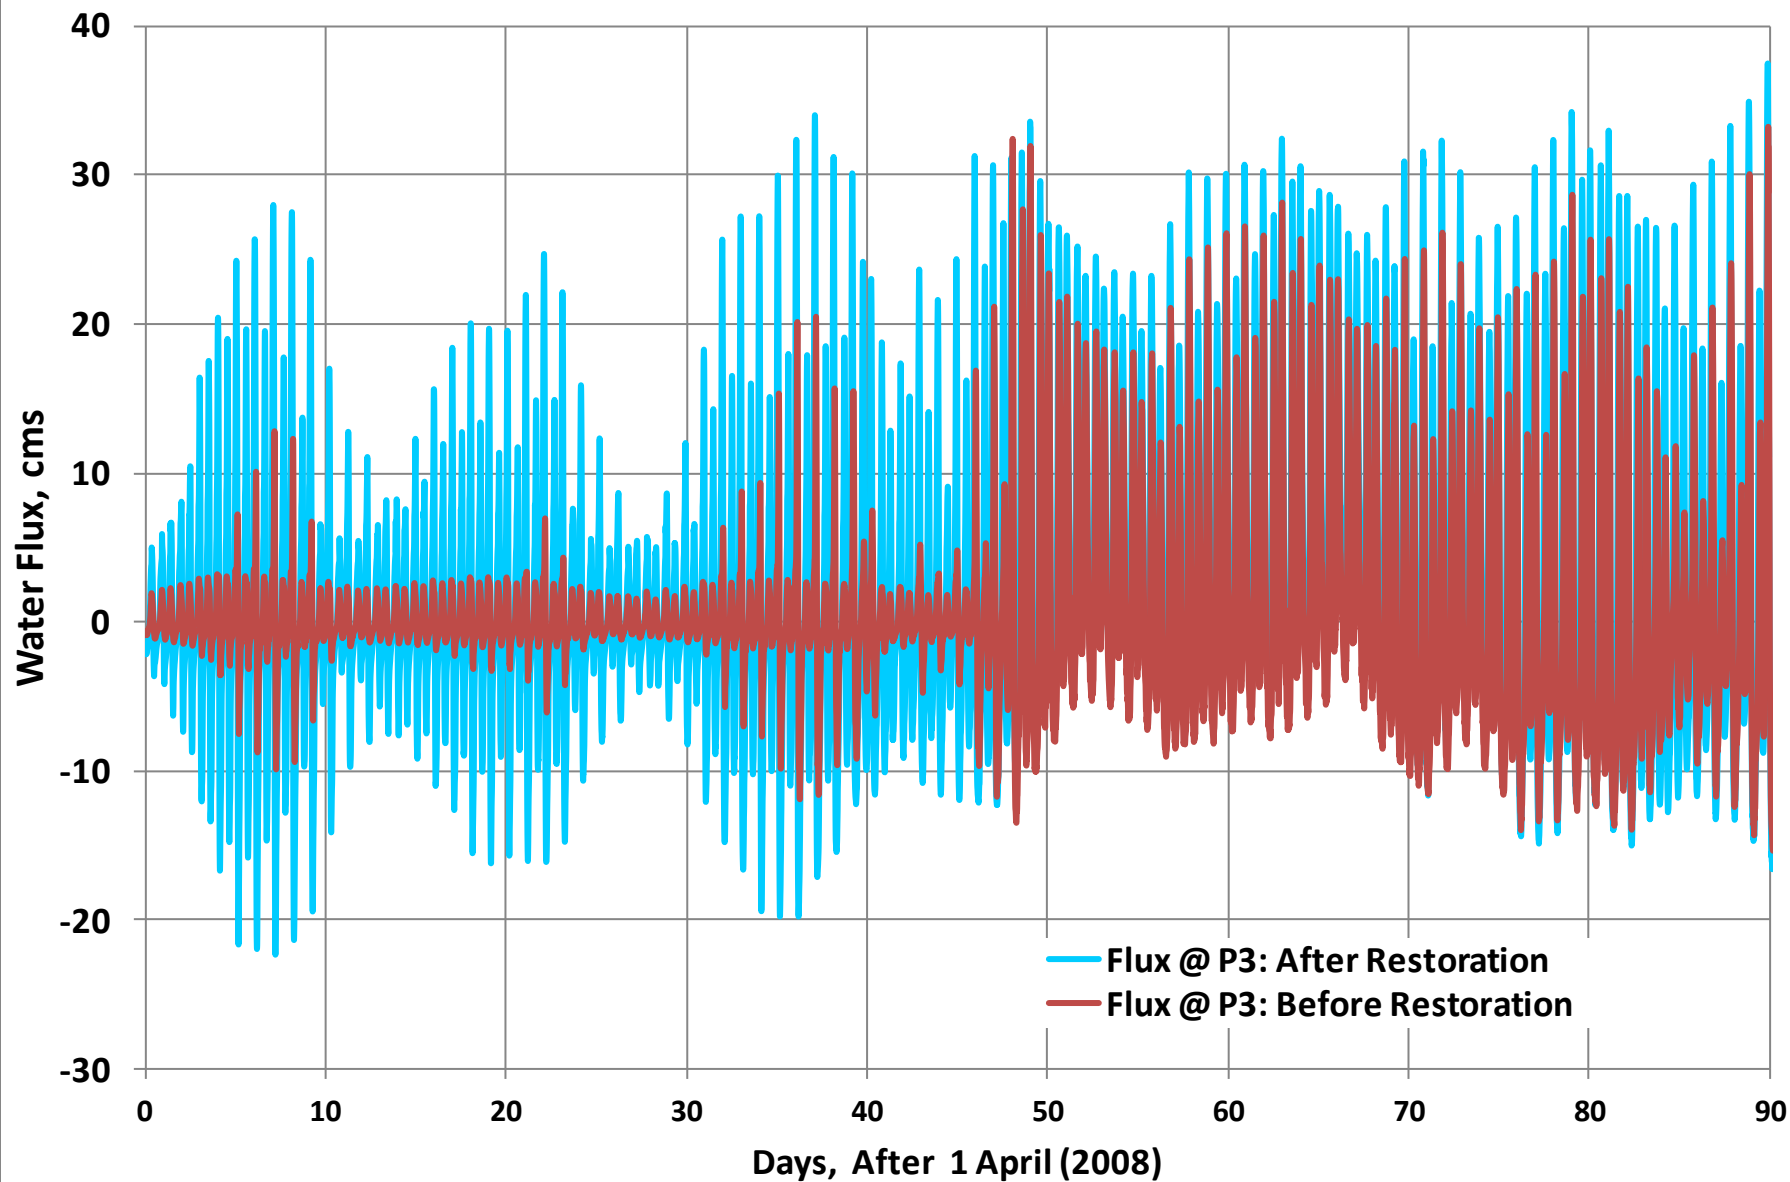
Tidal FLUX at Crims Island - Comparison Before vs. After Restoration @ Transect 3

The tidal flux increase into/out of Crims Island is vastly increased by the restored condition; especially for non-flood stage (non-freshet) river flow.

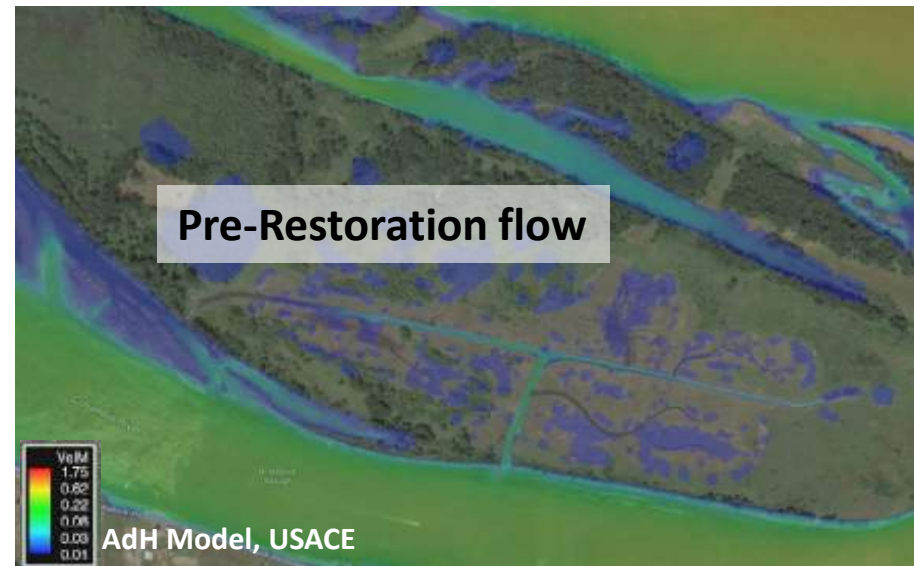
PRE-Restoration condition in 2004.

Pre-Restoration flow

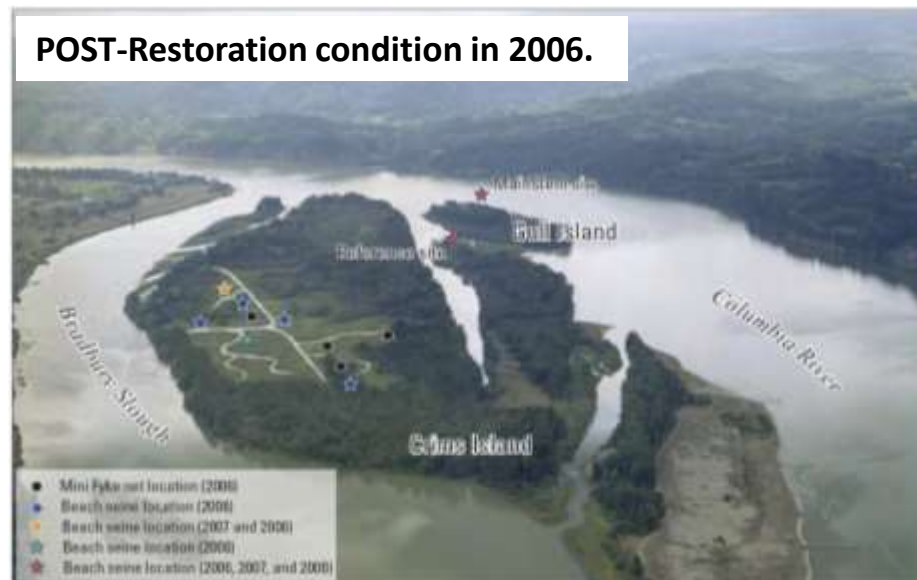
POST-Restoration condition in 2006.

Post-Restoration flow

Restoration of Crims Island near Longview, Washington, re-established 38.1 hectares of marsh and swamp in the tidal freshwater portion of the Columbia River Estuary and a 95-percent increase in available juvenile salmon rearing habitat at Crims Island. View toward downstream.

Essential to have two-way connectivity for the T-channel (restoration implemented additional outlet to Bradbury Slough)—allows full tidal prism exchange
