Action Effectiveness Monitoring for the Lower Columbia River Estuary Habitat Restoration Program

Project Number: 2003-007-00

**Action Effectiveness Monitoring for the Lower Columbia River and Estuary Habitat
Restoration Program Annual Report for Year 9 (September 2012 to September 2013)**

Annual Report for Project Number: 2003-007-00, Contract Number: 59063

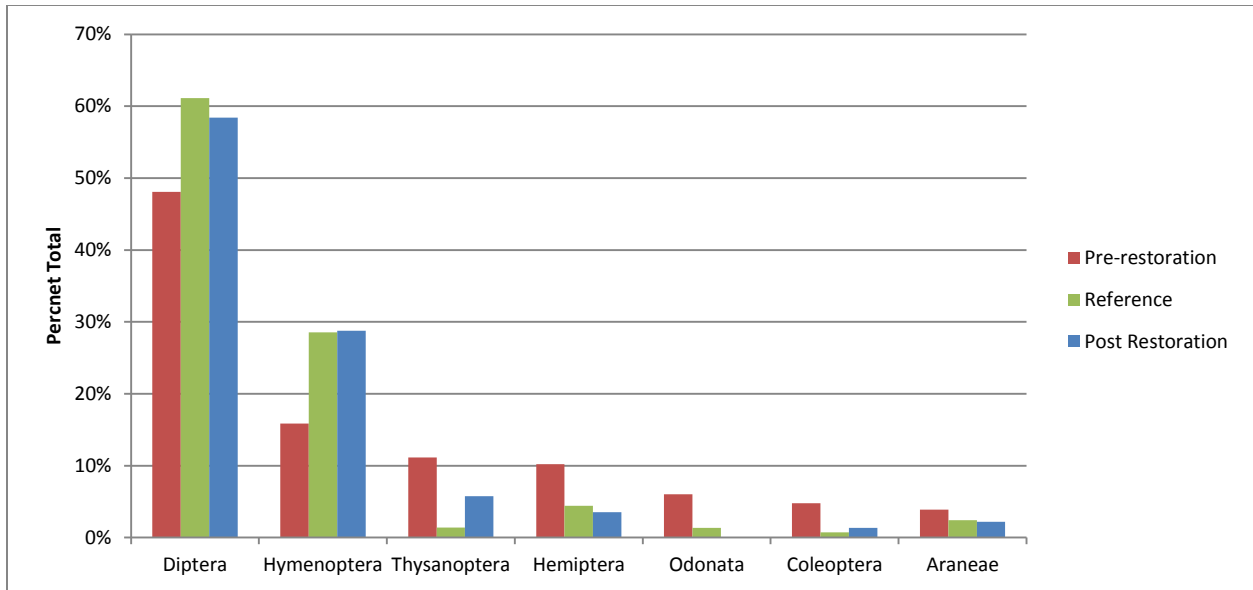
The top ten macroinvertebrate species by family from restoration and reference sites were grouped to order. Diptera was the most prevalent macroinvertebrate order at pre-restoration, reference, and post restoration sites at 48%, 61%, and 58% respectively (Figure 3). Hymenoptera was the second most prevalent order found at sites regardless of site condition with pre-restoration at 15% and reference and post restoration at 29% (Figure 3).

Figure 3. Percent macroinvertebrate found at pre-restoration, post restoration, and reference sites.

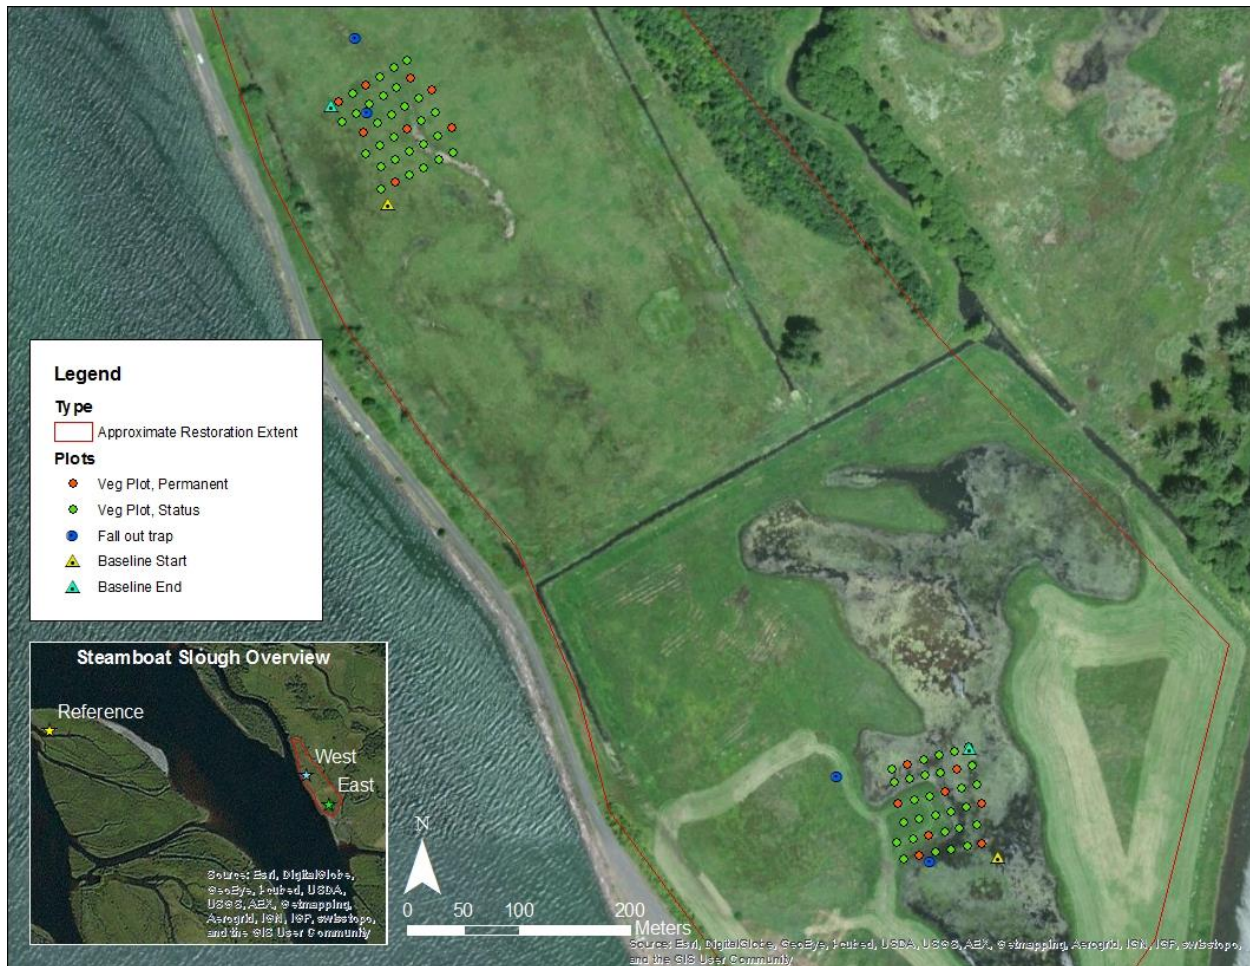
Figure 6. 2013 vegetation and macroinvertebrate sampling locations at Steamboat Slough restoration site.

- Located in area that will be affected by the dike removal, near proposed site of excavated channel.
- 70 m x 60 m, with 36 quadrat locations
- Baseline azimuth: 312° magnetic
- Transect azimuth: 42° magnetic
- Transect spacing: 12m, random start: 10
- Quadrat spacing: 10 m, random starts: 0, 7, 3, 9, 1, 5
- 8 permanent quadrats, randomly selected, systematically to ensure coverage on all transects

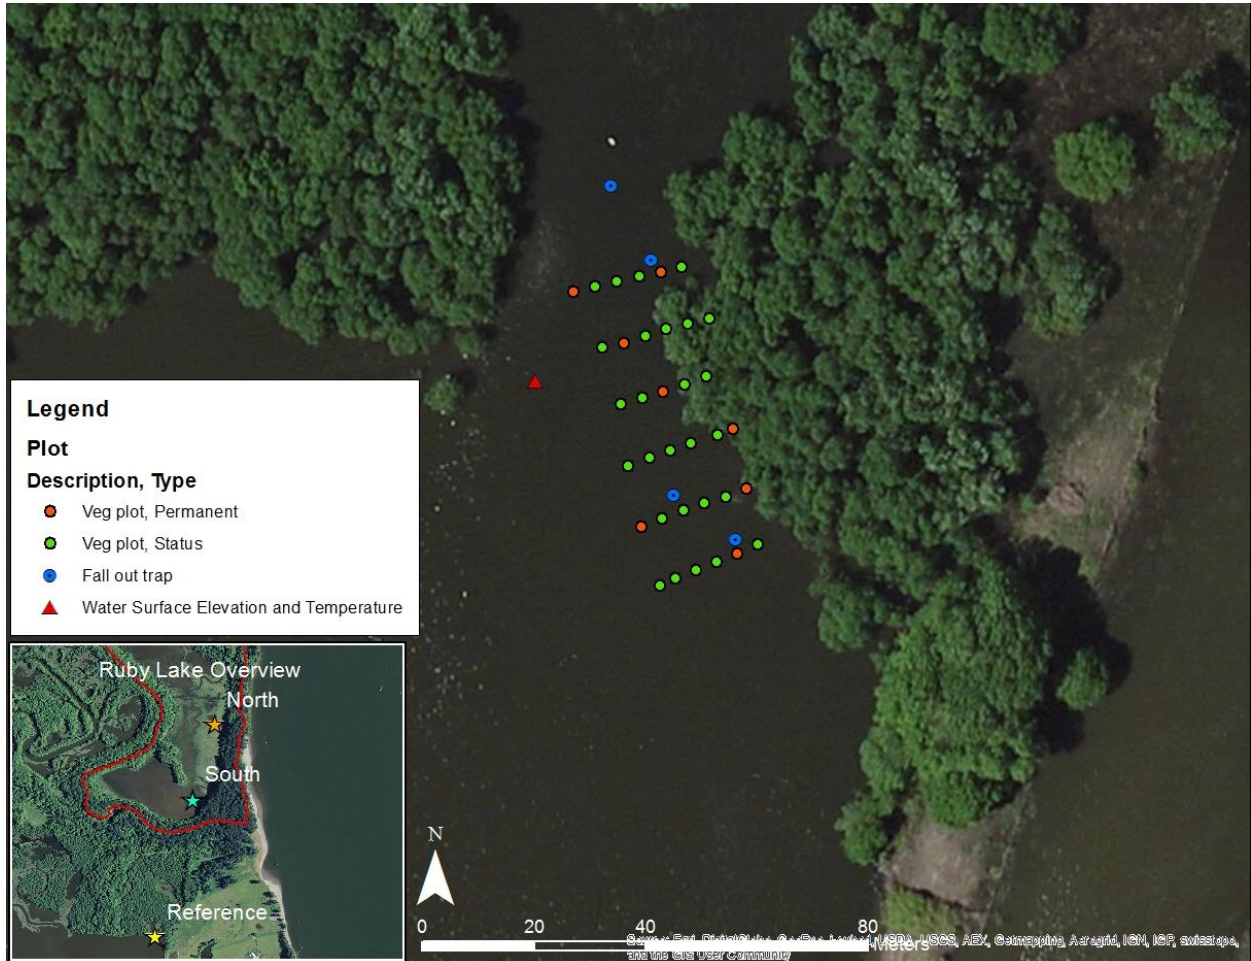
Figure 9. 2013 vegetation and macroinvertebrate sampling locations at the Cunningham Lake reference site.

Insect fall out traps were randomly placed in sampling areas. The four traps each were placed at the vegetation sampling area to characterize the macroinvertebrate species richness and diversity.

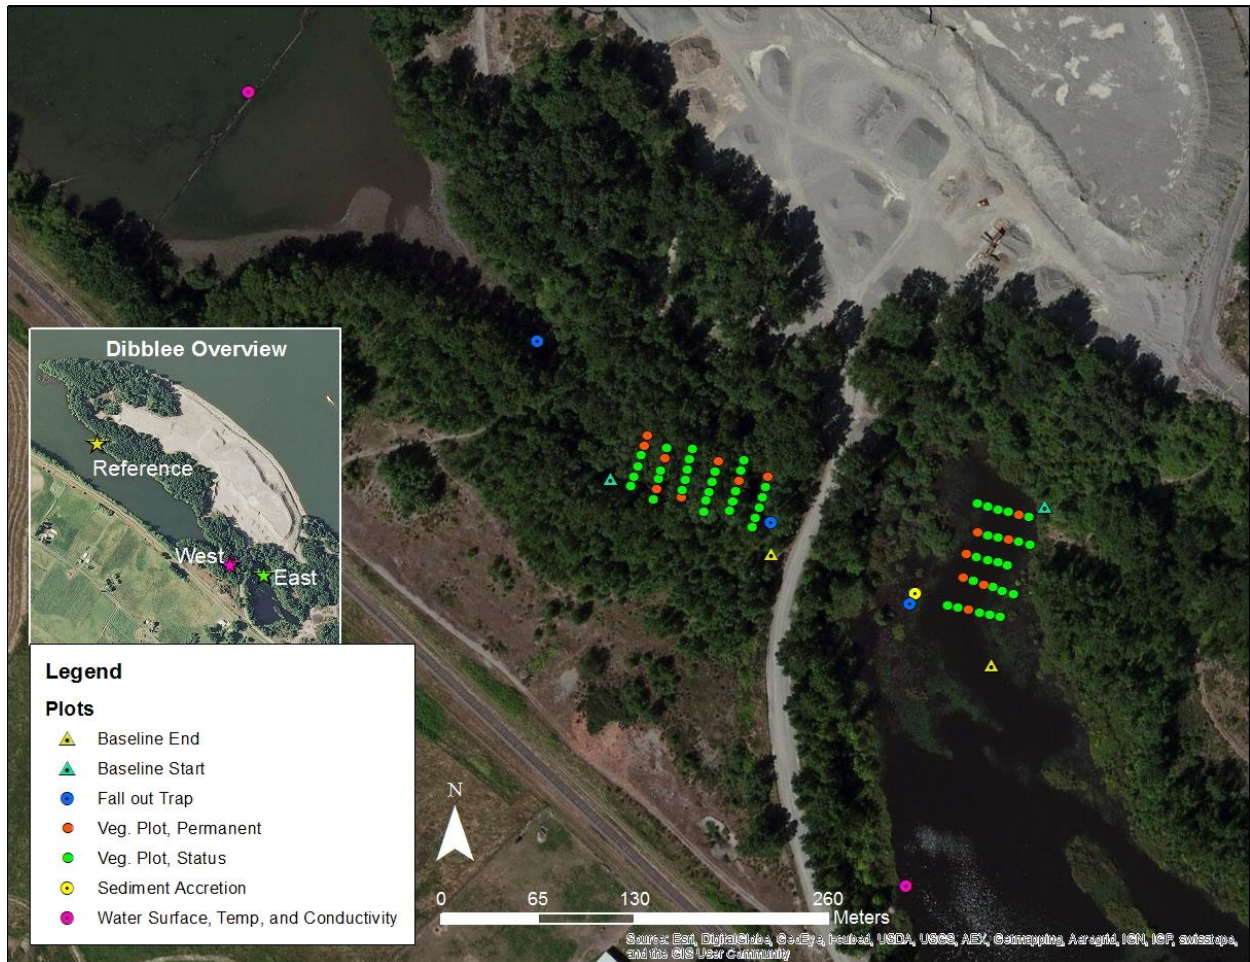
Figure 10. 2013 vegetation and macroinvertebrate sampling locations at Dibblee Slough restoration site.

- Located on north side of area inside culvert in the upper end of herbaceous wetland vegetation in natural inlet.
- 74 m x 30 m, with 36 quadrat locations
- Baseline azimuth: 180° magnetic
- Transect azimuth: 270° magnetic
- Transect spacing: 12m, random start: 3
- Quadrat spacing: 5 m, random starts: 4, 0, 2, 1, 3, 4
- 8 permanent quadrats, randomly selected, systematically to ensure coverage on all transects
