Water Quality Monitoring Report: Columbia County Soil and Water Conservation District Water Quality Trend Monitoring Program 2017

**Columbia County SWCD
3150 NW 229th, Ave., Suite 150
Hillsboro, OR 97124
Phone: (503) 693-5700
Fax: (503) 693-4999**

Lower Columbia Estuary Partnership

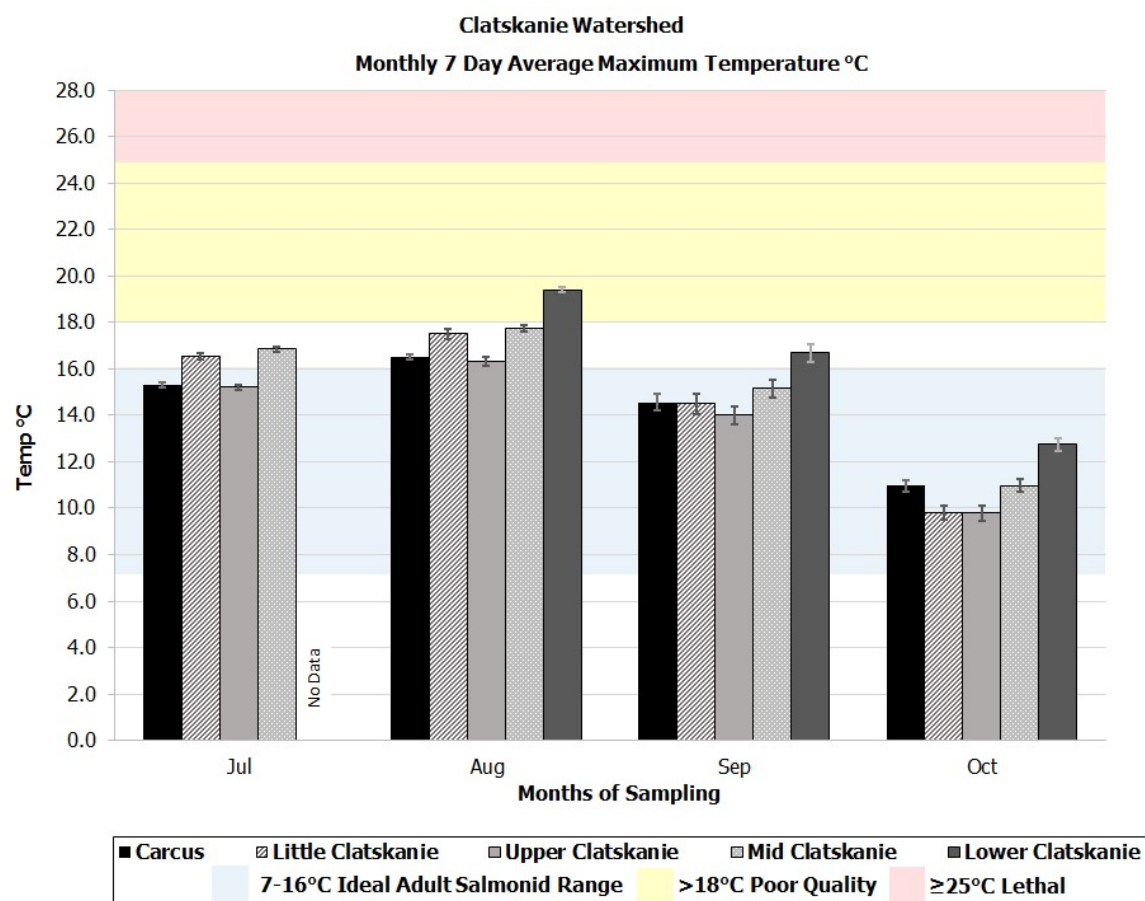
Figure 4: Clatskanie Watershed monthly mean 7-day average maximum temperatures (7dMAM) from July to October 2017. See Table 3 for details on salmonid temperature thresholds.

Between July and October Upper Clatskanie and Carcus Creek 7-day average maximum temperatures (7dMAM) remained below the 18°C temperature threshold (year-round salmon rearing habitat maximum, Figure 3). In Little Clatskanie Creek and Middle Clatskanie temperatures exceeded 18°C in late July- Early August. The Lower mainstem Clatskanie river was only monitored from mid-August to early October and exceeded 18°C during August and early September (Figure 3). On average monthly temperatures for Carcus Creek, Little Clatskanie Creek, Upper Clatskanie, and Mid-Clatskanie River remained below 18°C during July-October (Figure 4).

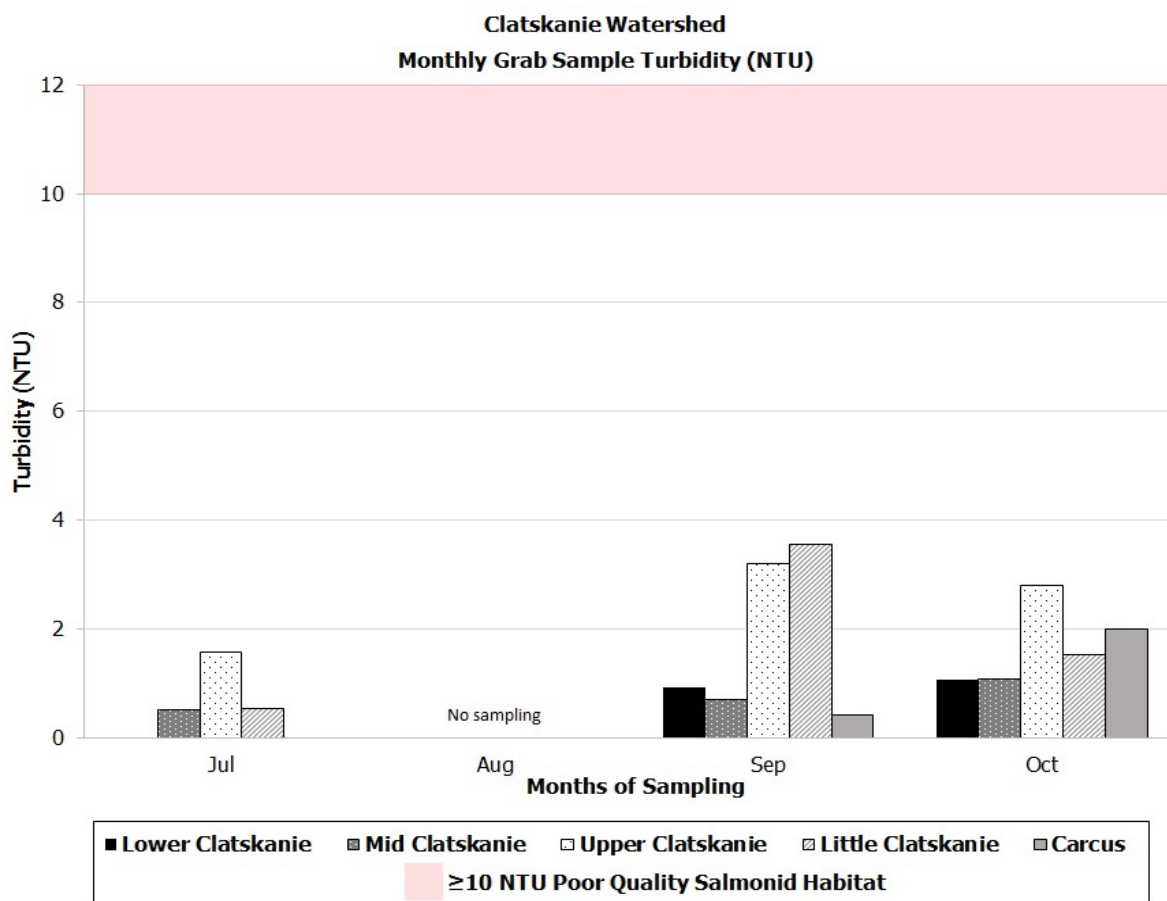
Figure 5: Clatskanie Watershed monthly grab sample turbidity (NTU) data from July to October 2017. See Table 3 for details on salmon habitat turbidity threshold.

Carcus Creek, Little Clatskanie Creek, Upper Clatskanie, Mid-Clatskanie, and Lower Clatskanie River sampling locations had relatively low (< 4 NTUs) turbidity levels recorded between July and October 2017 (Figure 5). Across all sampling events Upper Clatskanie Creek showed elevated turbidity levels relative to the other sample locations, except Little Clatskanie Creek in September which also exhibited an elevated turbidity relative to the other sites monitored (Figure 5). All sites remained below the 10 NTU salmon habitat turbidity threshold during the study period.

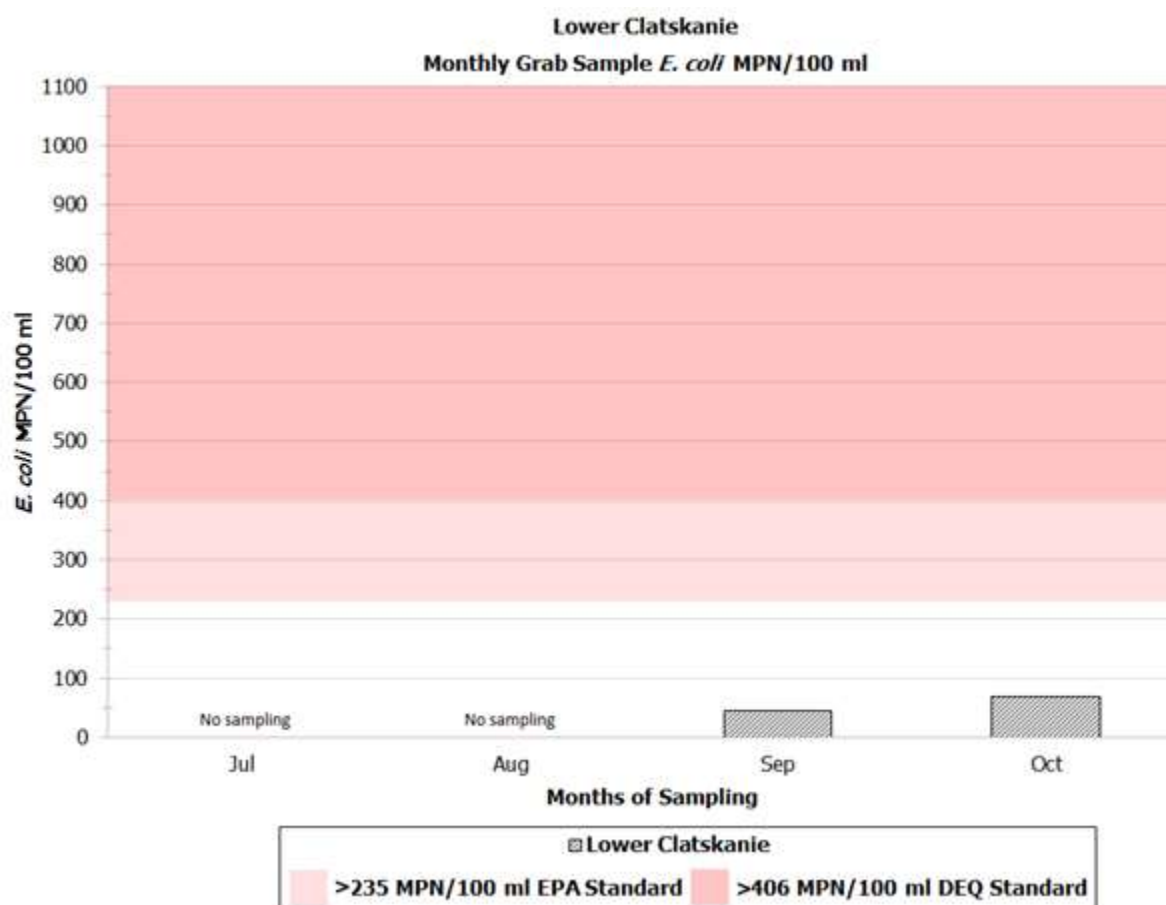
Figure 6: Clatskanie Watershed monthly grab sample *E. coli* bacteria data from July to October 2017. See Table 3 for details on *E. coli* bacteria thresholds.

Stream sampling of *E. coli* bacteria levels in the Clatskanie Watershed were only collected in Lower Clatskanie Creek during September and October 2017 and exhibited low *E. coli* levels (<100 MPN/100 ml) during these sampling events (Figure 6).

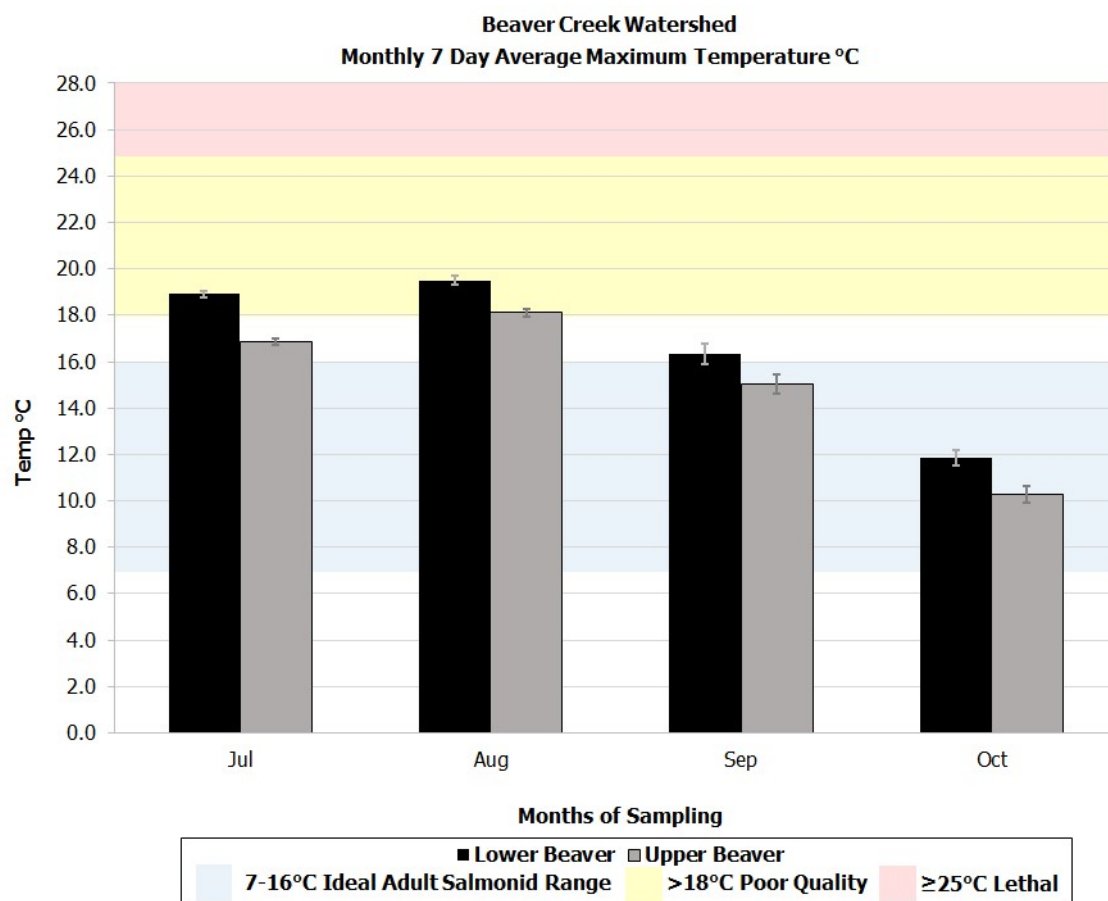
Figure 8. Beaver Creek Watershed monthly mean 7-day average maximum temperatures (7dMAM) from July to October 2017. See Table 3 for details on salmonid temperature thresholds.

Between July and August Lower Beaver Creek 7dMAM consistently remained above the 18°C temperature, however temperatures dropped down below the 18°C temperature threshold in September and October 2017 (Figure 7). Upper Beaver Creek exhibited periods of > 18°C in August but generally maintained temperatures below 18°C during the July through October study period (Figure 7). Monthly average maximum temperatures followed similar trends with Lower Beaver Creek with average temperatures falling between 18-20°C in July and August and then dropping below 18°C in September and October (Figure 8). Average monthly temperatures for Upper Beaver Creek only exceeded 18°C in August (Figure 8).

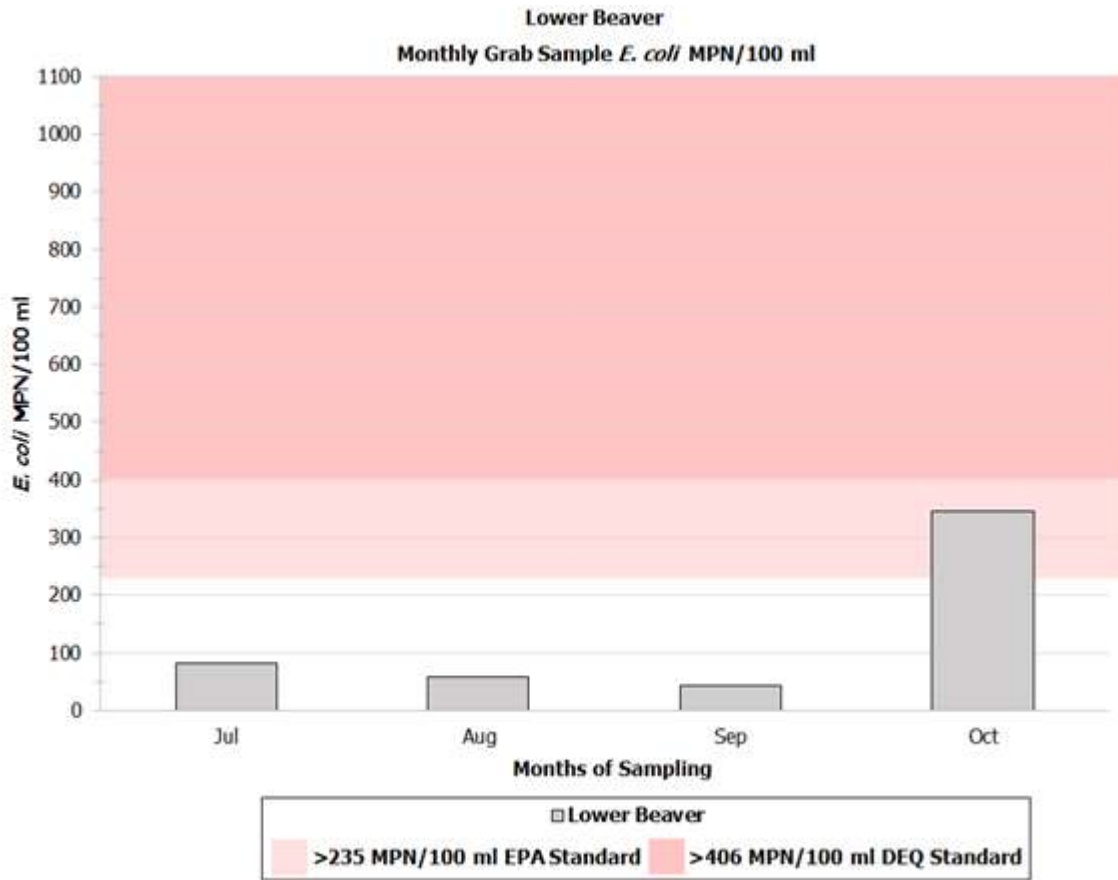
Figure 10. Beaver Creek Watershed monthly grab sample *E. coli* bacteria data from July to October 2017. See Table 3 for details on *E. coli* bacteria thresholds.

E. coli bacteria levels in the Beaver Creek Watershed were only collected in Lower Beaver Creek and exhibited low *E. coli* levels throughout the study period, however the October sample was elevated beyond the EPA health standard <235 MPN/100 ml (Figure 10).

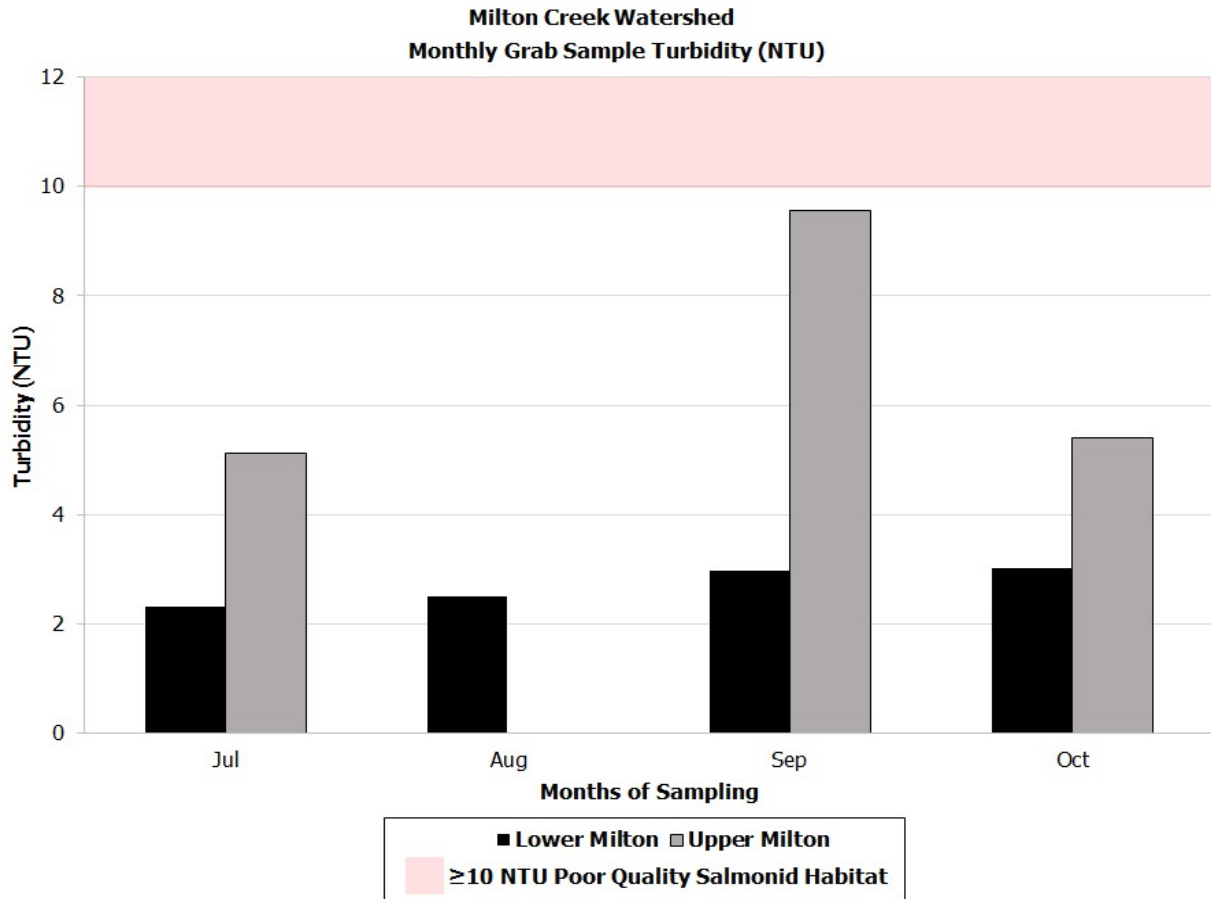
Figure 13. Milton Creek Watershed monthly grab sample turbidity (NTU) data from July to October 2017. See Table 3 for details on salmon habitat turbidity threshold.

Lower Milton Creek turbidity was consistently lower than Upper Milton Creek which exhibited generally elevated turbidity levels throughout the study period, with levels near >10 NTU turbidity observed in September (Figure 13).

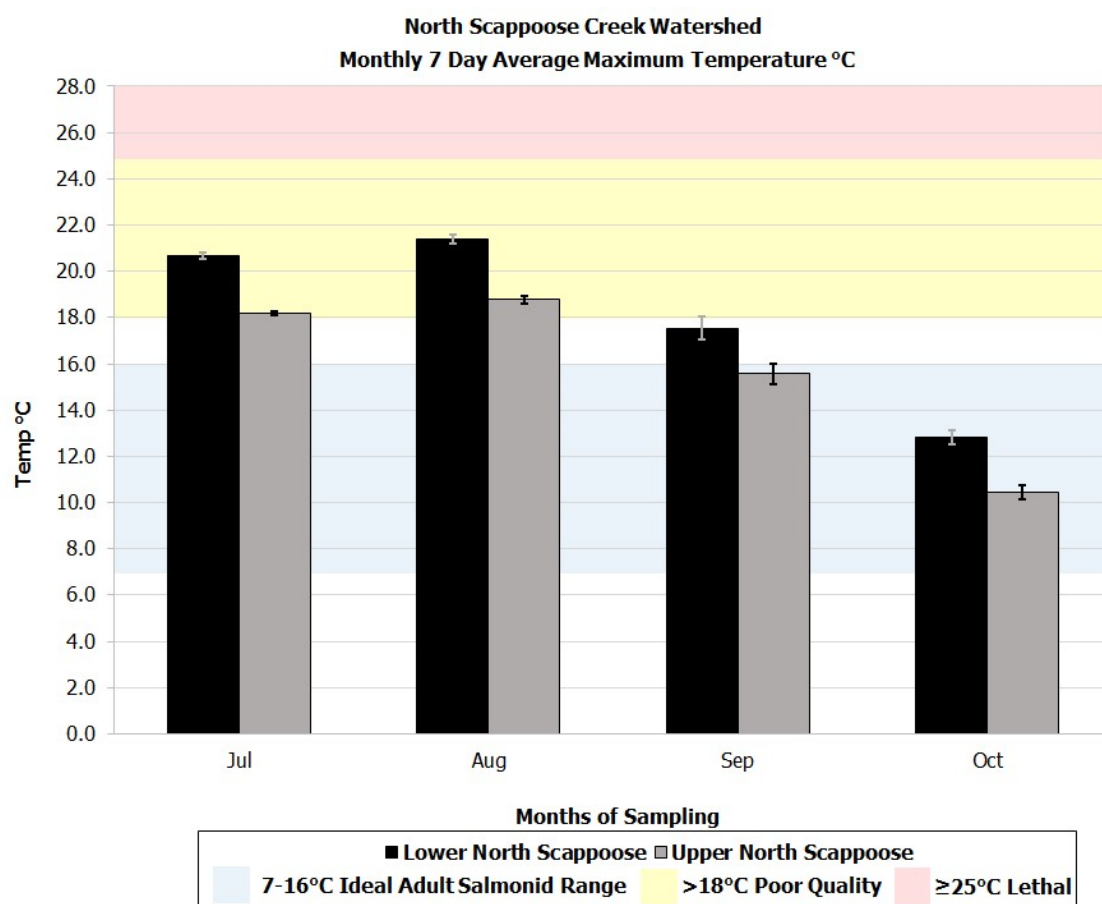
Figure 16. North Scappoose Watershed monthly mean 7-day average maximum temperatures (7dMAM) from July to October 2017. See Table 3 for details on salmonid temperature thresholds.

On average monthly maximum stream temperatures in both Lower and Upper North Scappoose Creek exceeded 18°C during July and August and remained below 18°C in September and October (Figure 16).

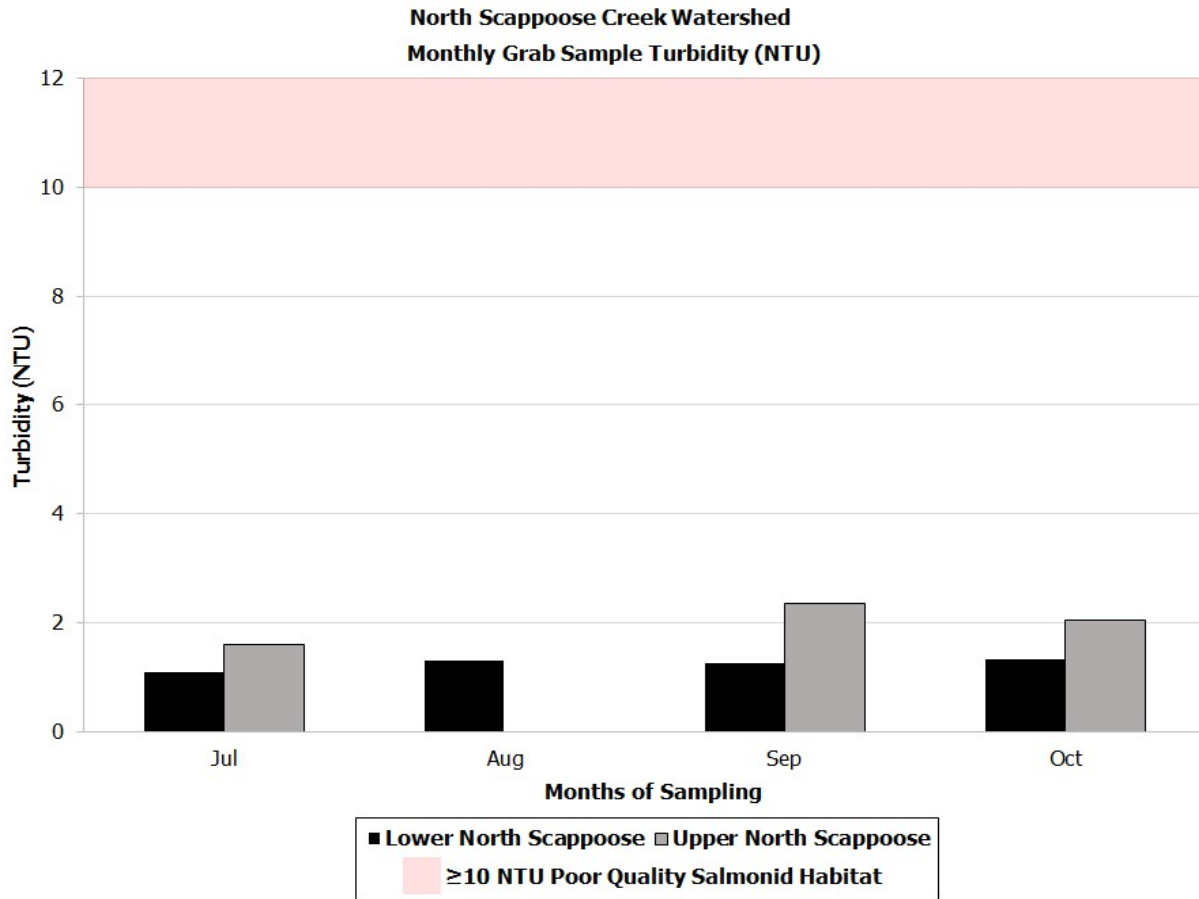
Figure 17. North Scappoose Watershed monthly grab sample turbidity (NTU) data from July to October 2017. See Table 3 for details on salmon habitat turbidity threshold.

Lower North Scappoose Creek turbidity was consistently lower than Upper North Scappoose Creek. Both Lower and Upper North Scappoose River turbidity levels were well below the 10 NTU turbidity threshold for poor water quality (Figure 17).

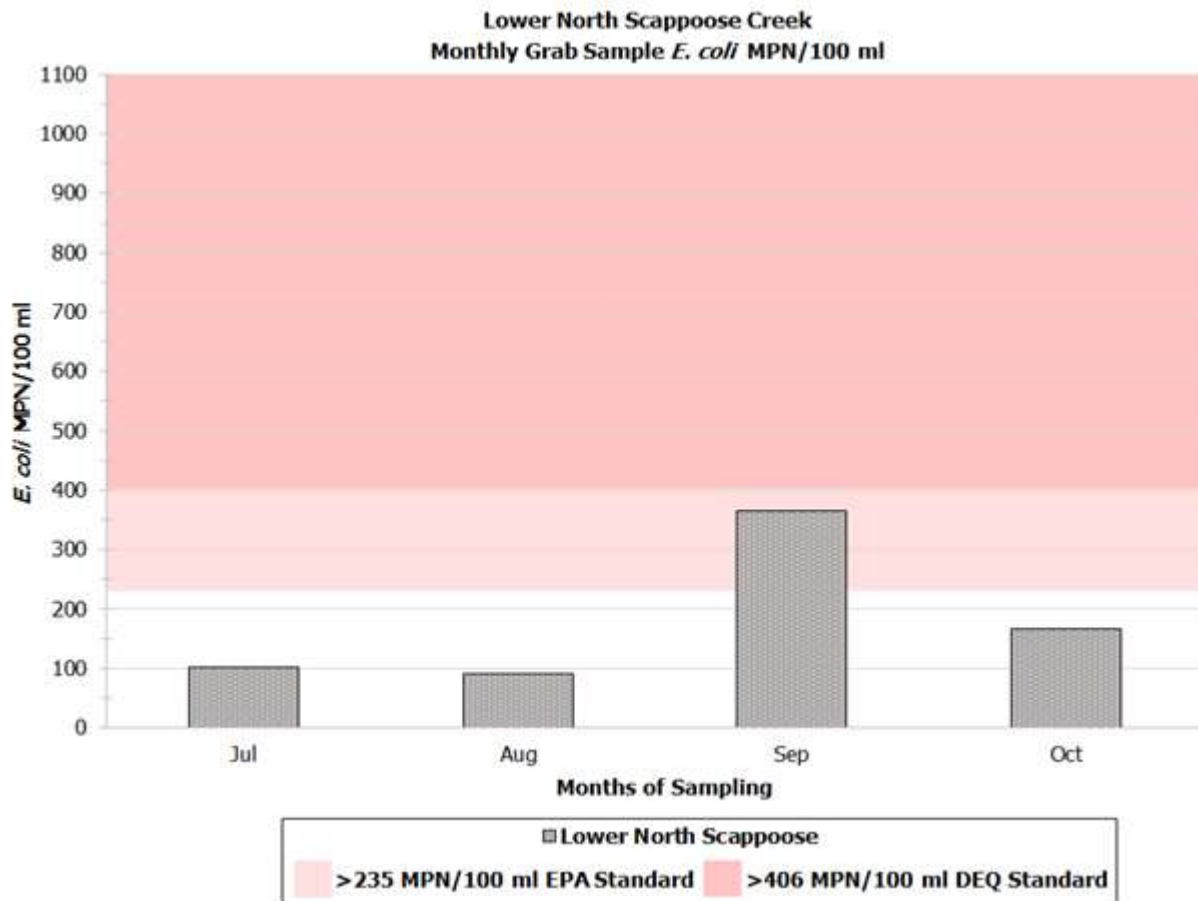
Figure 18. North Scappoose Watershed monthly grab sample *E. coli* bacteria data from July to October 2017. See Table 3 for details on *E. coli* bacteria thresholds.

Lower North Scappoose Creek exhibited low *E. coli* levels (<235 MPN/100 ml) in July, August, and October. Elevated levels (>235 MPN/100 ml) of *E. coli* were observed in September, exceeding the EPA health standard (Figure 18).

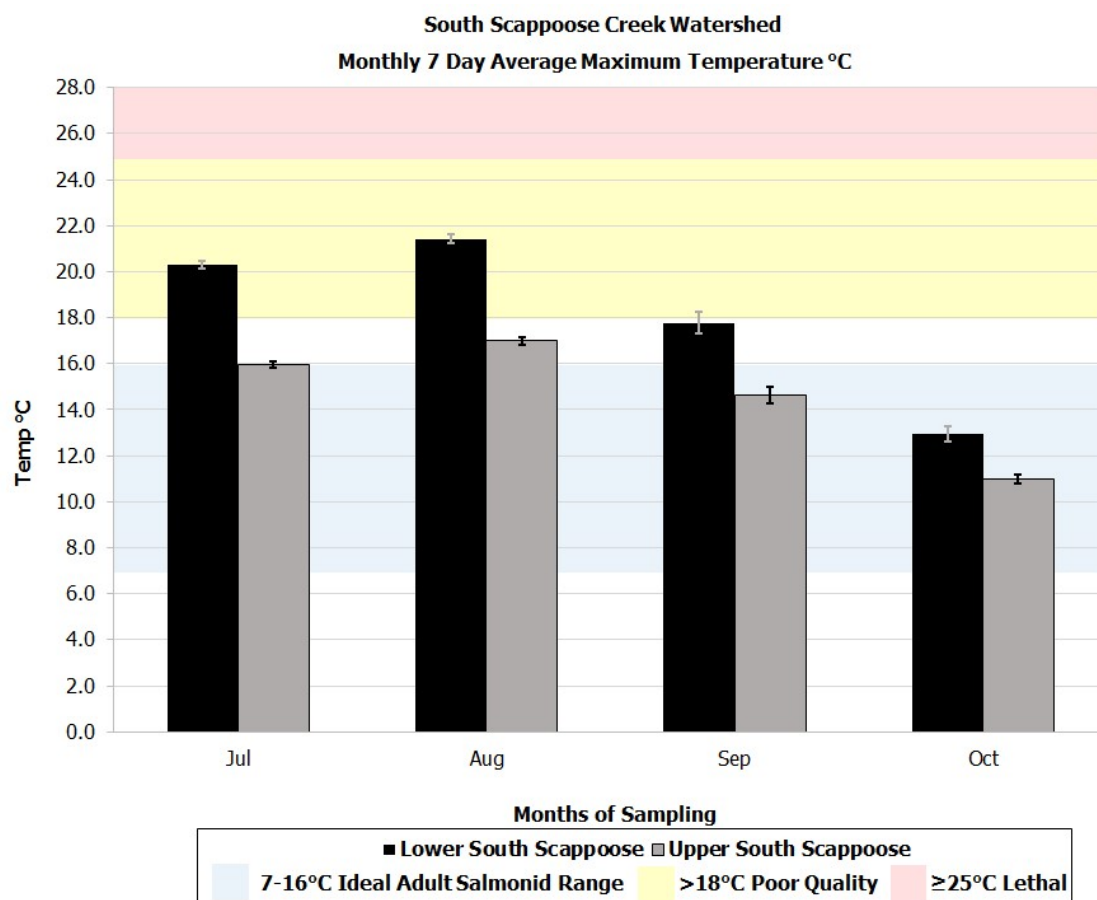
Figure 20 South Scappoose Watershed monthly mean 7-day average maximum temperatures (7dMAM) from July to October 2017. See Table 3 for details on salmonid temperature thresholds.

On average maximum stream temperatures in Lower North Scappoose Creek exceeded 18°C during July and August and remained below 18°C in September and October. Average maximum stream temperatures in Upper South Scappoose river remained below the 18°C threshold for the entire study period (July-October) (Figure 20).

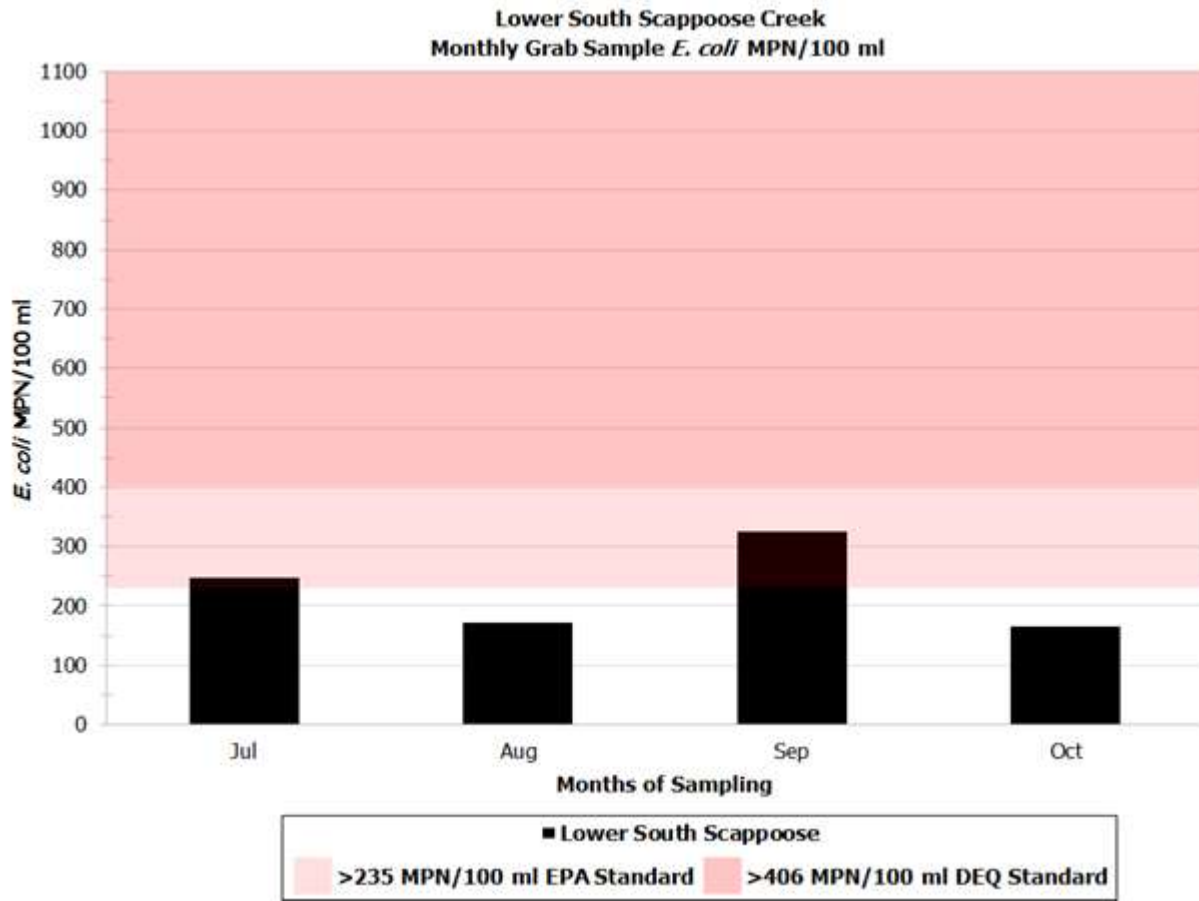
Figure 22. South Scappoose Watershed monthly grab sample *E. coli* bacteria data from July to October 2017. See Table 3 for details on *E. coli* bacteria thresholds.

Lower South Scappoose River generally exhibited elevated *E. coli* levels throughout the study period; in July and September levels exceeded the EPA health standard <235 MPN/100 ml (

Figure 22).

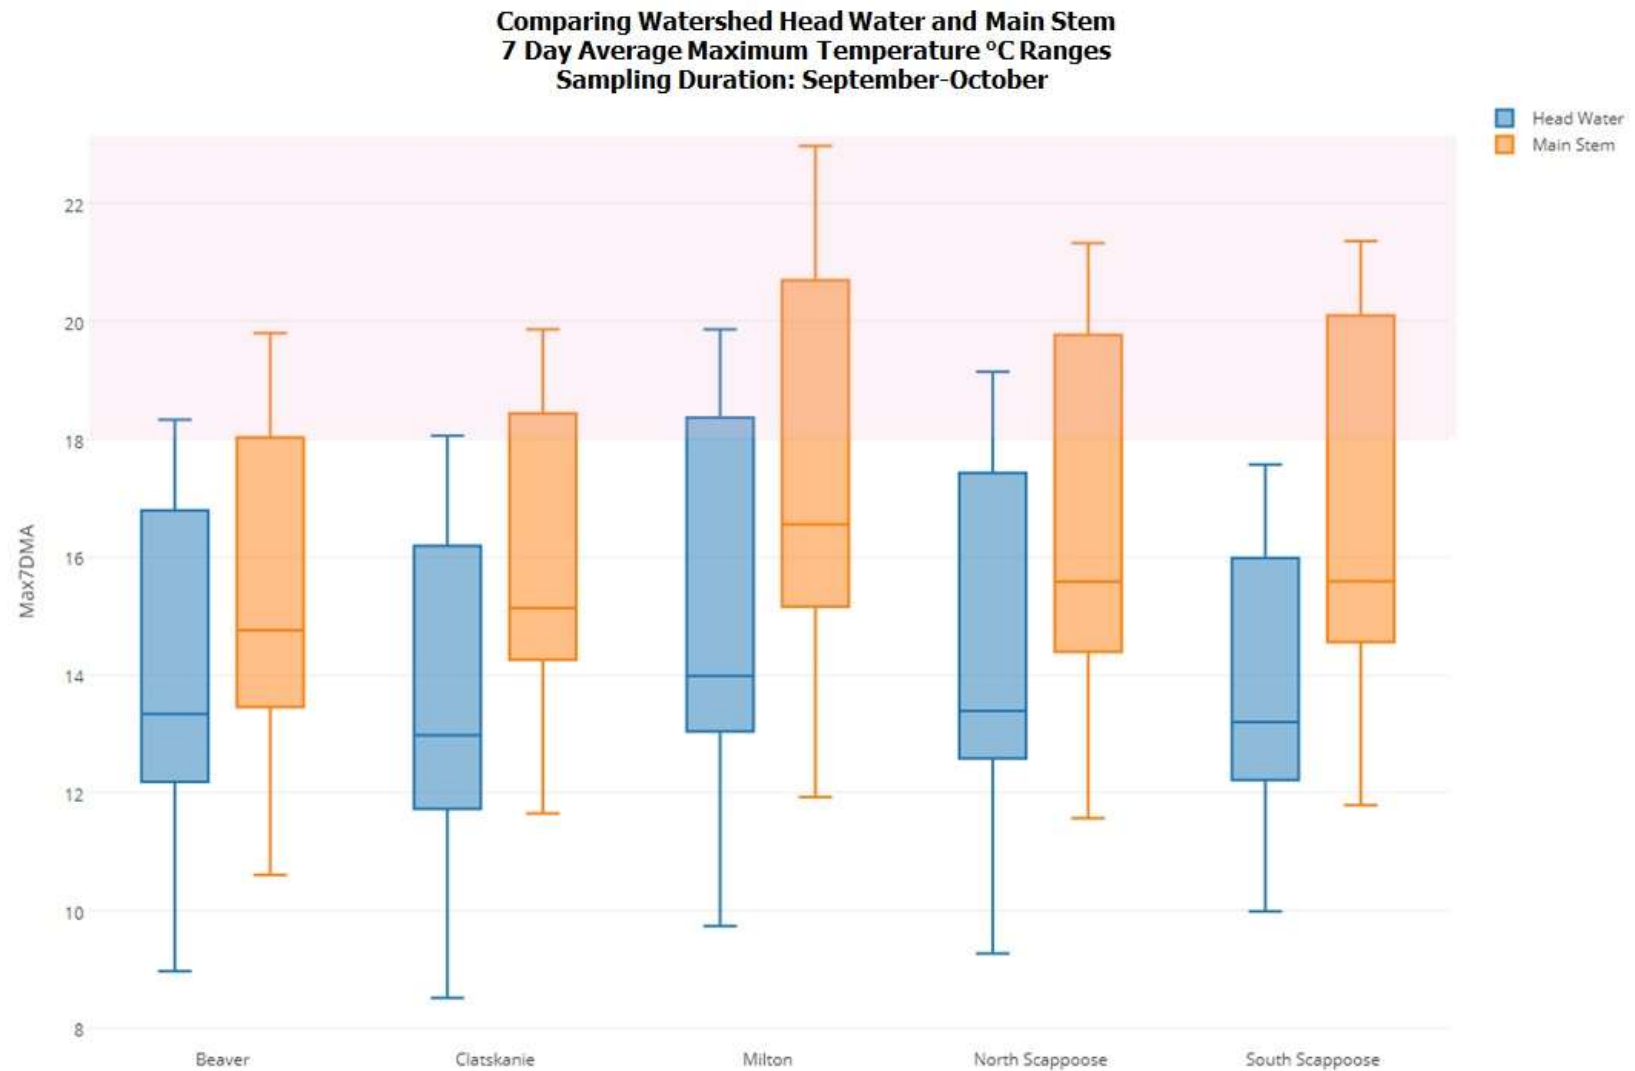
Figure 23. Comparison of 7 day average maximum temperature ranges for watershed head waters and lower mainstem sites

During the study period (July-October) the warmest average temperatures were recorded in the main stem (lower watershed) sampling locations, while the head water sampling locations generally remained below 18°C. The coolest average maximum temperatures were found in the Beaver, Clatskanie, and South Scappoose head waters. Beaver and Clatskanie maintained the cooler average maximum temperatures in the the lower main stem. Milton, North and South Scappoose Watersheds generally exhibited overall warmer average maximum temperature in main stems (Figure 23).

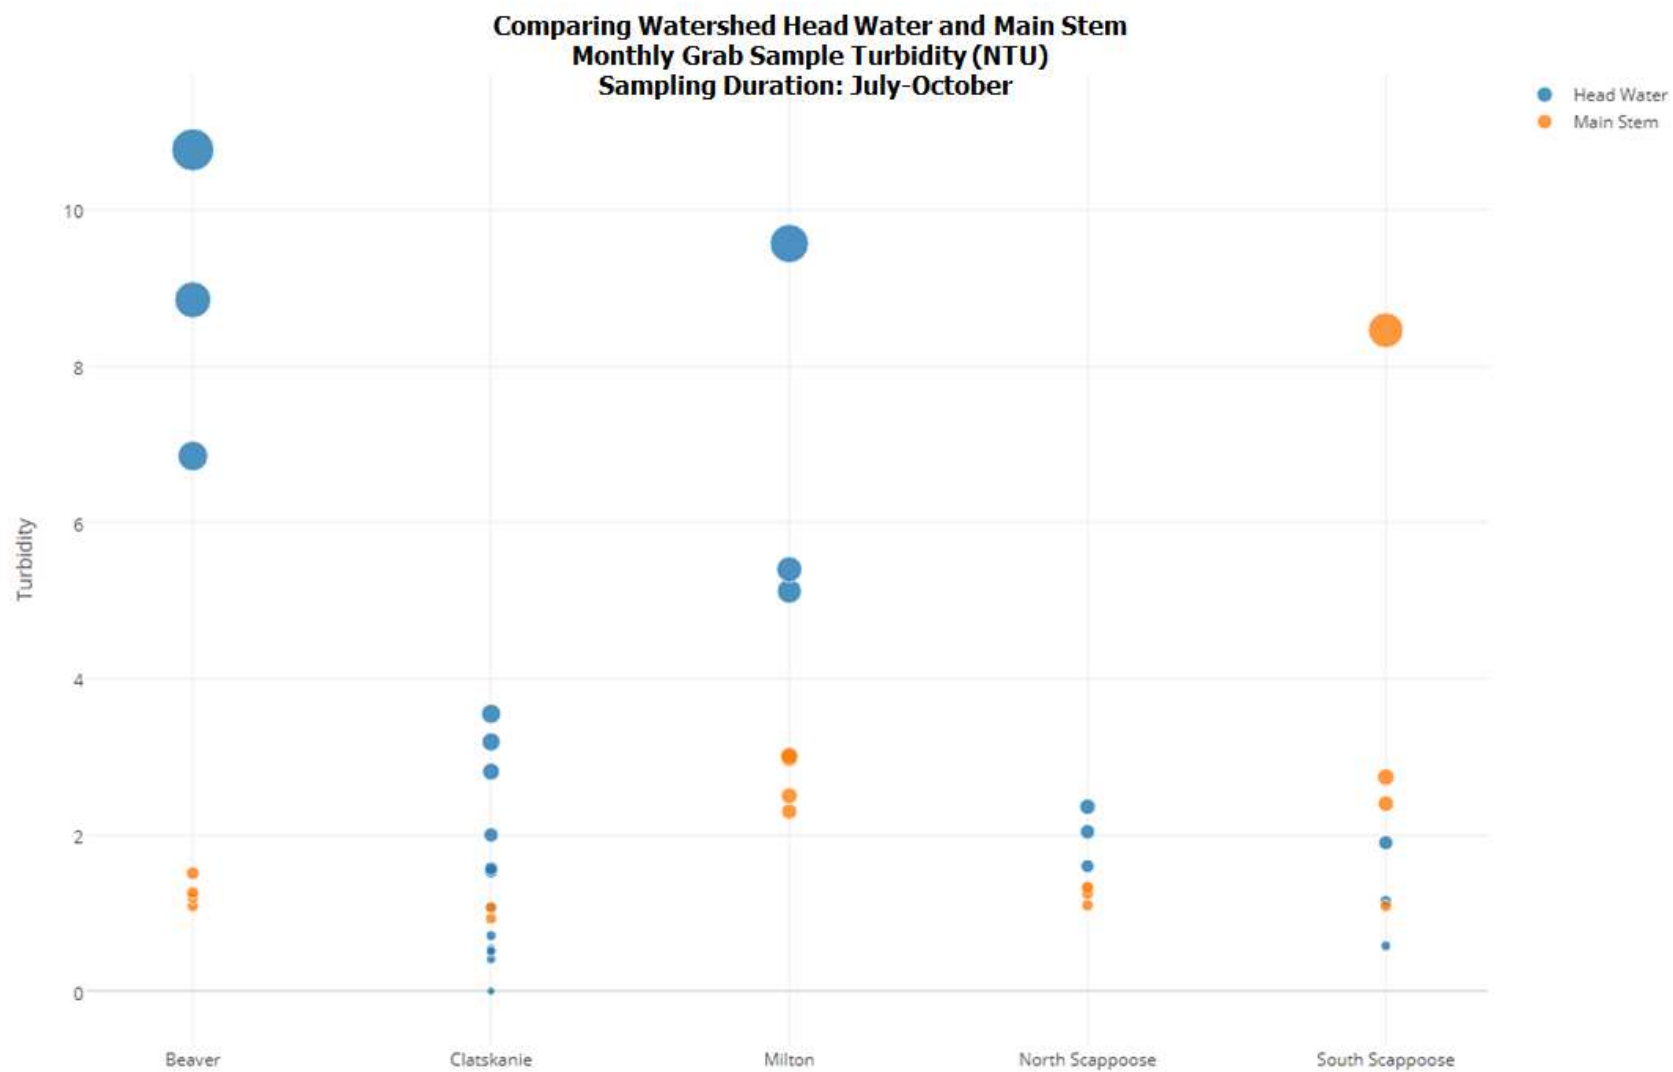
Figure 24. Monthly turbidity sampling in July through October in the headwater and mainstem for all monitored watersheds

For turbidity, the highest turbidities were recorded in the head waters of Beaver Creek and Milton Creek. For main stem sites, South Scappoose Creek consistently had higher turbidity than most of other head water sites. (Figure 24).

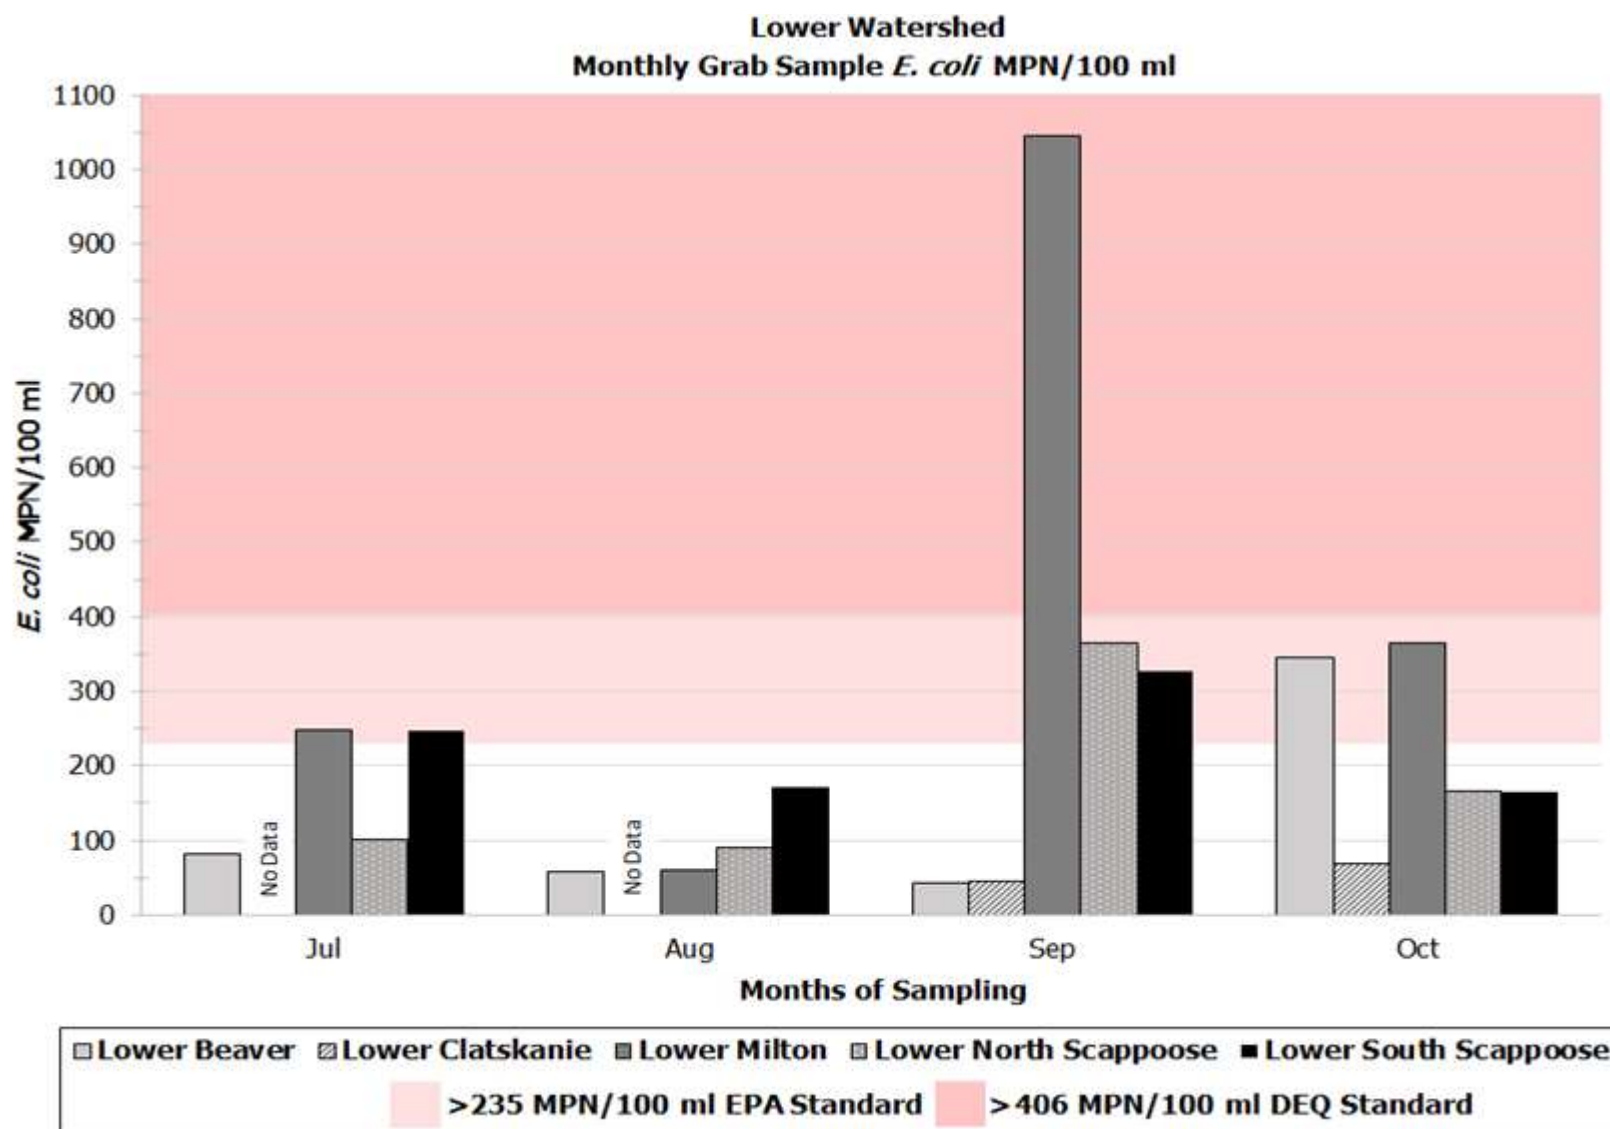
Figure 25. Monthly comparison of *E. Coli* results between monitored watersheds from July through October

Across all the sites *E. coli* levels were greatest in September and lowest in August. Milton Creek generally had the greatest counts of *E. coli*, while Lower Beaver and Lower Clatskanie had the lowest *E. coli* levels. In July, Lower Milton and Lower South Scappoose exceeded the EPA health standard. In August sites exceeded established health levels. Lower Milton had exceeded the DEQ standard by for *E. Coli* by double while Lower North and South Scappoose creeks exceeded the EPA health standard threshold in September. October saw a reduction in *E. Coli* levels, but Lower Milton still exceeded the EPA health

standard threshold. Lower Beaver Creek exceeded the EPA health standard threshold in October (Figure 25).

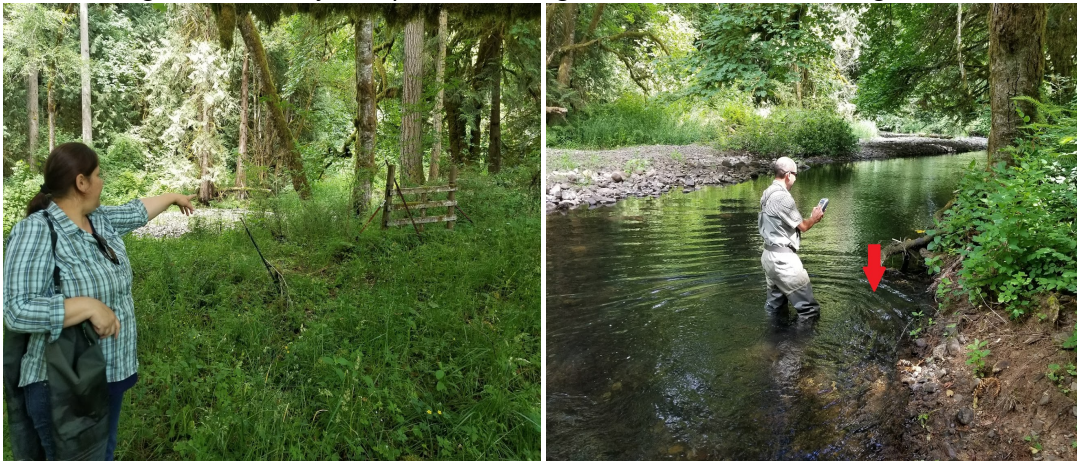
Clatskanie Watershed						
Site Code	Site Name	Description	GPS Coordinates	Logger Serial Number	Installed Date/Time	Installed Temp °C
LC	Lower Clatskanie	Data: Bacteria, Temp/WL, Turbidity	Lat: 46.080002 Long: -123.166841	20112654	8/17/2017 15:30	19.8
Site Code	Site Name	Description	GPS Coordinates	Logger Serial Number	Installed Date/Time	Installed Temp °C
MC	Middle Clatskanie	Data: Temp/WL, Turbidity Private property (must notify owner ahead of time) off of Swedetown road, walk through field behind the home, then cross through an old gate to access river. Data logger placed near an undercut bank with some overhanging roots	Lat: 46.045193 Long: -123.095813	20112657	6/28/2017 15:28	14.6

Location Image: River access just beyond old fence gate, near bank root overhang

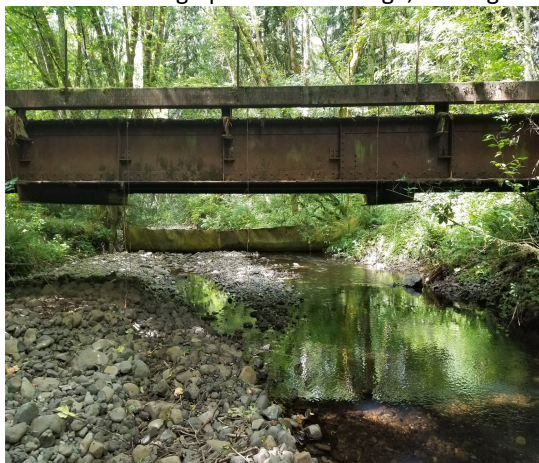
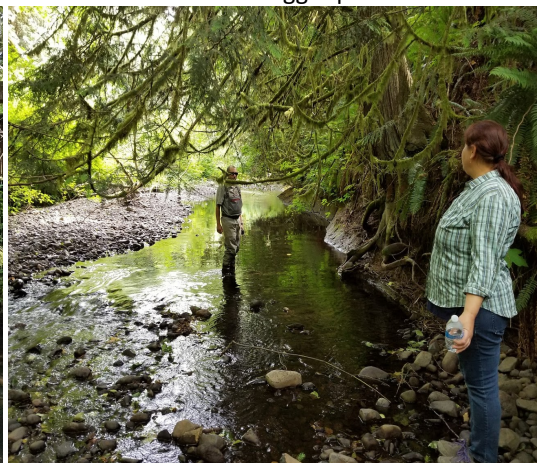
Site Code	Site Name	Description	GPS Coordinates	Logger Serial Number	Installed Date/Time	Installed Temp °C
CAR	Carcus	Data: Temp/WL, Turbidity Stream accessed via private drive off Swedetown Rd, data logger placed a few meters upstream of the bridge (to be out of way of impending construction).	Lat: 46.038533	20112662	6/28/2017 15:54	14.1
			Long: -123.085543

Location: Looking up stream at bridge, looking down stream towards data logger placement

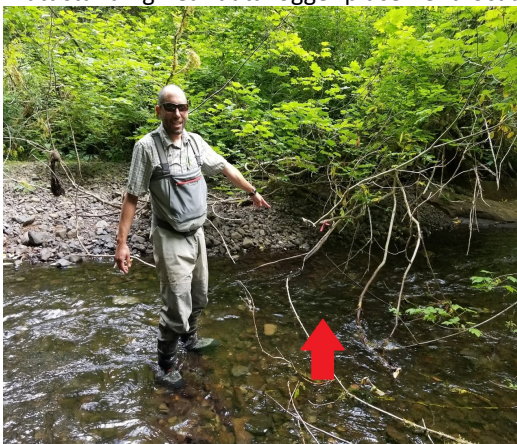
Matt standing near data logger placement location, under vine maple (flagged with pink tape)

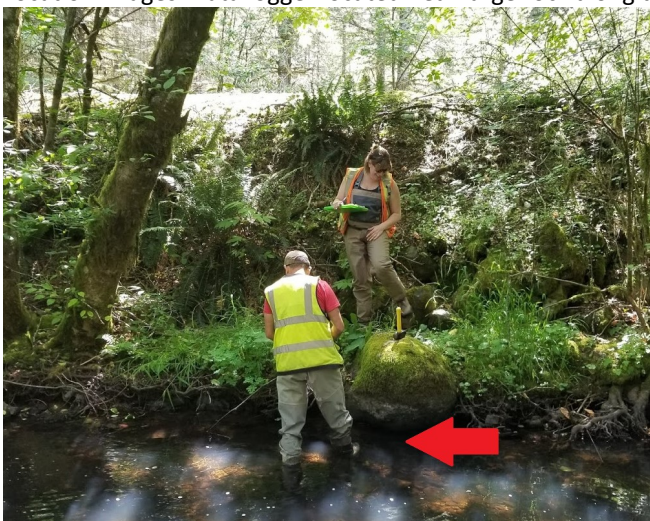
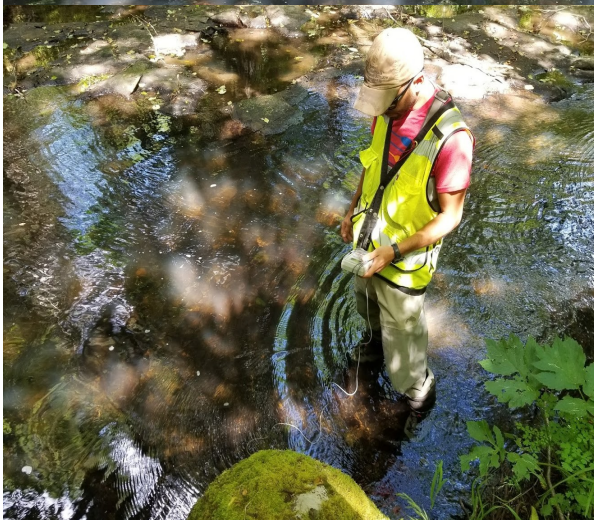
Location images: Data logger located near large rock along the river bank

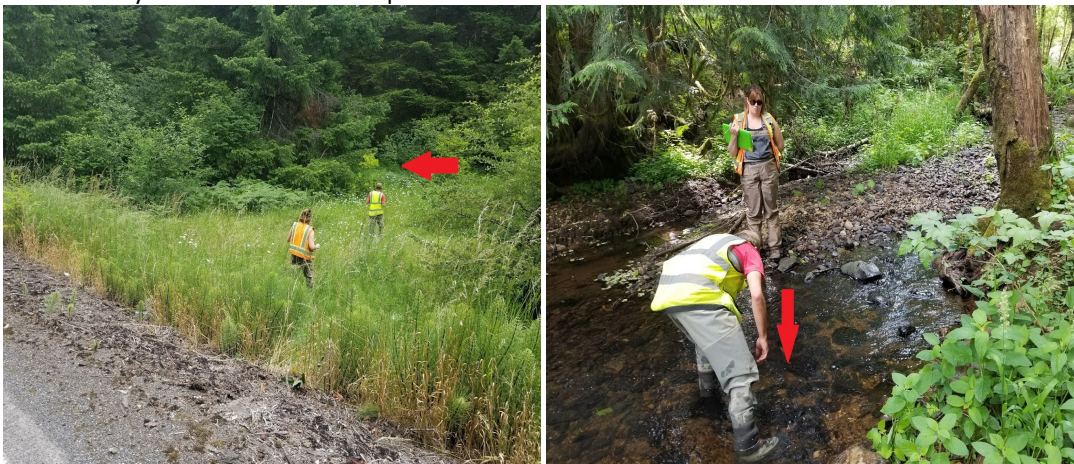
Grassy opening along right side of road side north of car pull out, data logger is located near flagging next to salmon berry shrub and cedar stump

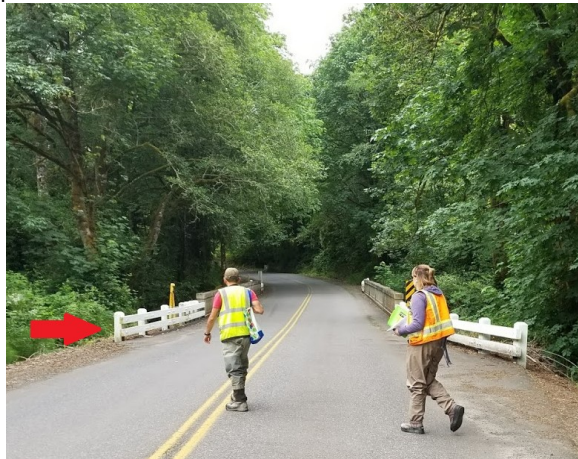
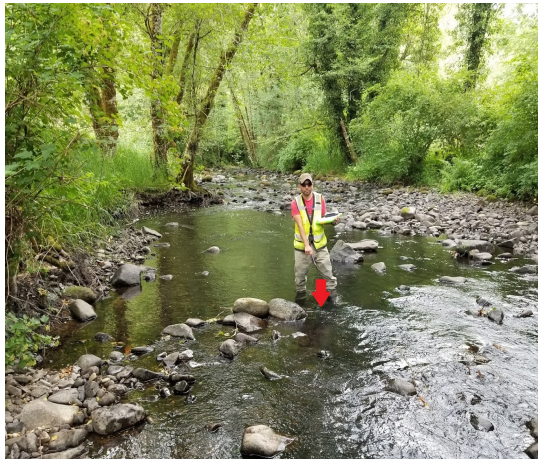
Location images: Park on side of the road and access stream on upstream side of bridge, data logger placed at the end of a rock pile just upstream of the bridge (large currant shrub on shore). Large rock near data logger placement marked with a black X.

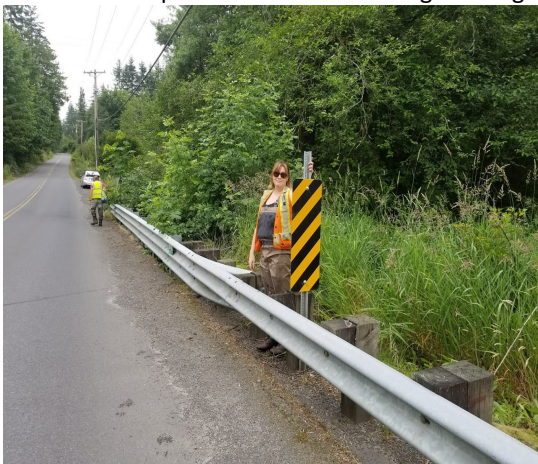
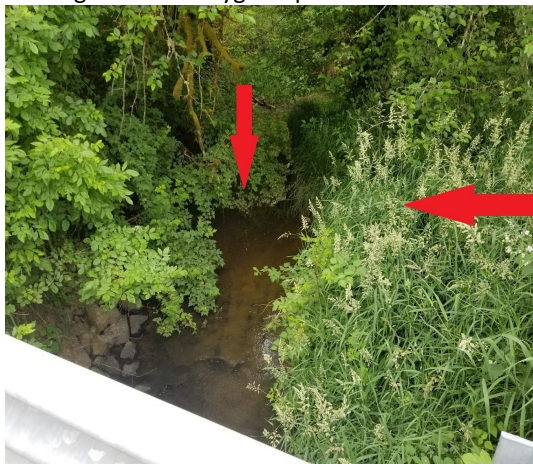
Site Code	Site Name	Description	GPS Coordinates	Logger Serial Number	Installed Date/Time	Installed Temp °C
UB	Upper Beaver UB	Data: Temp/WL, Turbidity Park just past bridge on Fernhill Road (near 73723 Fern Hill Rd), and walk down on the upstream side of the bridge through the large reed canarygrass patch. Located upstream of bridge, under a large currant shrub with pink flagging marking its location	Lat: 46.062373 Long: -122.965167	20112653	6/29/2017 10:44	14.0

Location images: Park just past bridge on Fernhill Road (near 73723 Fern Hill Rd Rainier, Oregon), and walk down on the upstream side of the bridge through the large reed canarygrass patch.
