Water Quality Monitoring Report: Columbia County Soil and Water Conservation District Water Quality Trend Monitoring Program 2017

**Columbia County SWCD
3150 NW 229th, Ave., Suite 150
Hillsboro, OR 97124
Phone: (503) 693-5700
Fax: (503) 693-4999**

Lower Columbia Estuary Partnership

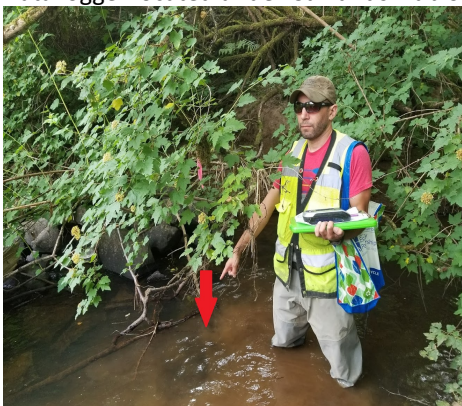
Data logger located under Currant shrub on far side of stream.

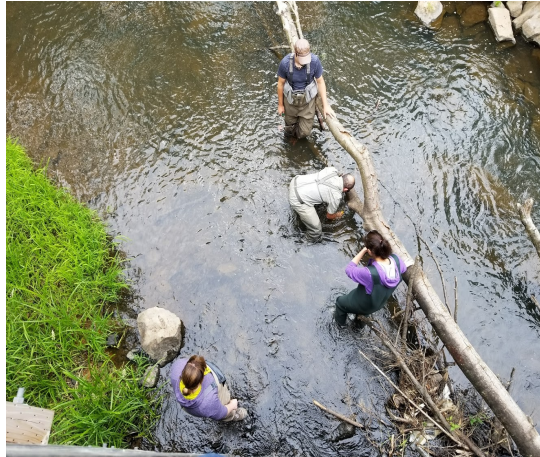
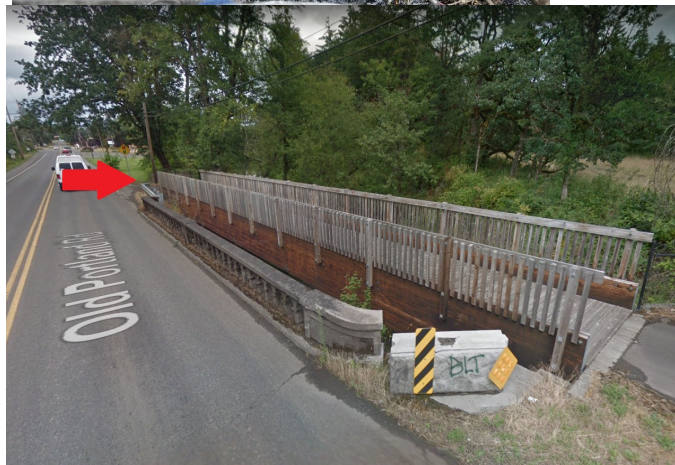
Location Image (looking down from the bridge, Matt is bending over data logger placement):

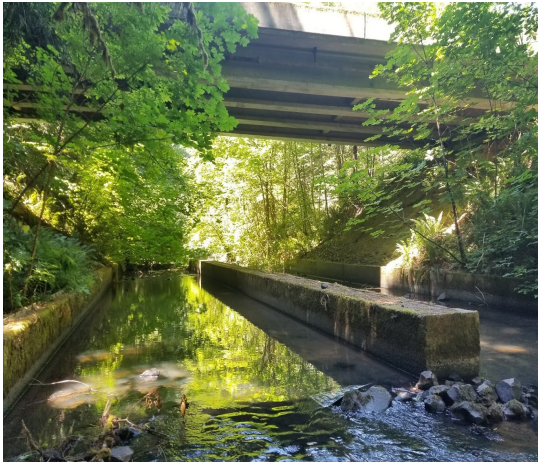
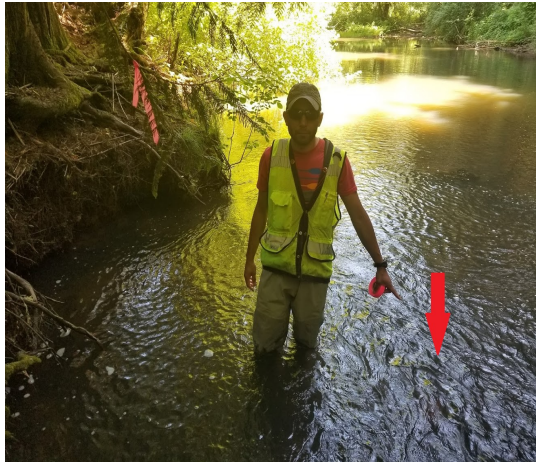
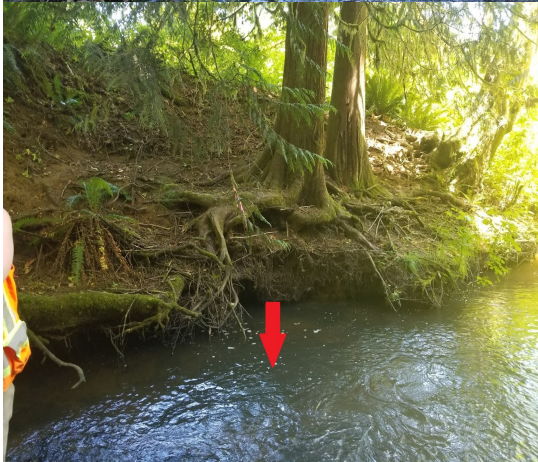
Location images: Downstream of bridge (a bit) near the north stream bank under flagged cedar tree in pool

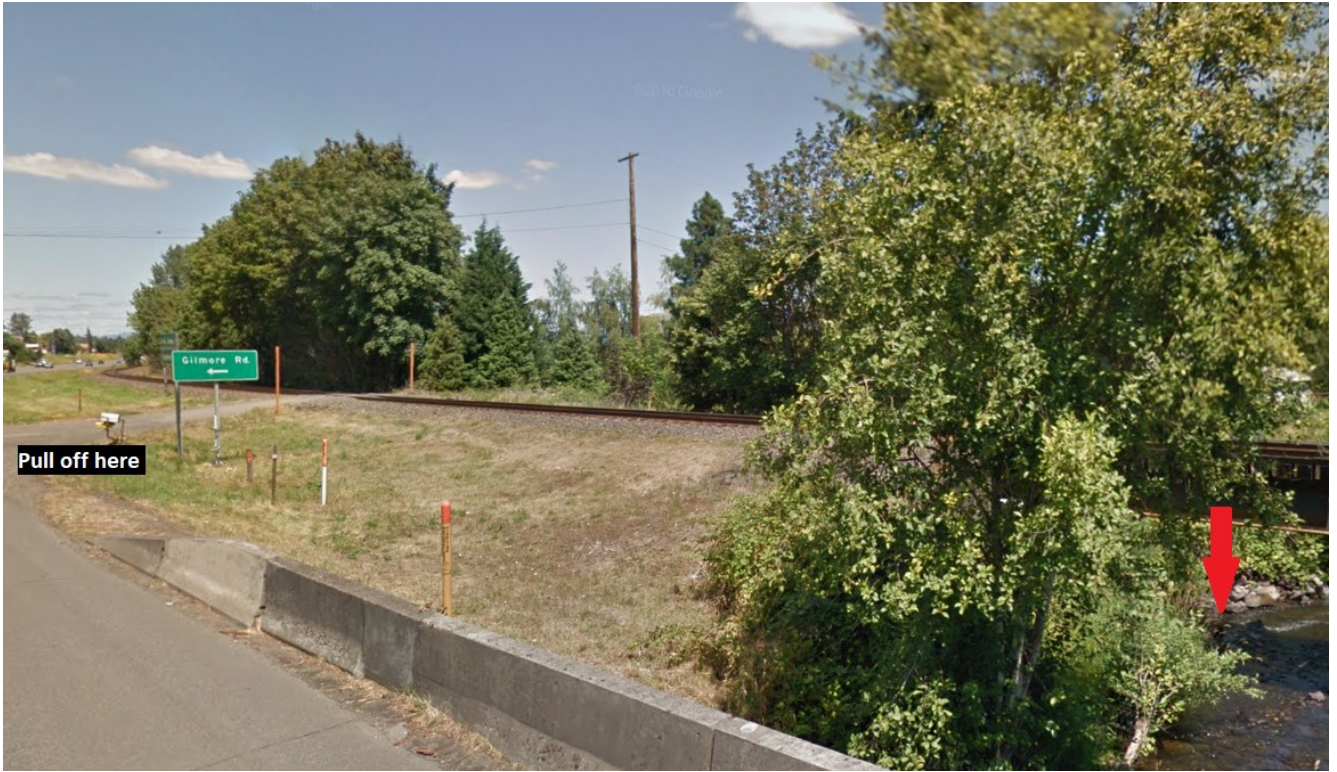
Scappoose Bay Watershed: North Scappoose Creek						
Site Code	Site Name	Description	GPS Coordinates	Logger Serial Number	Installed Date/Time	Installed Temp °C
LNS	Lower North Scappoose	Data: Bacteria, Temp/WL, Turbidity Pull off HWY 30 just north of bridge along Rosewood lane. Enter stream on the north bank at the railroad bridge (large patch of reed canarygrass) crossing. Data logger tided to old piling (flagged) on north bank of stream under railroad bridge.	Lat: 45.771786	20112652	6/29/2017 14:19	17.2

Location images: Pull off HWY 30 just north of bridge along Rosewood lane.

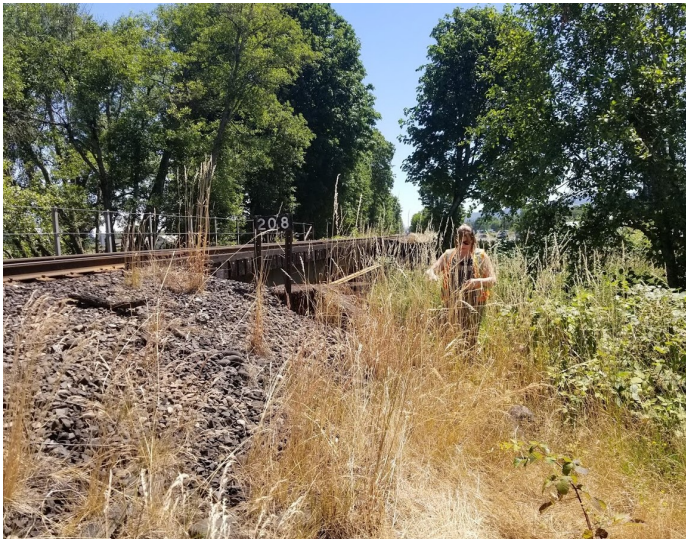
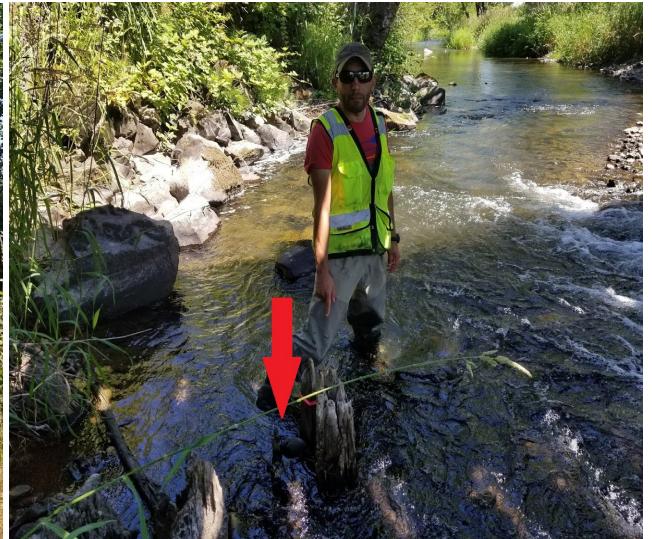
Enter stream on the north bank at the railroad bridge (large patch of reed canarygrass) crossing. Data logger tied to old piling on north bank of stream under railroad bridge.

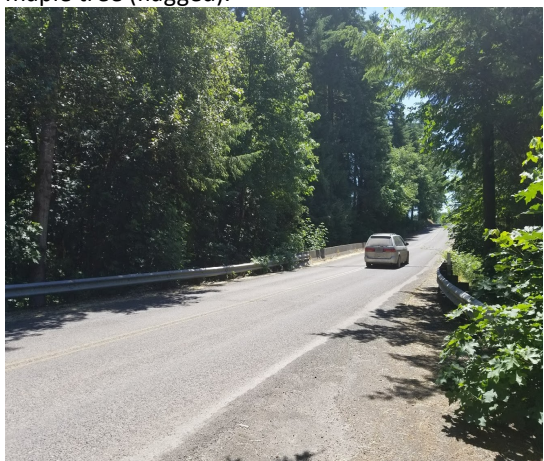
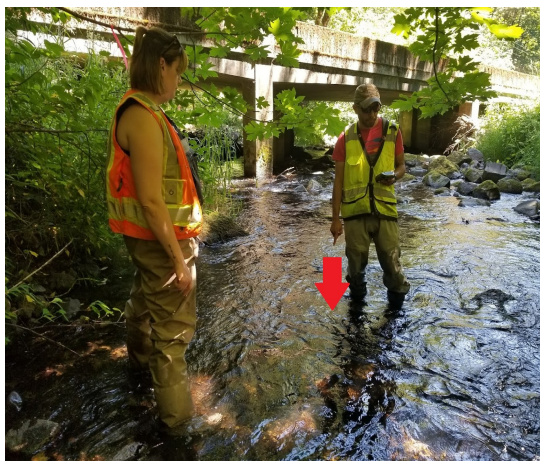
Location images: Descend on the upstream side of the bridge on the North bank. Data logger placed on North bank under maple tree (flagged).

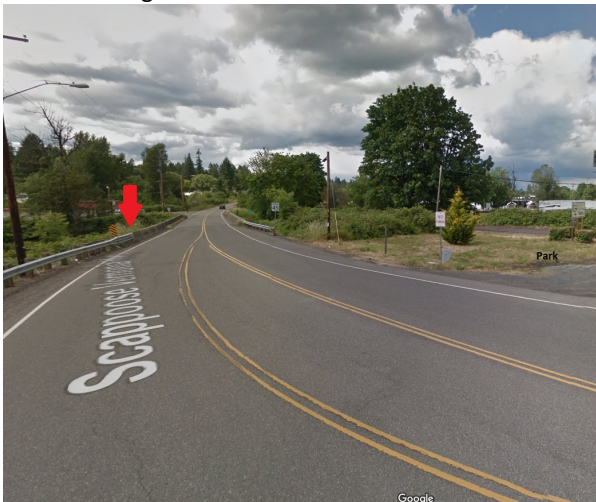
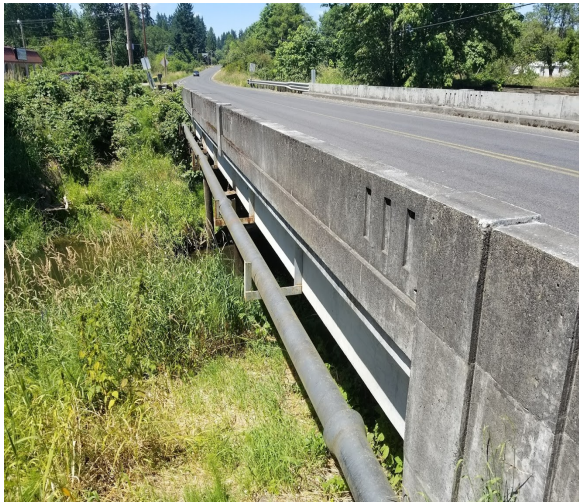
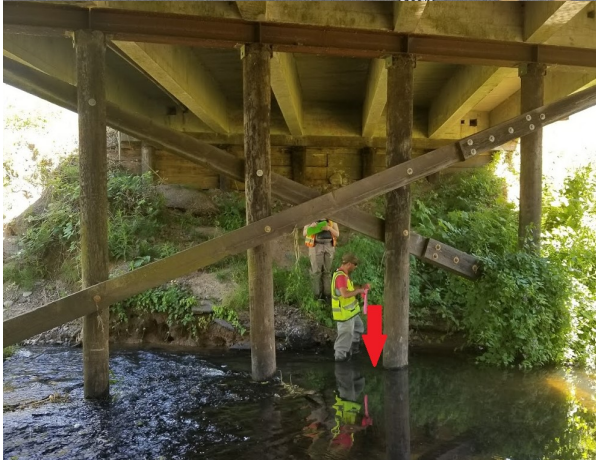
Scappoose Bay Watershed: South Scappoose Creek						
Site Code	Site Name	Description	GPS Coordinates	Logger Serial Number	Installed Date/Time	Installed Temp °C
LSS	Lower South Scappoose	Data: Bacteria, Temp/WL, Turbidity Park at the CZ trail area just off HWY 30, then decent on the south side of the bridge on the upstream side. Data logger tied to piling under bridge on south bank. Piling flagged.	Lat: 45.762739	20112658	6/29/2017 13:59	16.3
			Long: -122.880973			
Location images:

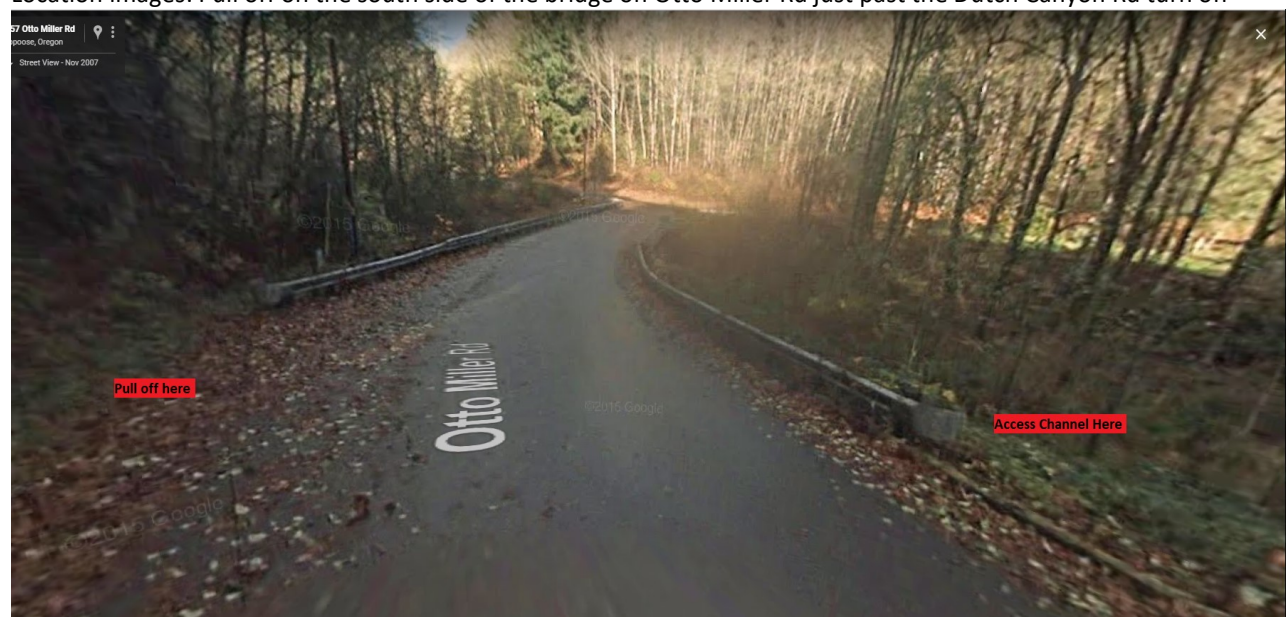
Site Code	Site Name	Description	GPS Coordinates	Logger Serial Number	Installed Date/Time	Installed Temp °C
USS	Upper South Scappoose	Data: Temp/WL, Turbidity Pull off on the south side of the bridge on Otto Miller Rd just past the Dutch Canyon Rd turn off (see image). Data logger located downstream of bridge under an alder tree (flagged).	Lat: 45.744219 Long: -122.961964	20112664	6/29/2017 14:44	13.7

Location images: Pull off on the south side of the bridge on Otto Miller Rd just past the Dutch Canyon Rd turn off
