# ***Barriers to Adult Pacific Lamprey at Road Crossings: Guidelines for Evaluating and Providing Passage***

*Living Document: Version 1.0*

***Lamprey Technical Workgroup***

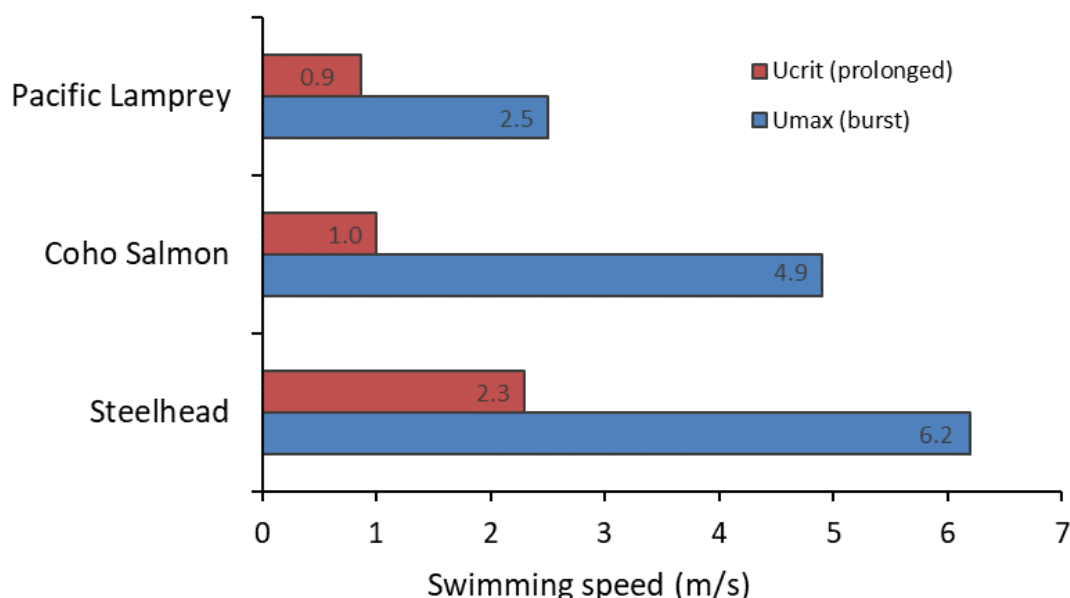
**Figure 1.** Estimated adult swimming speeds of Pacific Lamprey (Mesa et al. 2003, Keefer et al. 2010) compared with anadromous salmonids (Bell 1990, Lee et al. 2003).

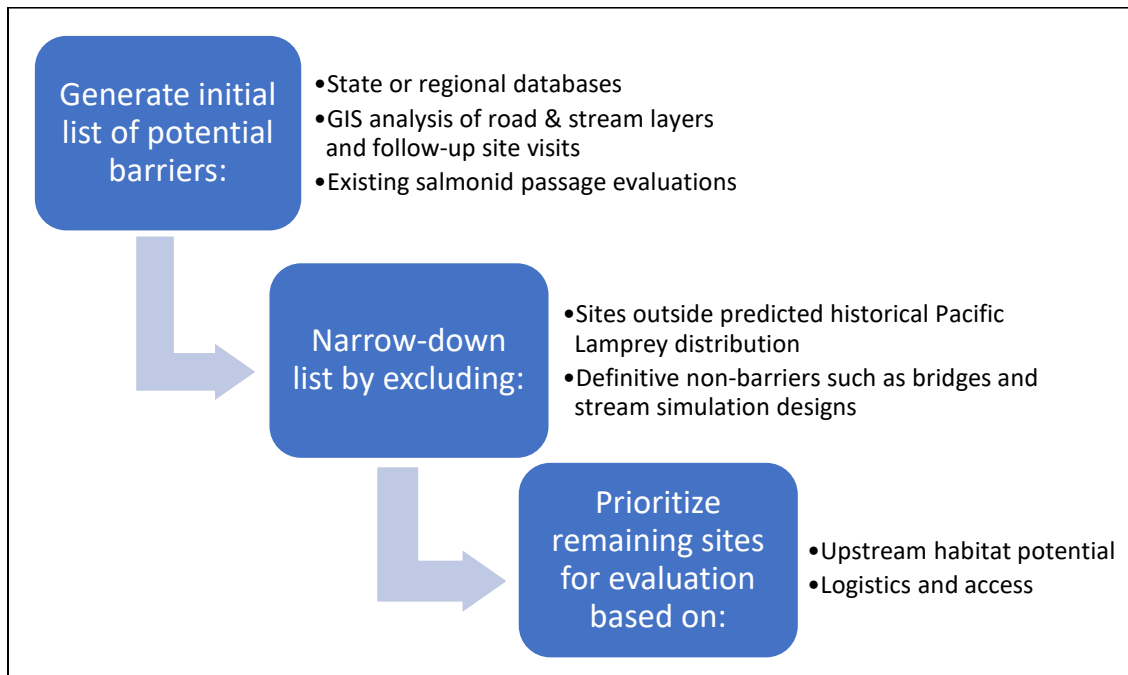
**Figure 6.** General process for identifying and prioritizing potential passage barriers for further evaluation.

If the objective is to assess passage for adult Pacific Lamprey throughout a property or watershed with a large number of road crossings, then assessments should prioritize sites that are most likely to (1) occur in streams within the historical distribution of Pacific Lamprey, (2) impede lamprey passage, and (3) block the most habitat upstream. The process for identifying and prioritizing sites within a study area for field and/or hydraulic analysis is summarized in Figure 6 and described below.

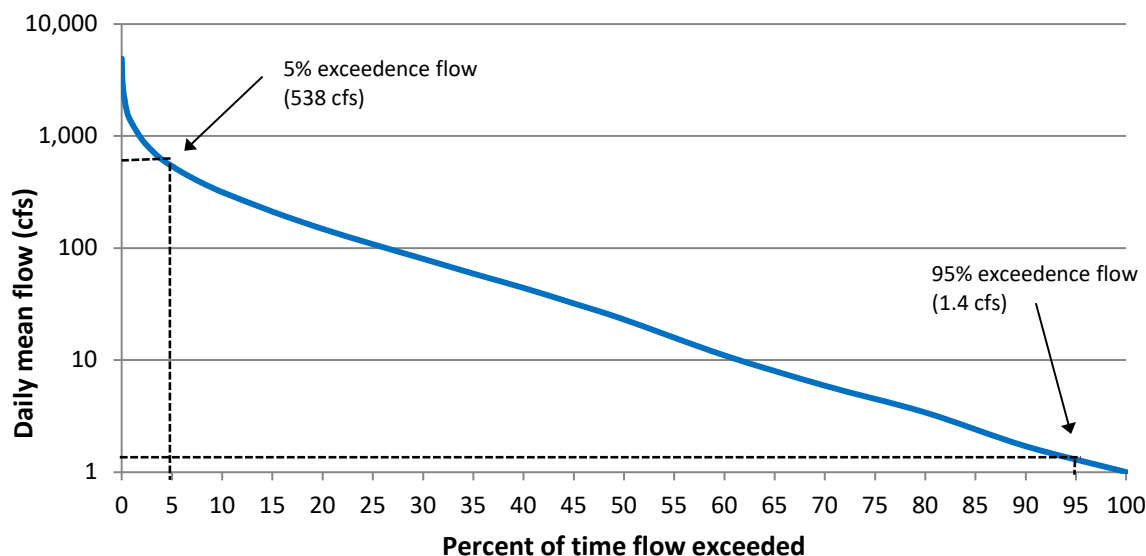
**Figure 8.** Example flow duration curve used to estimate fish migration flows. Data from Bull Creek, 1961-2013 (USGS gauge 11476600).

Because adult Pacific Lamprey are found in freshwater throughout the entire year and have the potential to move during any month, migration flows should conservatively be calculated for the entire year. For watersheds where more information on migration is available, the migration period can be adjusted. For example, Stillwater Sciences (2014) calculated migration flows for December–July, the “core migration period” for adult Pacific Lamprey in the Eel River.

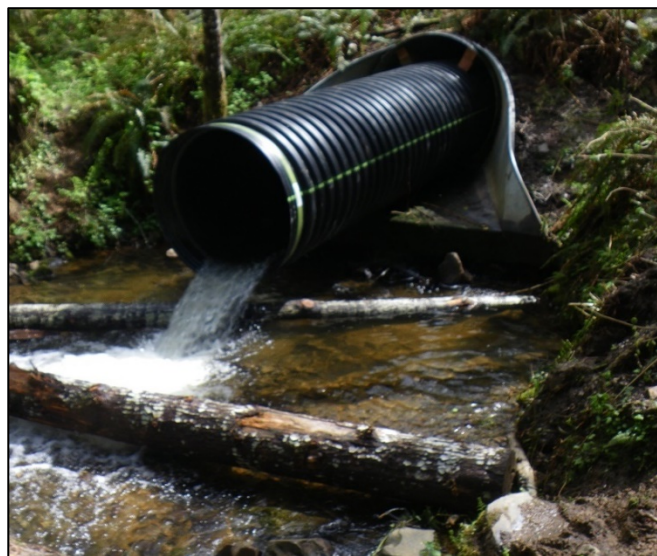
**Figure 1.** Coho Creek outlet prior to restoration. The perched, undersized and failing culvert was slip lined with a plastic pipe to prolong life.

Coho Creek is a small coastal tributary to the Necanicum Estuary in Oregon. The culvert had a 2-ft perch and was a full barrier to fish passage for both lamprey species and adult and juvenile salmonids due to the jump height, velocities that exceed fish swimming capabilities in the 160-ft pipe, and inadequate flow depths (Figure 1). The culvert was also a failure risk creating a human safety hazard on the only access/egress road to a local elementary school and a Community Tsunami Evacuation Route. Prior to restoration, the culvert was slip lined with a plastic pipe in an attempt to prevent catastrophic failure that would have released approximately 3,500 yd<sup>3</sup> of 20-ft high road fill into a high-quality wetland downstream. There was approximately one mile of spawning and rearing habitat upstream. The active channel width in the vicinity of the culvert was 10 ft, the active channel depth was approximately 1.5 ft, the substrate was dominated by gravel, the gradient was 3%, and the habitat bedforms were dominated by riffle and pool features.

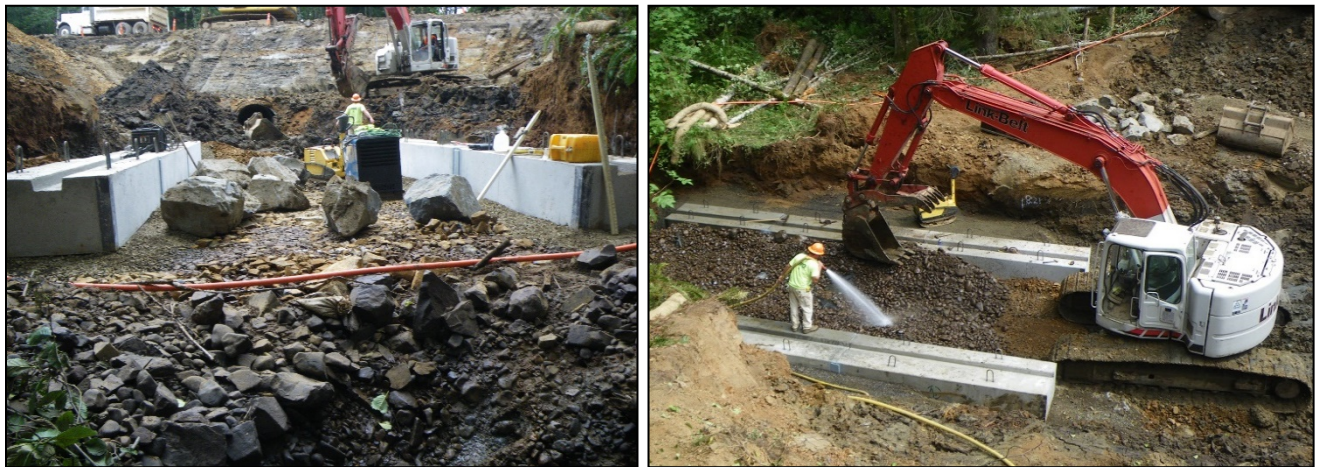
Figure 4. Proper sizing and installation of streambed materials is critical to success, including washing in fine sediment to ‘seal’ the streambed features. This ensures that when flow is returned to the channel, a low flow channel is maintained rather than flow going subsurface.

Proper construction of streambed simulation features is as critical as the design elements (Figure 3). Having the designer on site to oversee construction and to inspect and approve stream simulation materials is important to ensure it is installed per specifications. The contractor prepared the area for footers per design specifications at the appropriate grade. Footers were installed one section at a time and then welded together. Grade and location were measured and checked as each footer was placed. The gravel, rock rib, and boulder gradation specifications were based on instream conditions and hydraulic analysis. Gravels were specified to be free of fines, thoroughly mixed and placed in the culvert to specified depth. In addition, 30 2-3 ft partially buried oversized boulders were placed near the surface of the gravel (50% embedded) to create hydraulic shadows and maintain the low flow channel form. After the gravel was placed, the surface was washed to allow the fines to work into open spaces and form a seal. Sand was washed in until the gravel was sealed and wash water flowed on top of the gravel (Figure 4).

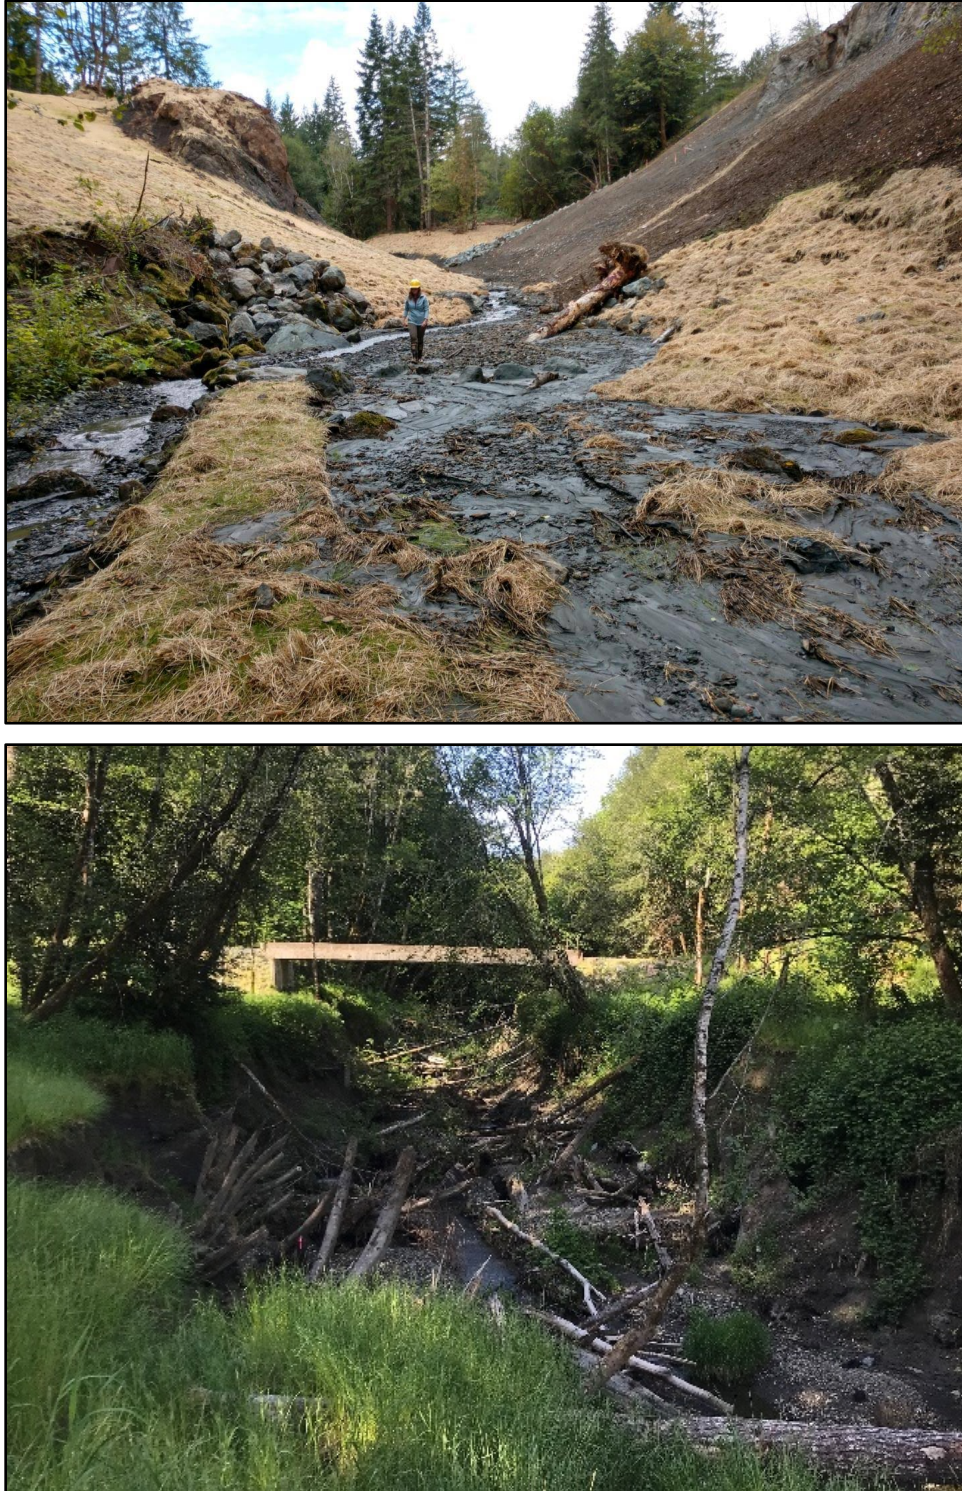
**Figure 3.** Pilot channel shortly after completion (top). Project site after first winter, showing natural recruitment of large wood. Constructed log jams will be placed in 2020 using the recruited wood in addition to larger pieces.

to further promote instream complexity. The removal of the culvert and placement of log structures has allowed for natural gravel export processes to provide spawning habitat in gravels and rearing habitat in fine sediment.

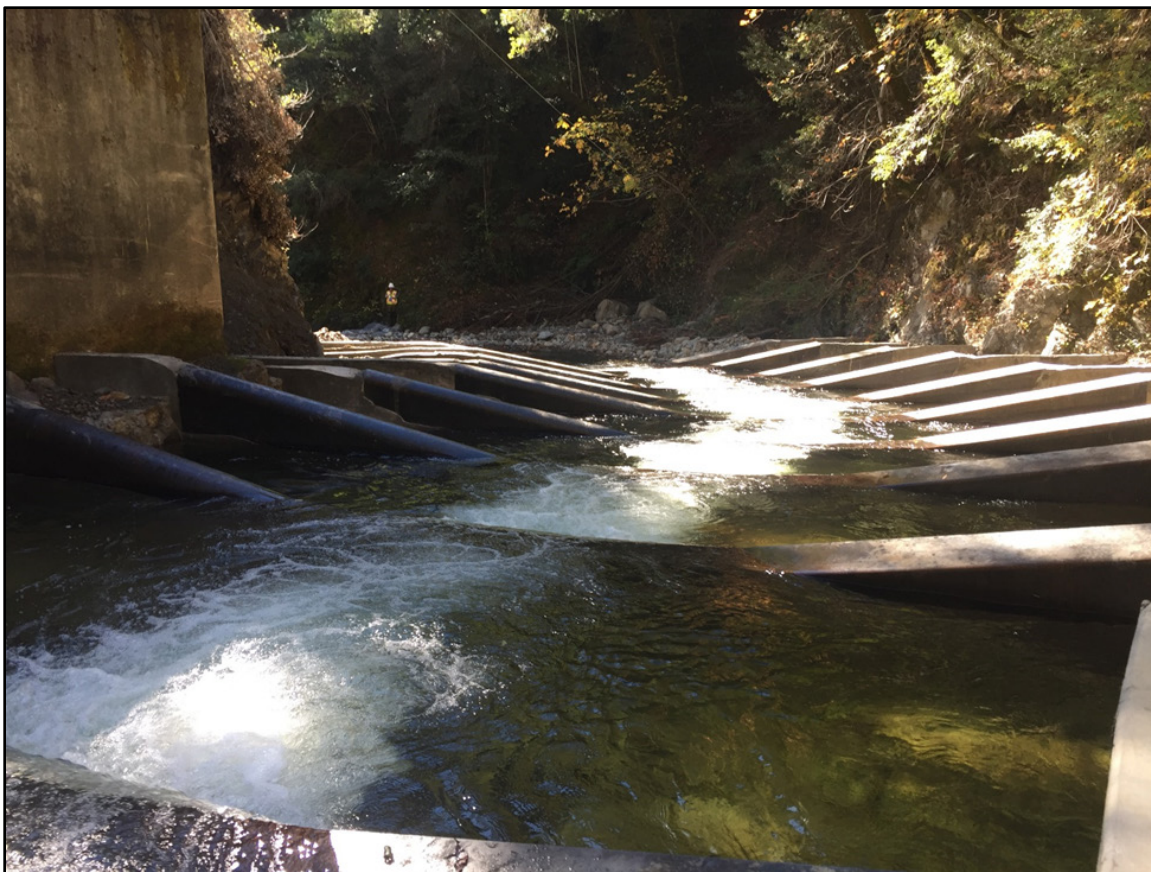
**Figure 3.** Post- project photo. Fishway with modified weir profiles installed downstream of the culvert. Rounded lamprey weir on left and squared salmonid weir on right.

Hydraulic solutions employed to address salmonid migration barriers at perched culverts can pose passage problems for migrating adult Pacific Lamprey because there are no continuous attachment surfaces. Prior to the retrofit, the outlet was onto concreted rock slope protection (RSP) that was perched approximately 6 ft above the water surface. The existing concrete apron and the culvert were not a complete barrier to the migration of Pacific Lamprey, as larvae had been documented upstream. It is likely that lamprey as could attach to and climb the wetted surface of the smooth apron and the sides of the interior of the culvert at some stream flows. However, the need to improve salmonid passage necessitated the installation of a new fishway that also accommodates lamprey passage.

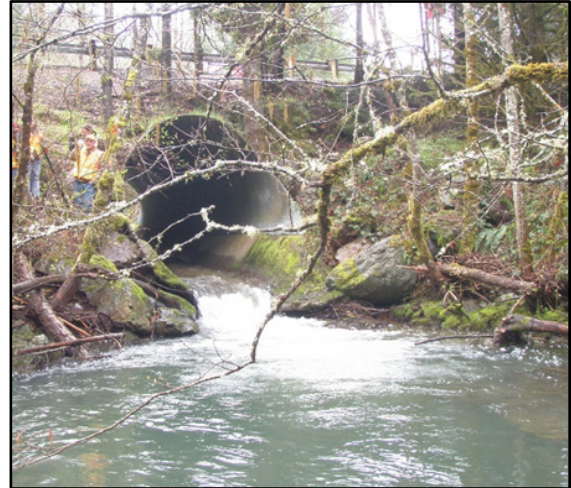
**Figure 1.** Pre-retrofit photo: culvert is perched above the water surface and undersized.

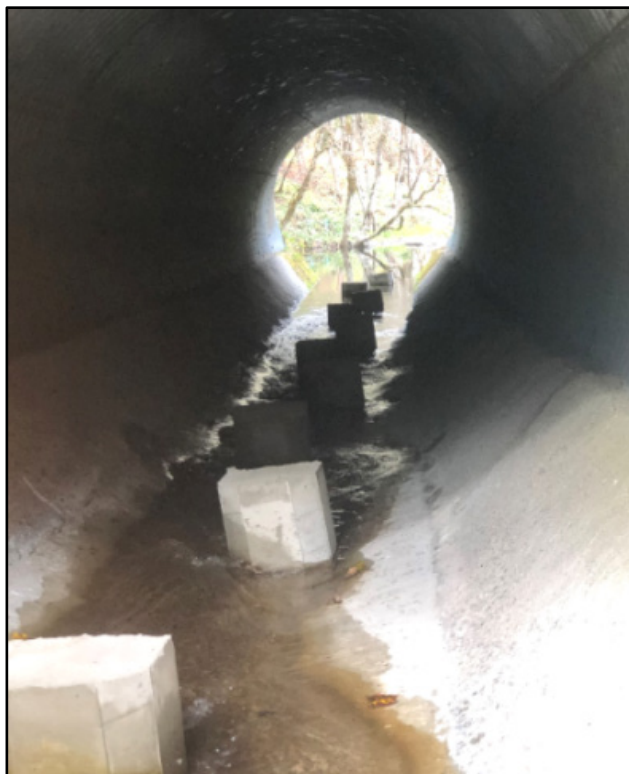
**Figure 3.** Post project photos. Fish blocks installed throughout the invert of the culvert to provide localized velocity reduction and resting areas for migrating fishes.

The blocks have a 90° corner on the downstream side, which would be better for lampreys if they were rounded. However, since lamprey may be using margins on side of culvert at waterline during upstream migration, square corners may not be an issue.

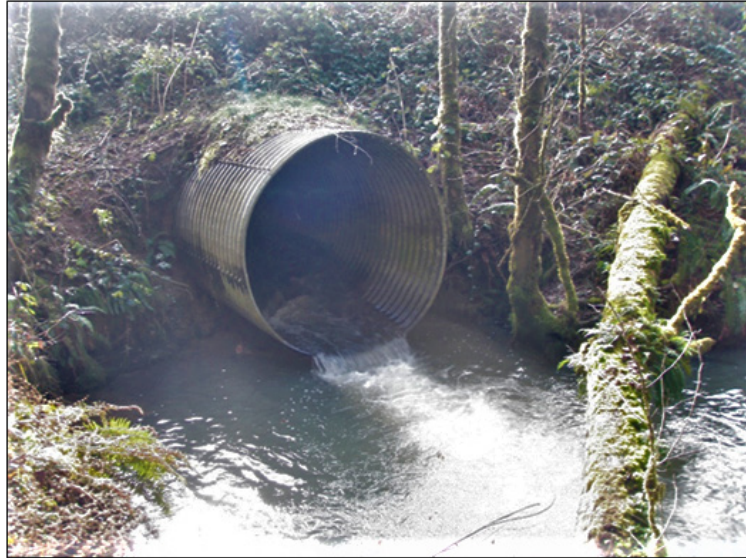
**Figure 1.** Pass Creek pre-retrofit, showing undersized culvert with perched outlet.

Perched culverts are a common passage problem for upstream migrating adult Pacific Lamprey because there are no continuous attachment surfaces and lampreys can't jump. Prior to the retrofit, the outlet of this culvert was perched approximately 1.0 ft above the water surface, preventing adult lampreys from entering the culvert (Figure 1). In addition, the culvert was undersized, creating very high-water velocities that prevented adult Pacific Lamprey from entering the culvert.

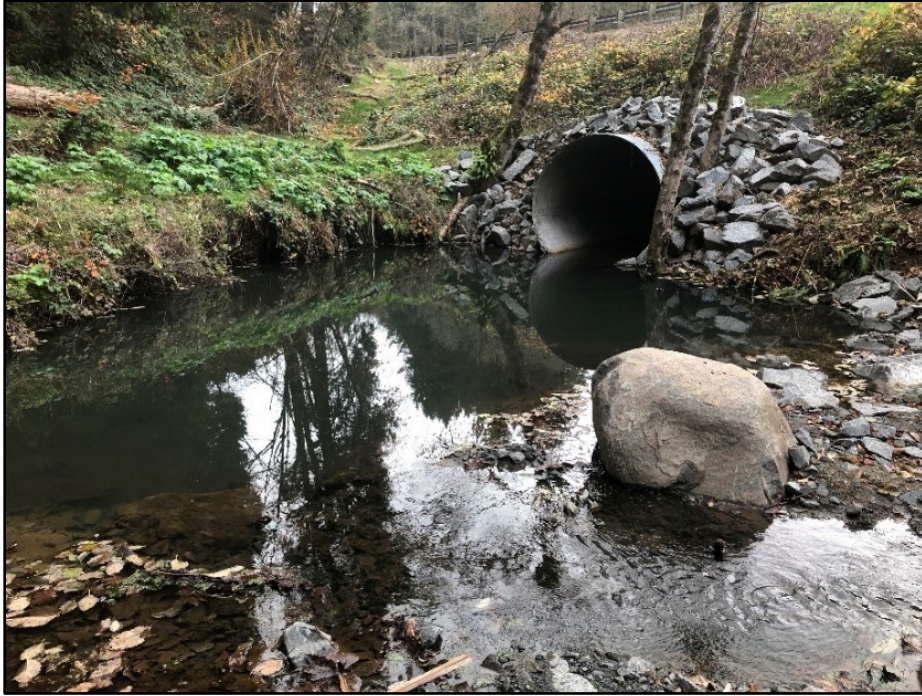
**Figure 2.** Pass creek post retrofit, showing boulder weir and roughened channel installed downstream of culvert to back-water outlet, eliminating perched condition and allowing fish and lamprey to swim into the culvert without jumping.

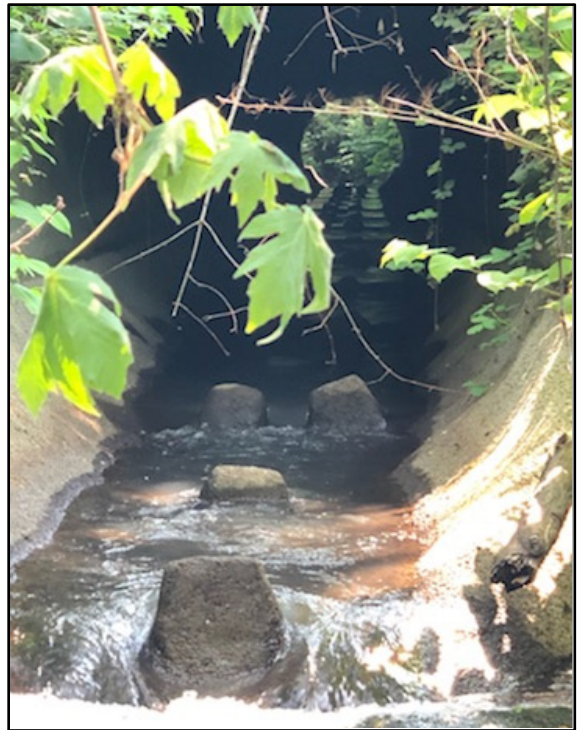
**Figure 3.** Pass Creek, post retrofit, showing smoothed concrete and “fish rocks” installed throughout invert of culvert to provide localized velocity reduction (left). Another example of “fish rocks” is shown (right) from a separate project, as the Pass Creek fish rocks were somewhat undersized for expected velocities.

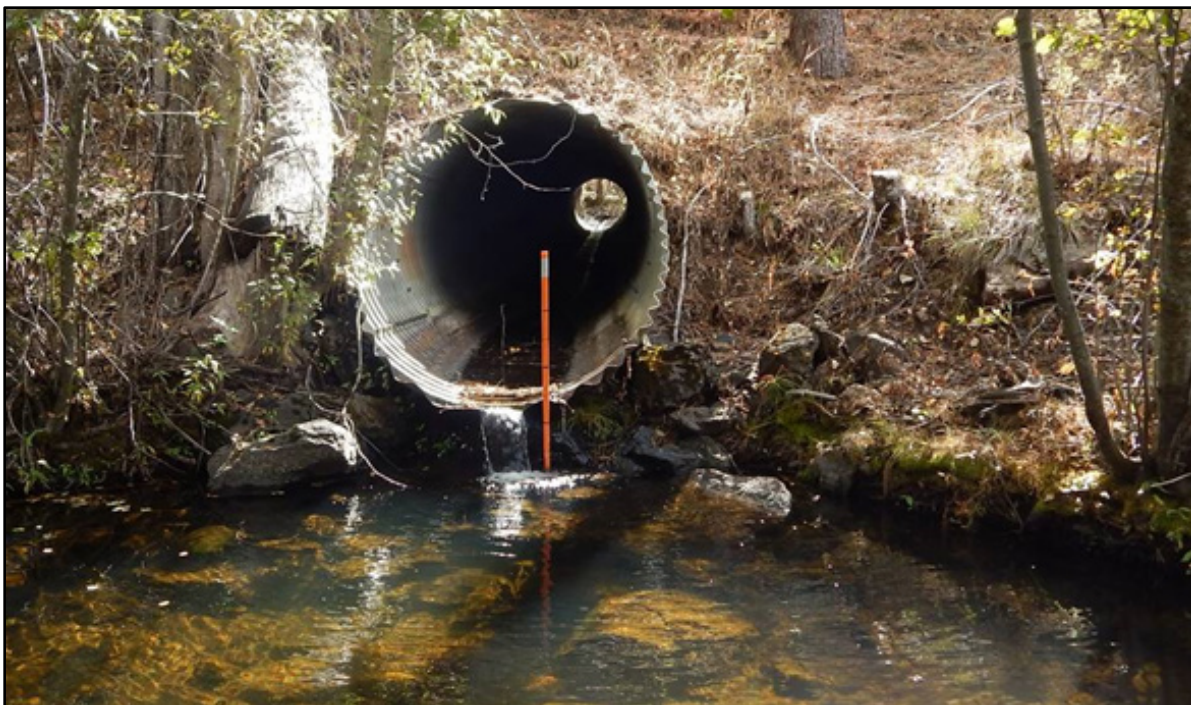
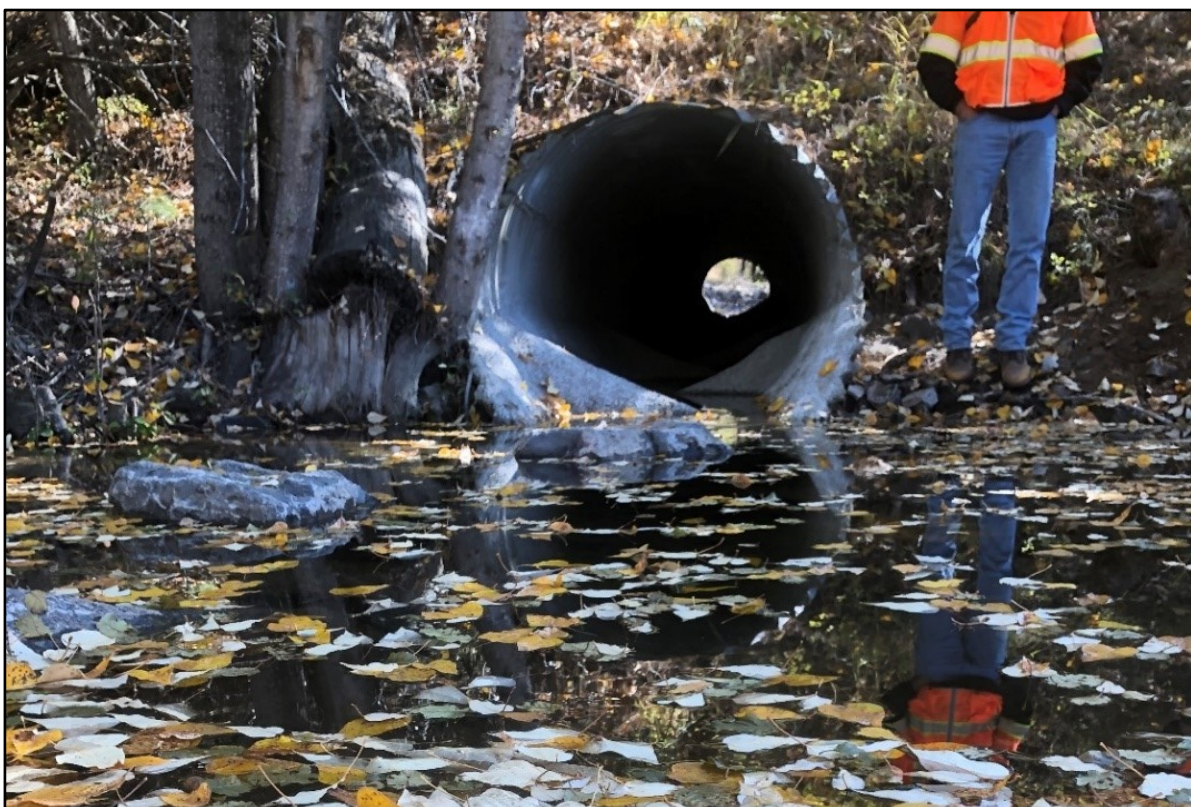
**Figure 2.** Marley Creek Culvert Outlet pre-project (top), with large perch creating barrier to upstream migrating fish and lamprey. After the project was completed, backwater conditions allow upstream fish migrations and rounded baffles were installed inside the culvert to add depth and reduce velocities.

The Marley Creek Culvert Repair and Fish Passage Project under Hwy 244 near Starkey, Oregon was completed in summer of 2019. The goals of the project included (1) alleviating a high priority barrier to upstream migrant native fish and (2) repairing a failing culvert. The culvert was repaired with a paved invert liner (Figure 1) and was not replaced due to the very high costs for replacement and other constraints associated with the project area. Prior to the project, the culvert was perched (Figure 2).

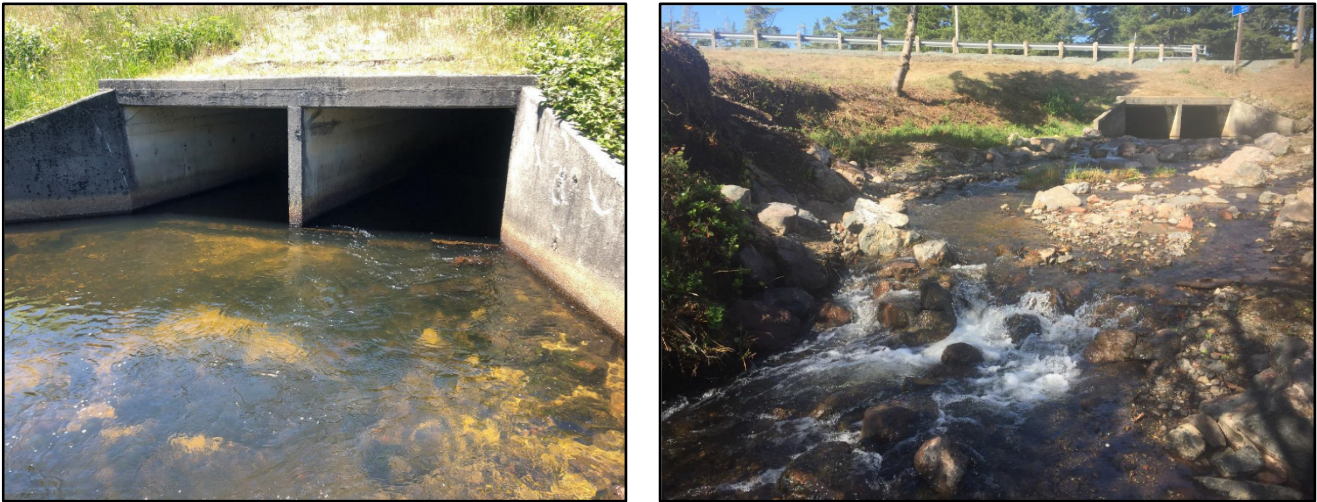
**Figure 2.** Post- project photos showing the modified baffle at culvert outlet and increased elevation of the outlet pool providing continuous passage into the culvert without requiring a jump (left) and the roughened channel downstream of the culvert (right).

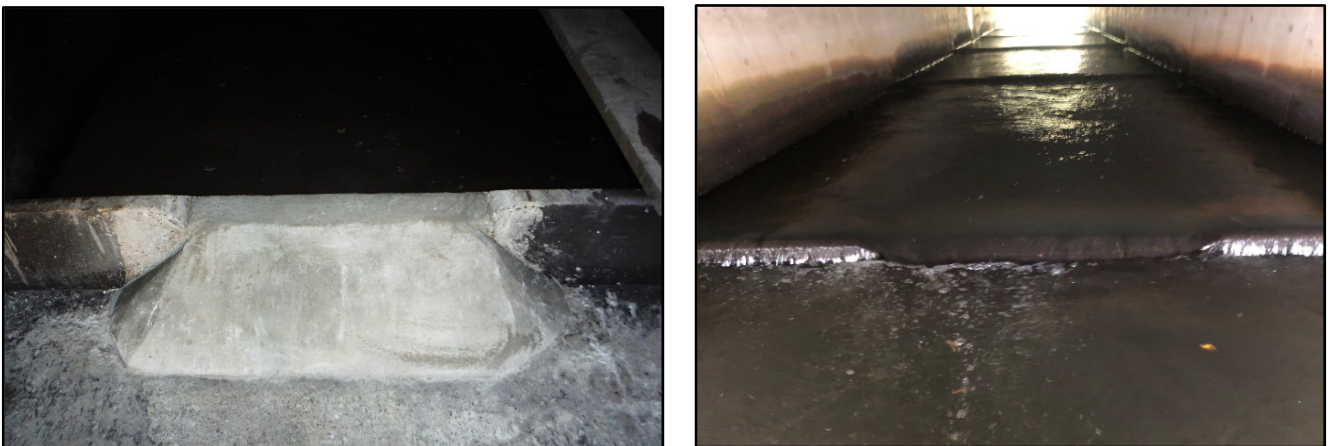
**Figure 3.** Photos of the modified baffle and ramp in dry and watered conditions. Middle portion of the baffle was cut down and a ramp was installed on each side of that cut to provide lamprey with a continuous attachment surface.
