Action Effectiveness Monitoring for the Lower Columbia River Estuary Habitat Restoration Program

Project Number: 2003-007-00

Action Effectiveness Monitoring for the Lower Columbia River Estuary Habitat Restoration Program Annual Report for Year 12 (October 2015 to September 2016)

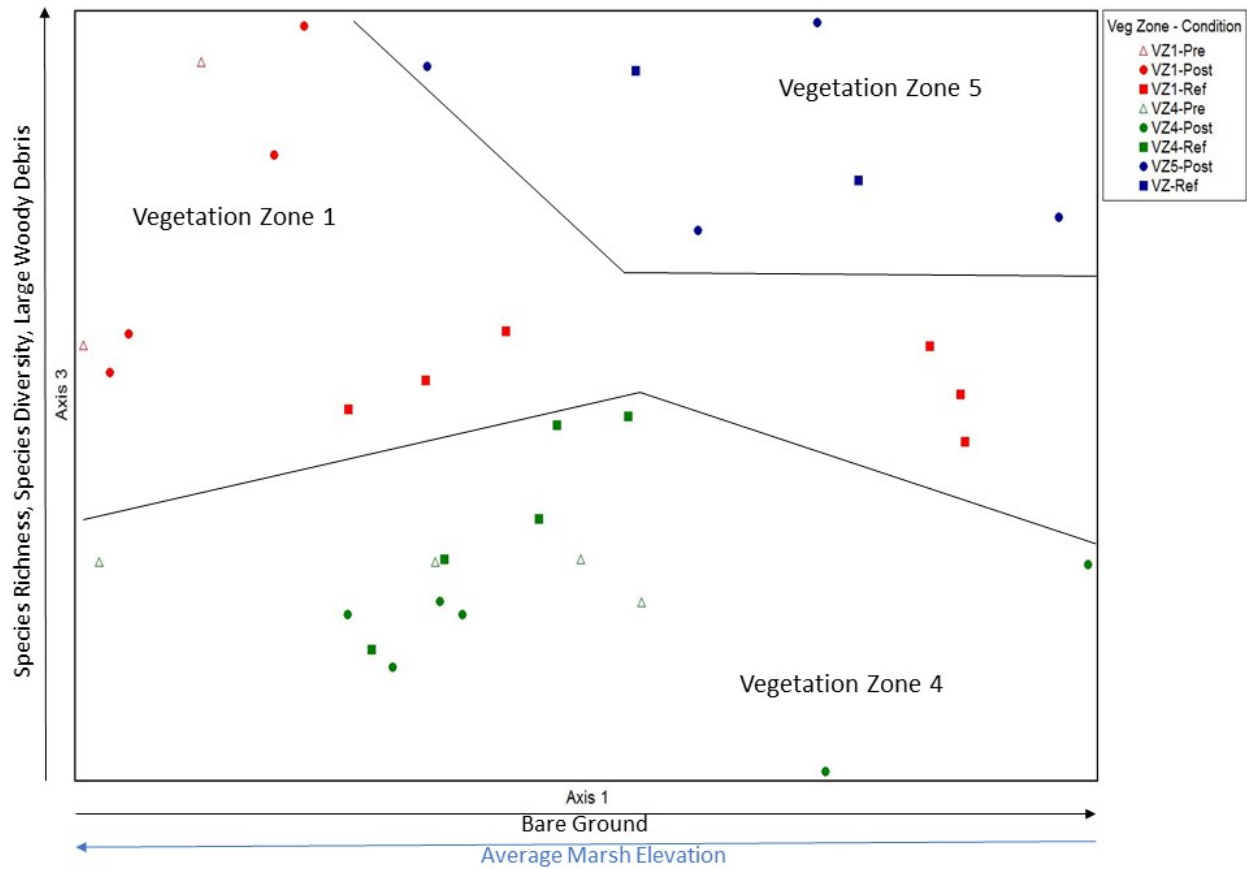
Figure 3. NMS ordination of sample units in species space. Axis 1 is correlated with bare ground and average marsh elevation. Axis 3 is correlated with species richness, species diversity, and large woody debris. Different vegetation zones are demarcated.

A NMS ordination with a three-dimensional solution of plots in species space was used (Final stress= 11.30, final stability ≤ 0.000001 , number of iterations= 72). The three-axis solution explained 82% of the variation in the data. The solution was rotated so bare ground and average marsh elevation was parallel with axis one. Species richness and species diversity were parallel with axis three (Figure 3). Axis one shows vegetation has a strong positive correlation with bare ground ($r = 0.77$) and a negative moderate correlation average marsh elevation ($r=0.51$).

Axis three shows a positive strong correlation with species richness ($r = .71$), a moderate correlation with species diversity ($r = .55$), and weak correlation with Large Woody Debris ($r = .41$) (Figure 3).

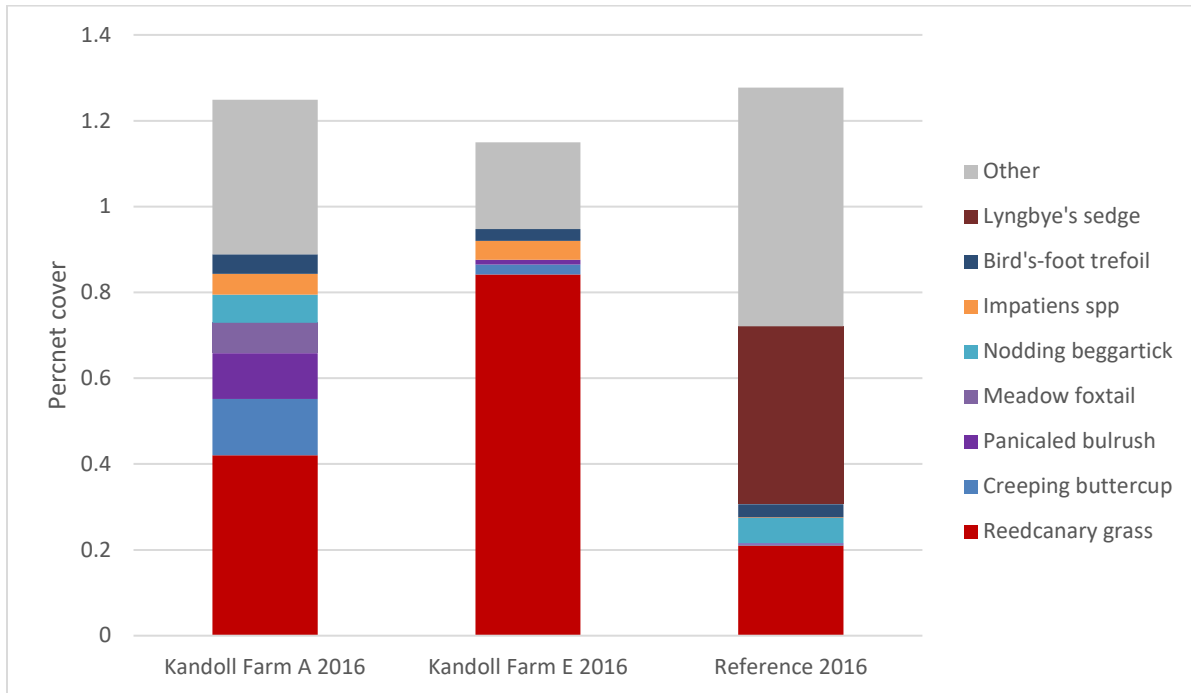
Figure 4. 2016 vegetation Status at Kandoll Farm

In 2016, the KFA monitoring site was characterized by mix of native and invasive species. Reed canarygrass (*Phalaris arundinacea*) and creeping buttercup (*Ranunculus repens*) were the

dominant vegetation species with an average cover of 55% (Figure 4). Native species Panicaled bulrush (*Scirpus microcarpus*), nodding beggartick (*Bidens cernua*), impatiens spp., and common rush (*Juncus effuses*) had an average cover of 25% (Figure 4). Reed canarygrass was the dominant species at the KFE monitoring site with an average cover of 84% (Figure 4). Together native Wapato (*Sagitaria latifolia*), Impatiens spp., and American skunkcabbage (*Lysichiton americanum*) had an average cover of 13%. At the reference site, Lyngbye's sedge (*Carex lyngbyei*) was the dominant vegetation species with an average cover of 41%, but invasive reed canarygrass had an average cover of 21% (Figure 4).

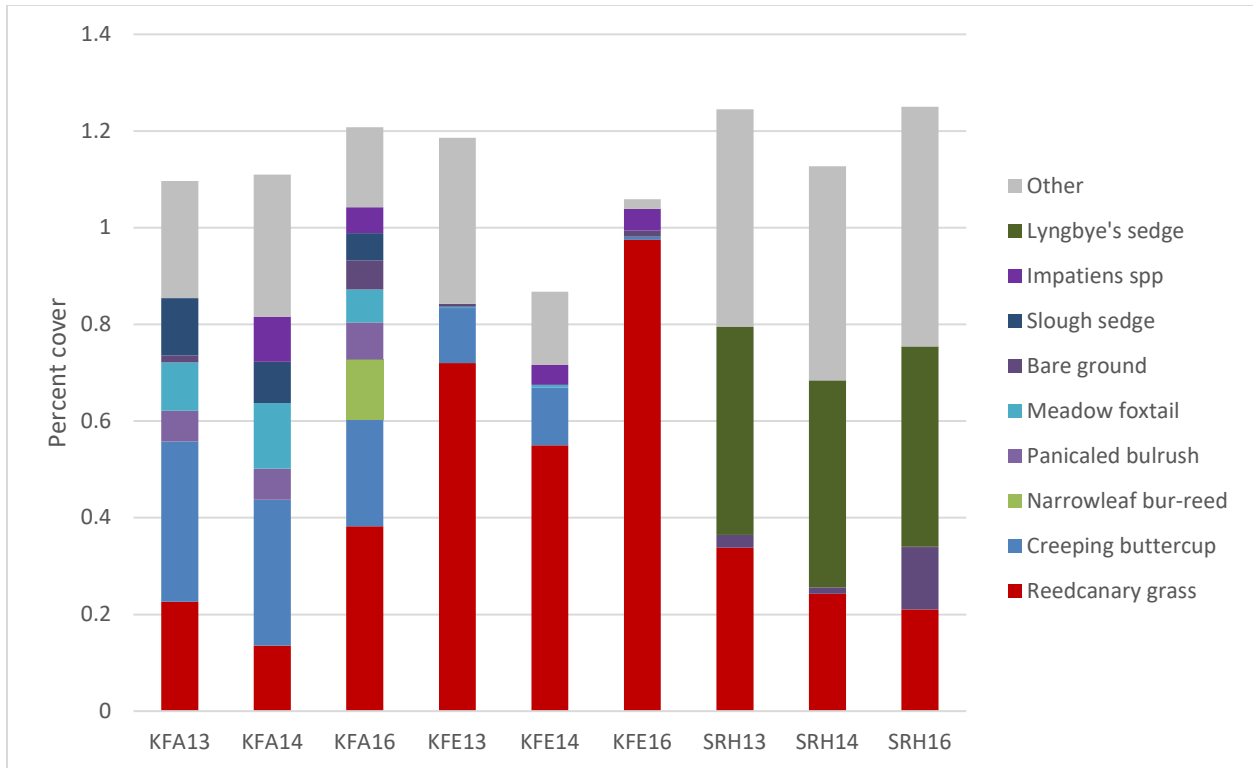
Figure 5. Trend vegetation cover and composition for Kandoll Farm and Secret River Reference site

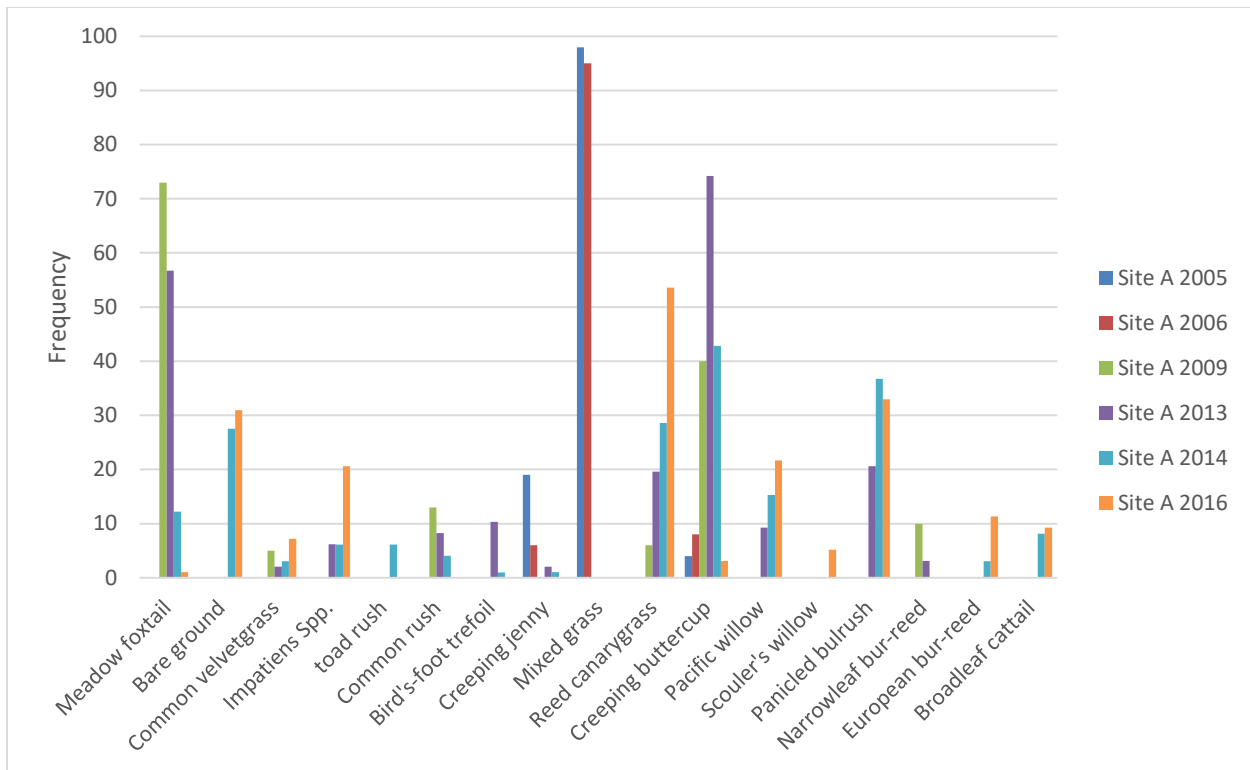
Figure 6. Frequency of occurrence for vegetation at Kandoll Farm A

Line point intercept monitoring transects were established during the first phase of restoration to track changes in vegetation. The vegetation community shifted following initial and subsequent restoration actions. At KFA the frequency of occurrence for vegetation species found in predominantly dry sites like mixed field grasses and meadow foxtail decreased while native and invasive wetland plants increased (Figure 6). At KFE a similar trend was observed with mixed field grasses disappearing from the site and wetland plants increasing (Figure 7). At both sites, the occurrence of planted willows (*Salix* spp.) is increasing along both transects (Figure 7).

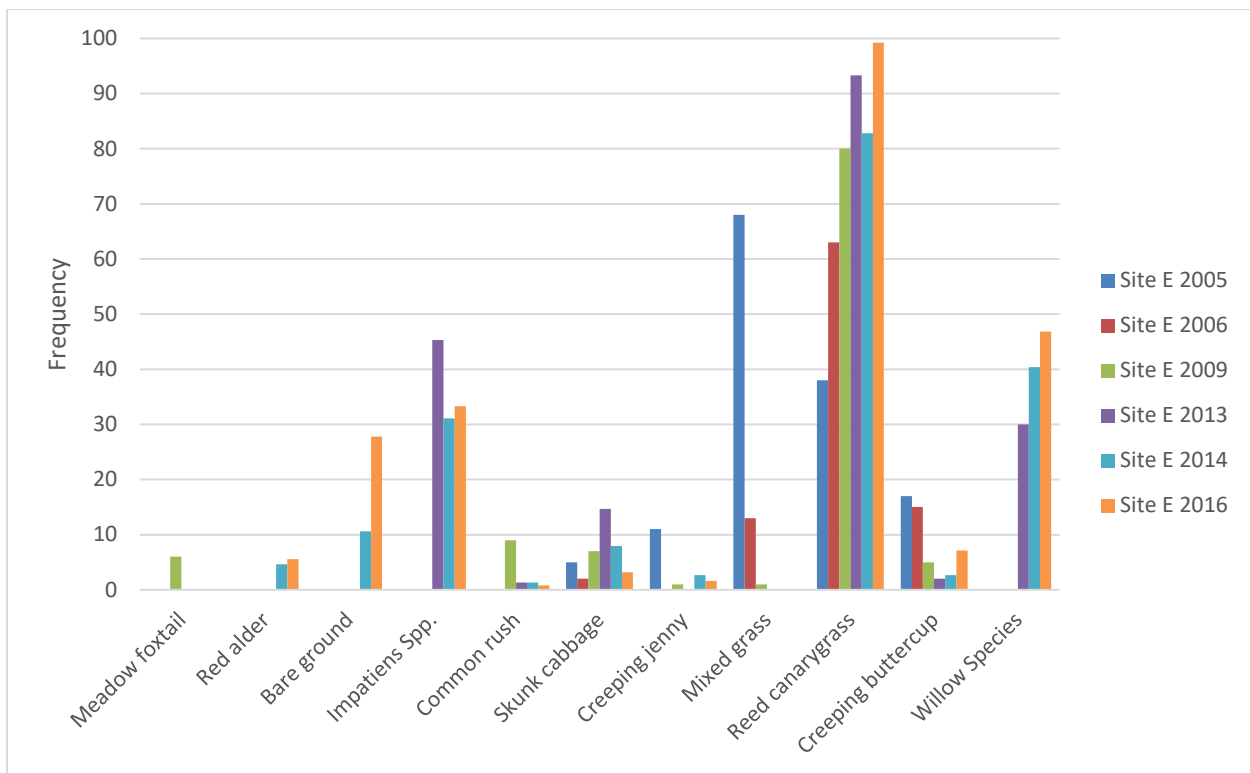
Figure 7. Frequency of occurrence for vegetation at Kandoll Farm E

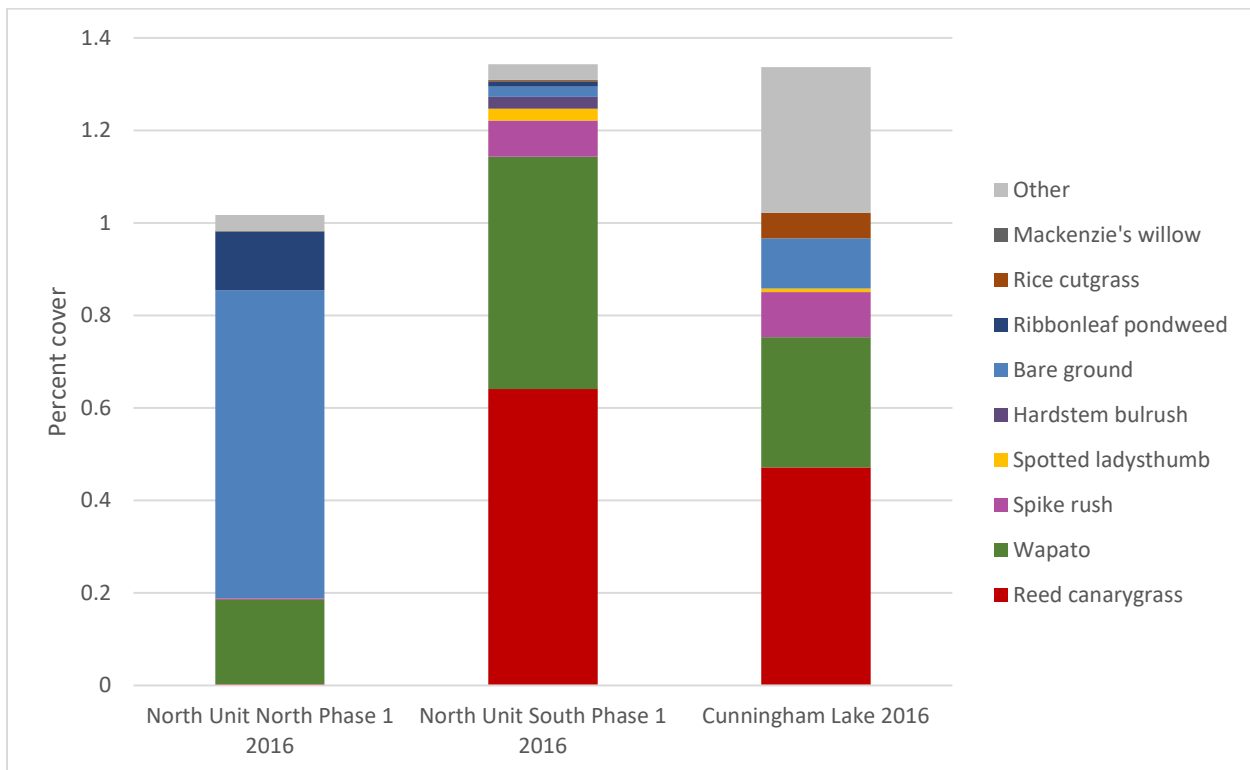
Figure 8. 2016 vegetation status at Sauvie Island North Unit Phase 1

The RLN site was primarily characterized by bare ground in 2016. Native wapato and ribbonleaf pondweed (*Potamogeton epihydrus*) were the dominant vegetation with an average vegetation cover of 18% and 13%, respectively (Figure 8). The RLS site was characterized by native and invasive vegetation species. Invasive reed canarygrass had an average cover of 64%, while native wapato had an average cover of 50% and spike rush had 8%. At the reference site the average cover of reed canarygrass was 47%. The dominant native species were wapato with an average cover of 28% and spike rush with an average cover of 10% (Figure 8).

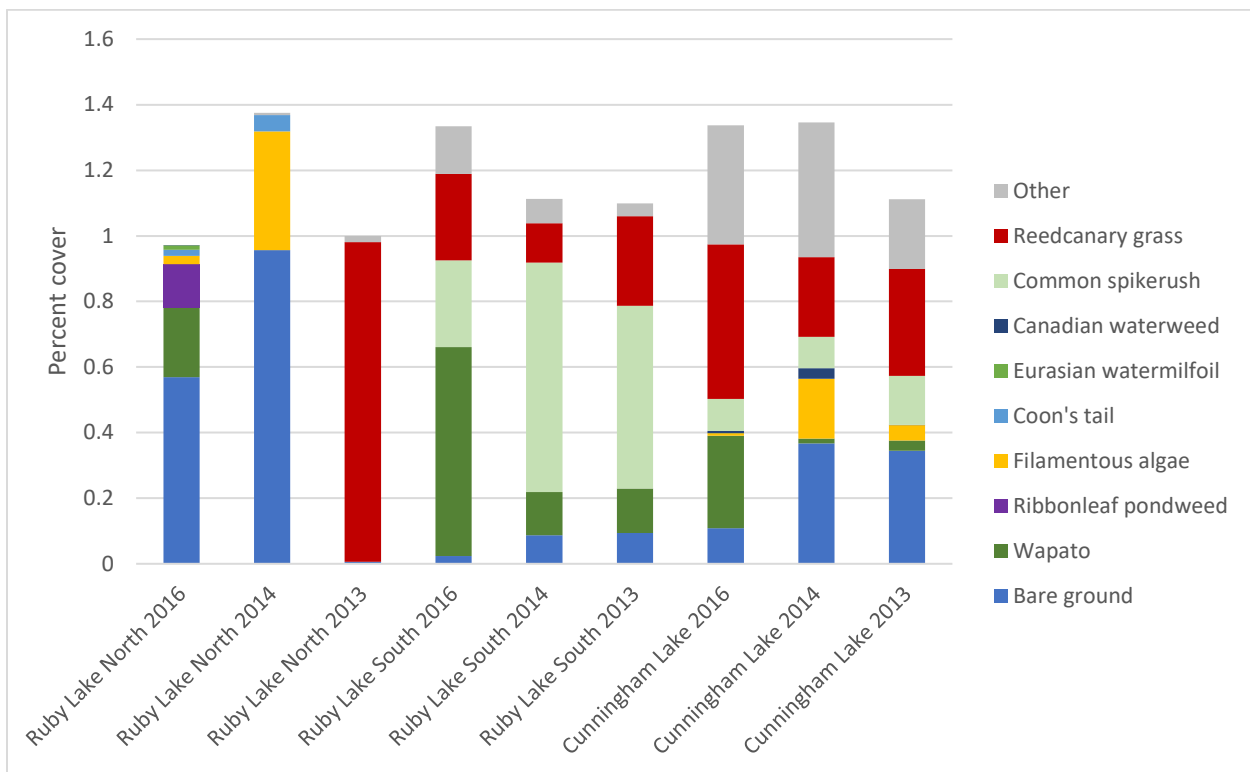
Figure 9. Trend vegetation cover and composition for Ruby Lake and Cunningham Lake Reference site

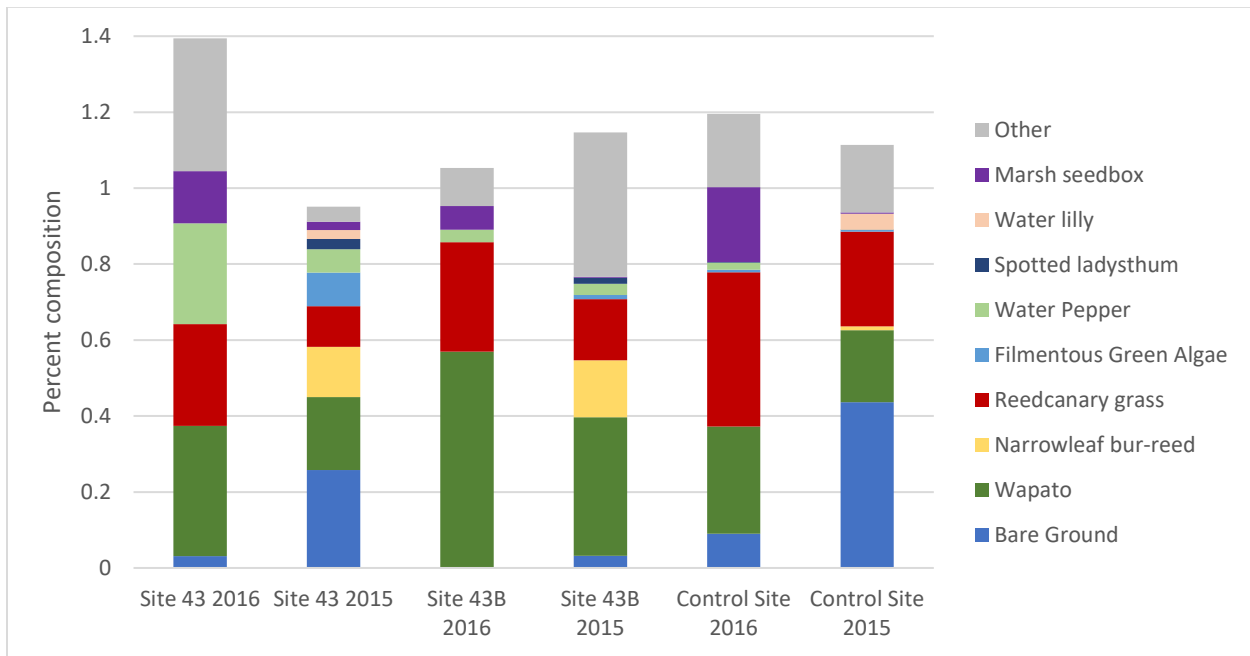
Figure 10. Trend vegetation cover and composition for La Center Wetlands and reference site

At site 43 species richness decreased and species diversity increased from pre-restoration to post-restoration (Table 9). Native wapato increased from an average cover of 19% to 34%; however, invasive reed canarygrass increased from 11% to 27% (Figure 10). Bare ground decreased by 22% between pre- and post-restoration. Two species, narrowleaf bur-reed and water lily (*Nymphaeaceae spp.*) were not found at the site post-restoration. For site 43B both species richness and species diversity decreased from pre-restoration to post-restoration condition. Wapato increased an average of 20% and reed canarygrass increased an average 13% between pre- and post-restoration. Over the same period of time bare ground decreased and narrowleaf bur-reed disappeared from the sampling area. The reference site followed a similar trend as site 43 with a decrease in species richness and an increase species diversity. Bare ground decreased by 35% between 2015 and 2016. During the same time, wapato increased 9% and reed canarygrass increased 19% (Figure 10).

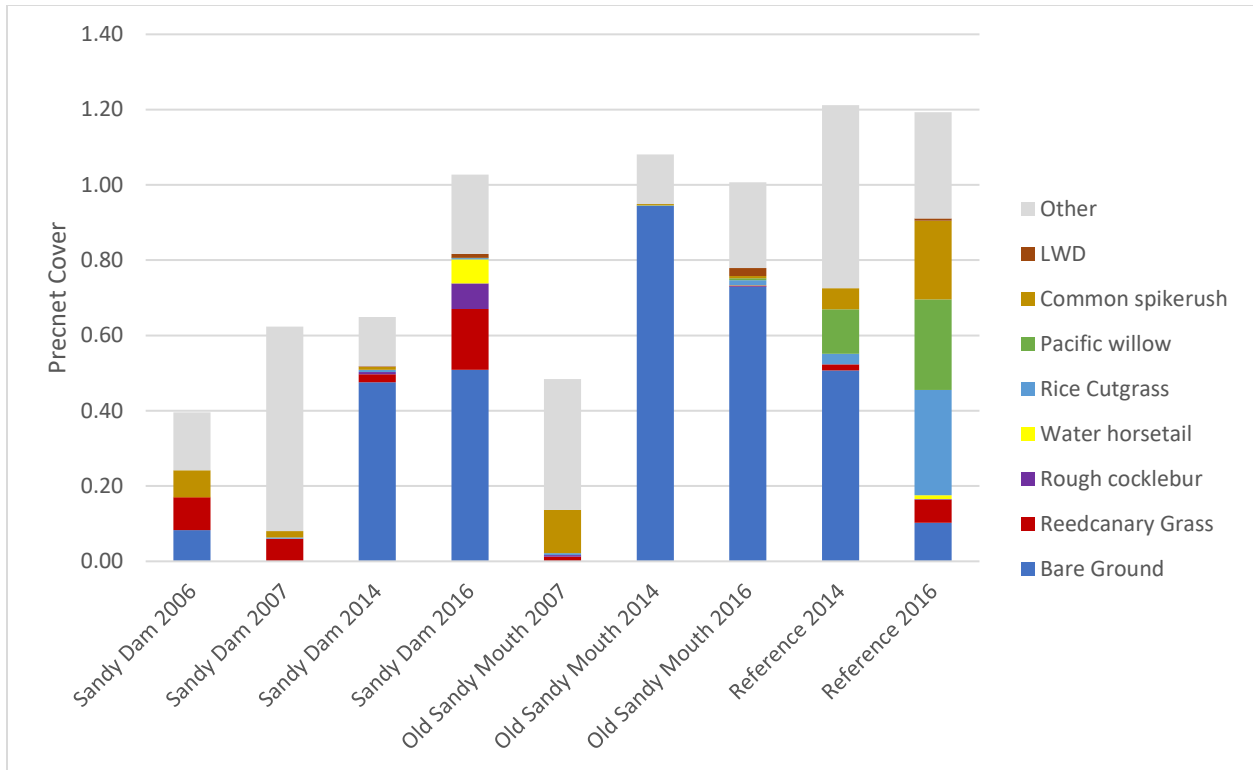
Figure 11. Trend vegetation cover and composition for Sandy River Delta and reference site

At the Sandy River Dam site and Old Sandy Mouth site species richness increased from pre-restoration to post-restoration. Species diversity remained relatively unchanged between pre- and post-restoration condition at the Sandy River Dam site, but increased at the Old Sandy Mouth (Table 11). Bare ground increased to 51% and reed canarygrass became the dominant vegetation post-restoration at the Sandy River Dam site (Figure 11). At the Old Sandy Mouth site, bare ground decreased to 73% three years post-restoration. Black cottonwood saplings (*Populus balsamifera*) were the dominant vegetation at the site with an average cover of 3% and large wood debris had an average cover of 2% (Figure 11). Rice cutgrass (*Leersia oryzoides*) and Pacific willow (*Salix lucida*) were the dominant vegetation species at the reference site with an average cover of 28% and 24% respectively (Figure 11).

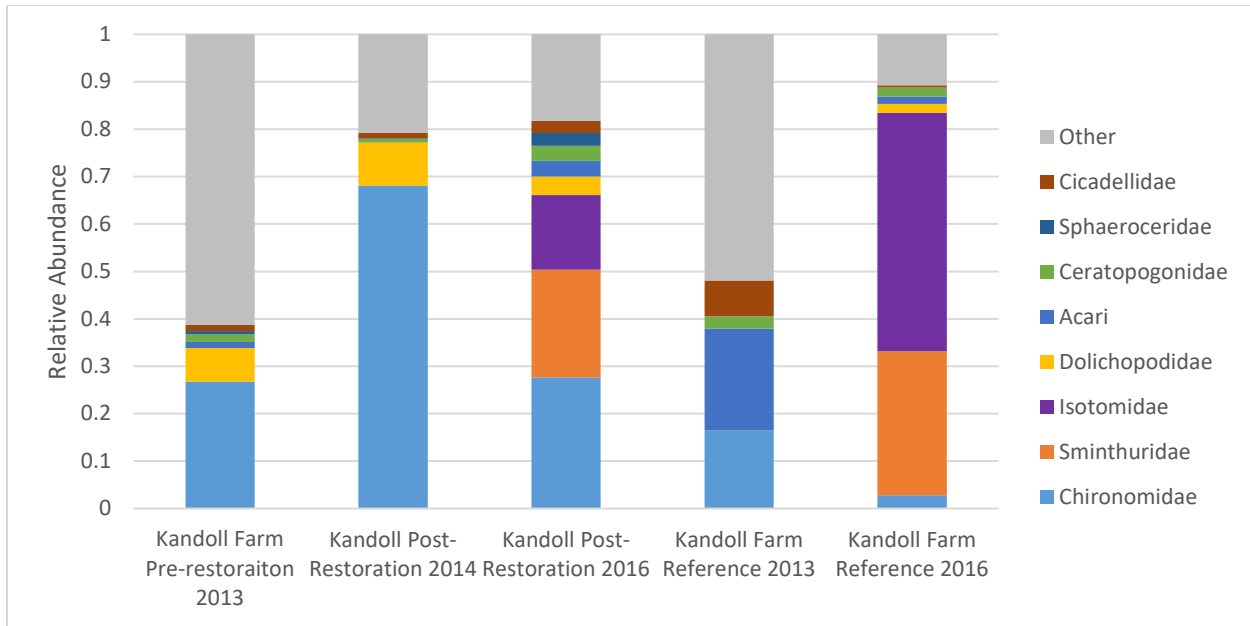
Figure 12. Terrestrial macroinvertebrate species composition at Kandoll Farm

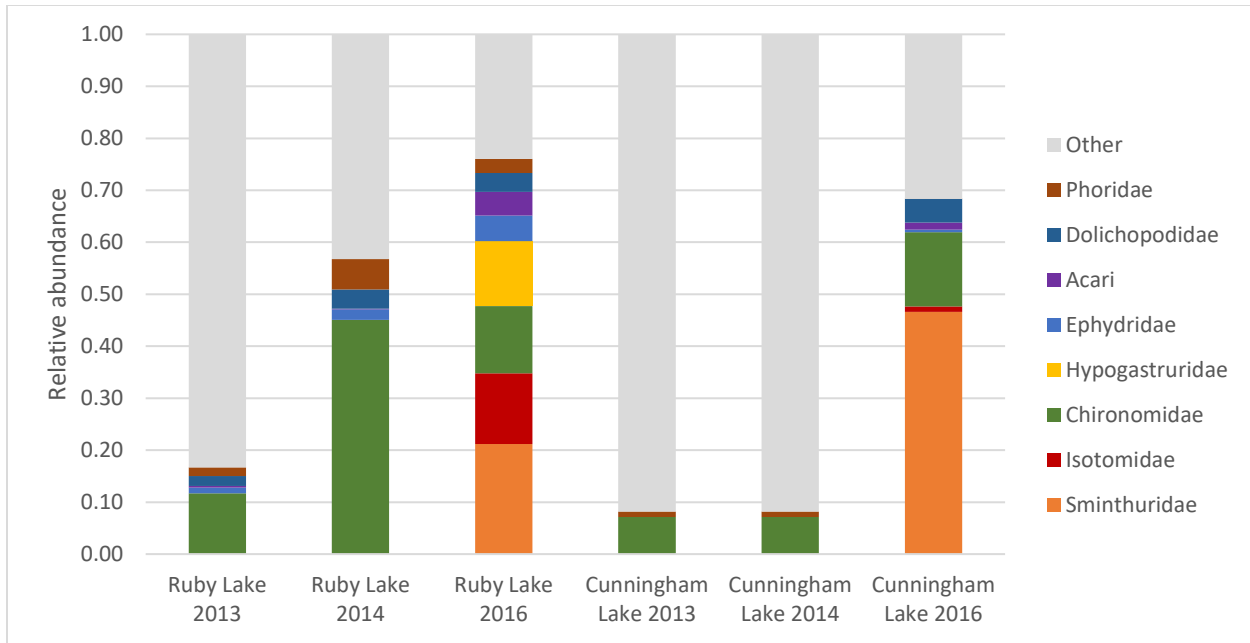
Figure 13. Terrestrial macroinvertebrate species composition at Ruby Lake

Ruby Lake was monitored for terrestrial macroinvertebrates pre-restoration in 2013 and two years post-restoration (2014, 2016). Species richness and species diversity were higher three years post-restoration compared to pre-restoration and one year post-restoration condition (Table 13). At the reference site, during the same period of time, species richness also increased, but species diversity decreased slightly (Table 13). In 2016, Sminthuridae was the most abundant species at Ruby Lake and the reference site composing 21% and 47% of the samples, respectively (Figure 13). Chironimidae was the second most abundant species at the reference site at 14% and third most abundant species at the restoration site at 13% (Figure 13).

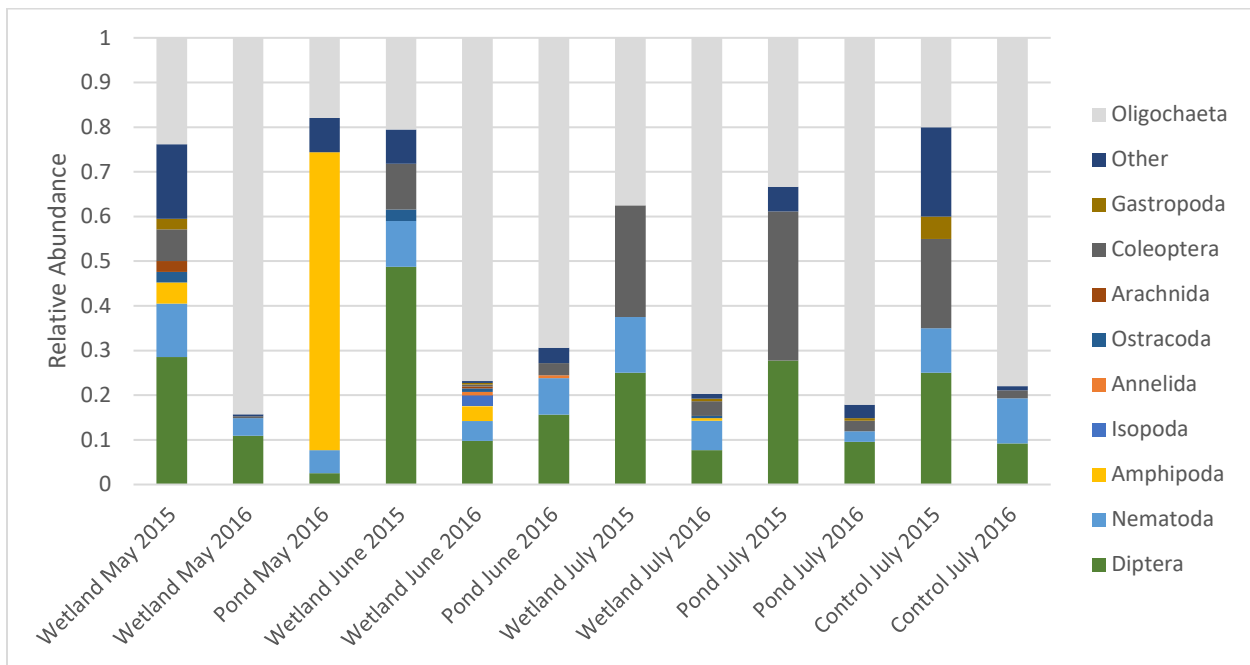
Figure 14. Percent portion of species in benthic samples at La Center Wetlands and control site

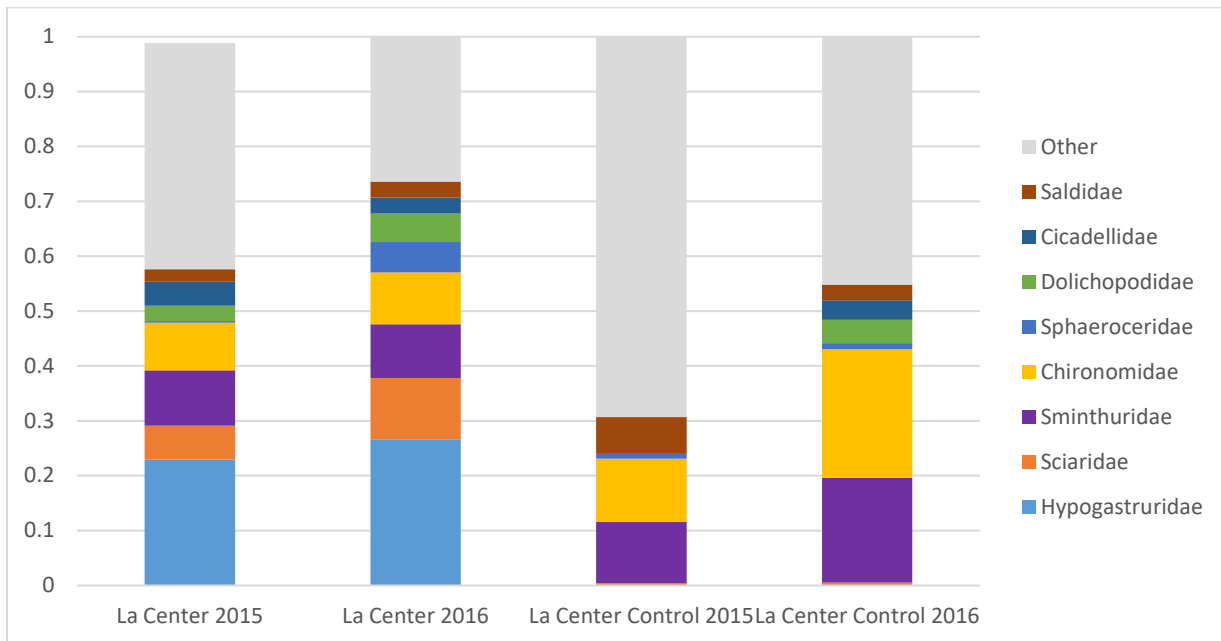
Figure 15. Percent portion of species in fallout trap samples at La Center Wetlands and control site

and follows a pattern observed pre-restoration. Chironomidae was observed at both the restoration and reference site in similar relative abundances as pre-restoration conditions (Figure 15)

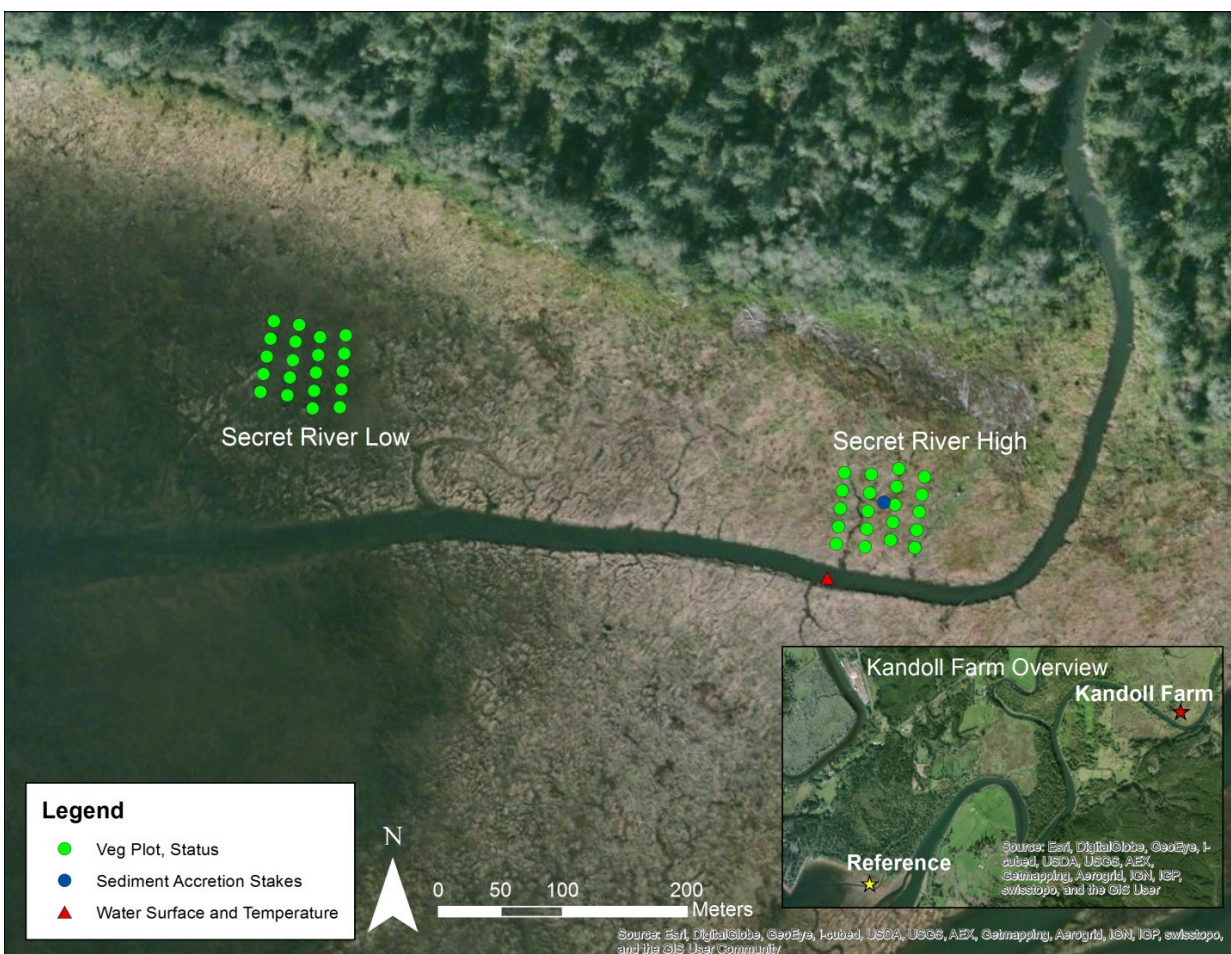
Figure 17. 2016 vegetation sampling locations at the Secret River marsh reference site.

- Located in the lower elevation area of the marsh close to the mouth of the channel.
- 60 m x 50 m, with 20 quadrat locations
- Baseline azimuth: 263° magnetic
- Transect azimuth: 353° magnetic
- Transect spacing: 15m, random start: 7
- Quadrat spacing: 10 m, random starts: 3, 1, 7, 8

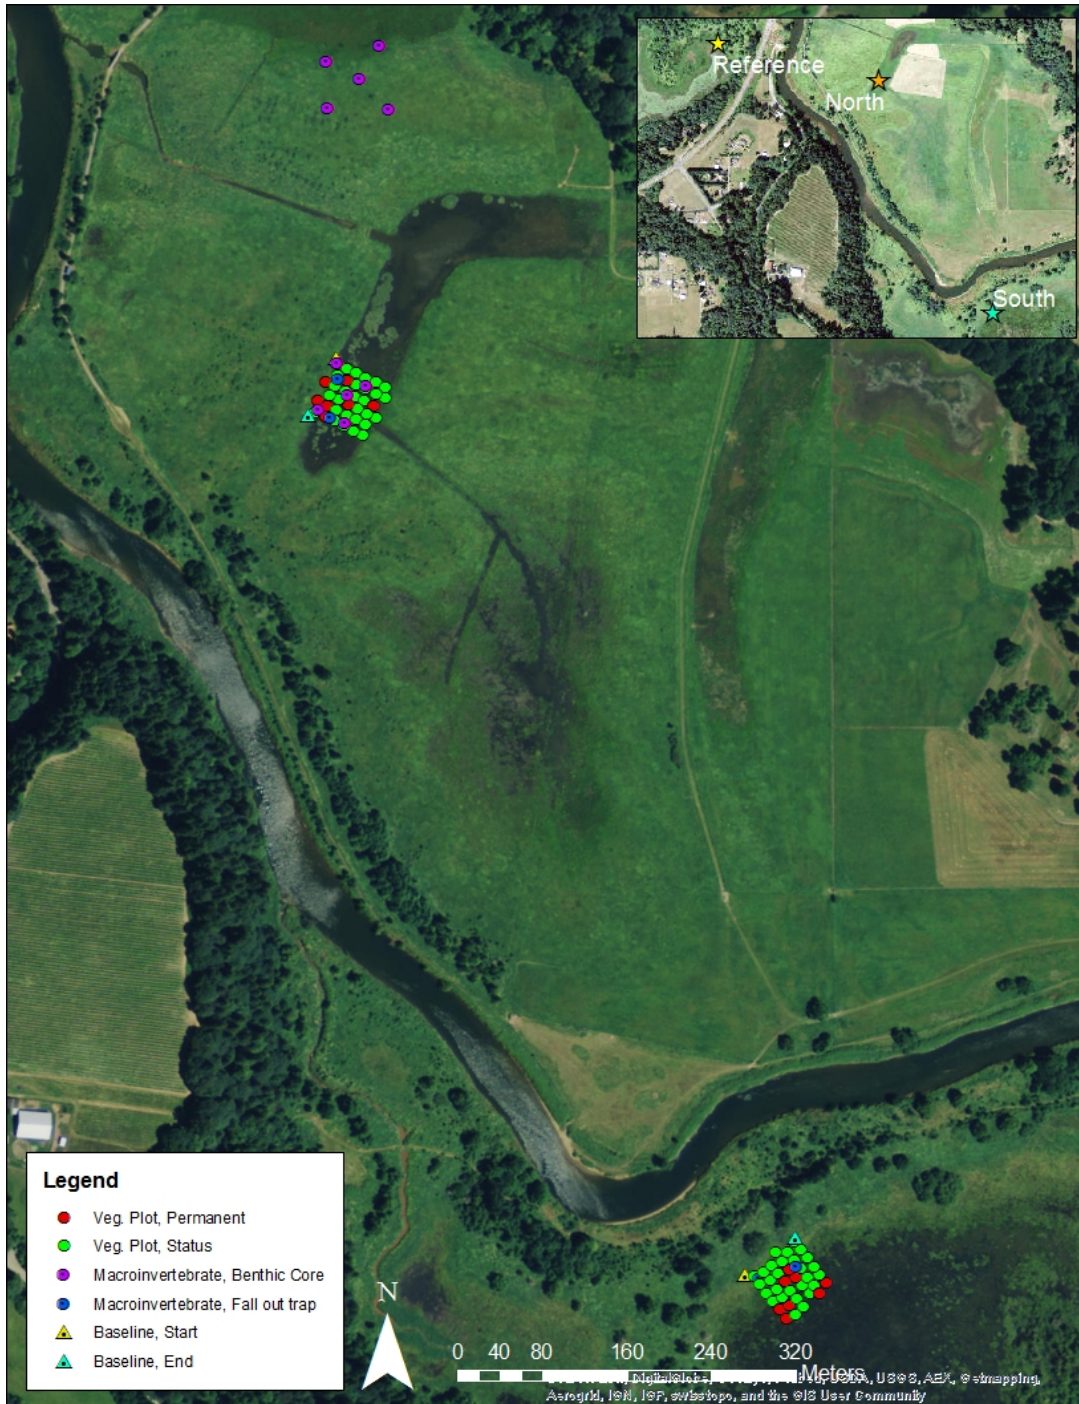
Figure 20. Vegetation and macroinvertebrate sampling locations at the La Center Wetlands restoration site.

- Located on the south side of the East Fork Lewis River.
- 60m x 60m, with 36 quadrat location
- Baseline azimuth: 39° magnetic
- Transect azimuth: 129° magnetic
- Transect spacing: 10 m, random start: 7
- Quadrat spacing: 10m, random starts: 5, 8, 7, 0, 6, 2
- 8 permanent quadrats, randomly selected, systematically to ensure coverage on all transects

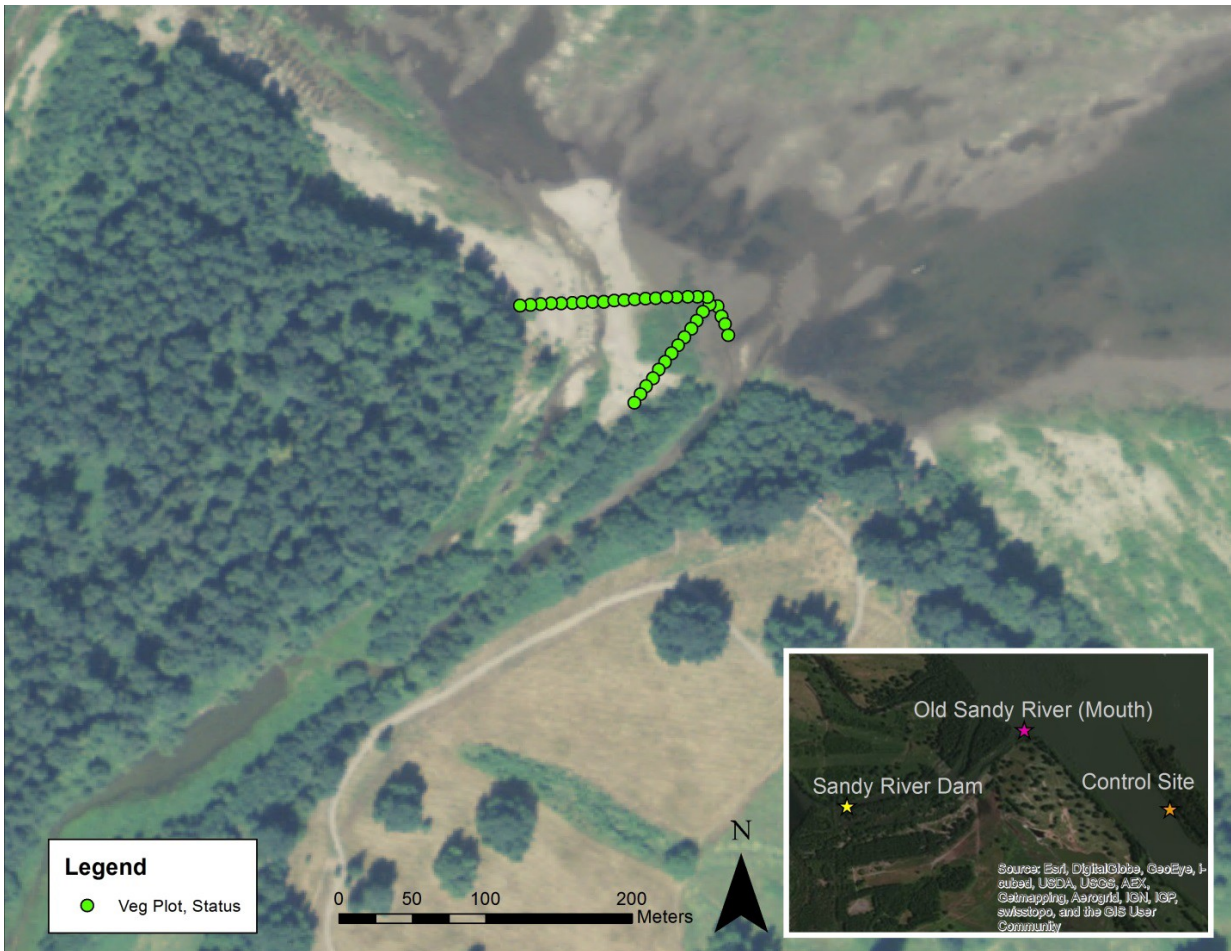
Figure 22. 2016 vegetation and macroinvertebrate sampling locations at the Sandy River mouth restoration site.

- 3 Transects with 36 quadrat locations
 - T-1: 149° magnetic, 20 m
 - T-2: 200° magnetic, 70 m
 - T-3: 250° magnetic, 95 m (end stake at 100 m)
- Quadrat spacing: 5 m, random starts: 3
- 8 permanent quadrats, randomly selected, systematically to ensure coverage on all transects (T1-18, T2-3, T2-33, T2-63, T3-38, T3-48, T3-78, T3-83)

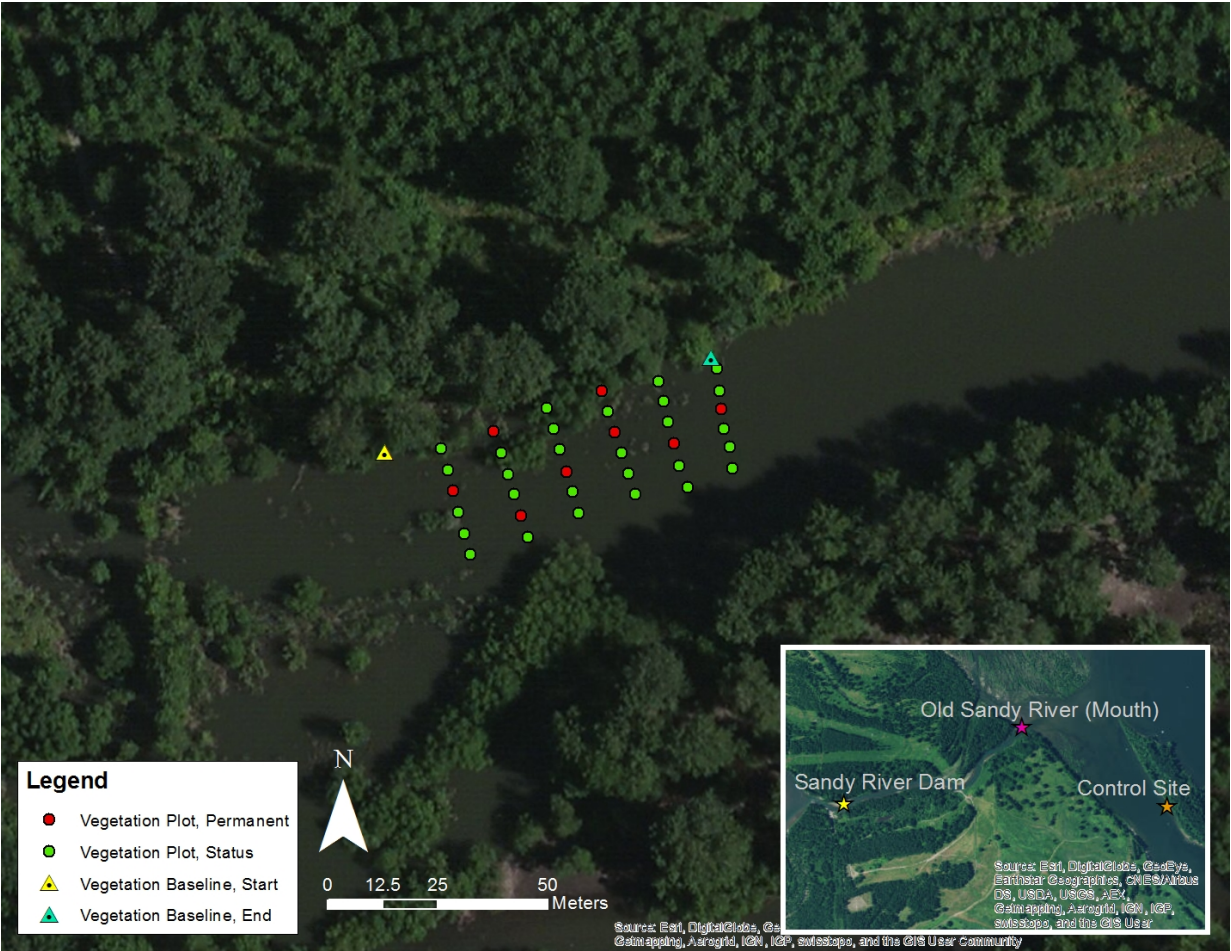
Figure 23. 2016 vegetation and macroinvertebrate sampling locations at the Sandy River dike breach restoration site.

- Located on the north side of the channel just downstream of the removed dike. Transect 77 overlaps with T-1 from the previous veg sample area.
- 80 m x 30 m, with 36 quadrat locations
- Baseline azimuth: 56° magnetic
- Transect azimuth: 146° magnetic
- Transect spacing: 13 m, random start: 12
- Quadrat spacing: 5 m, random starts: 2, 2, 0, 0, 2, 2
- 8 permanent quadrats, randomly selected, systematically to ensure coverage on all transects

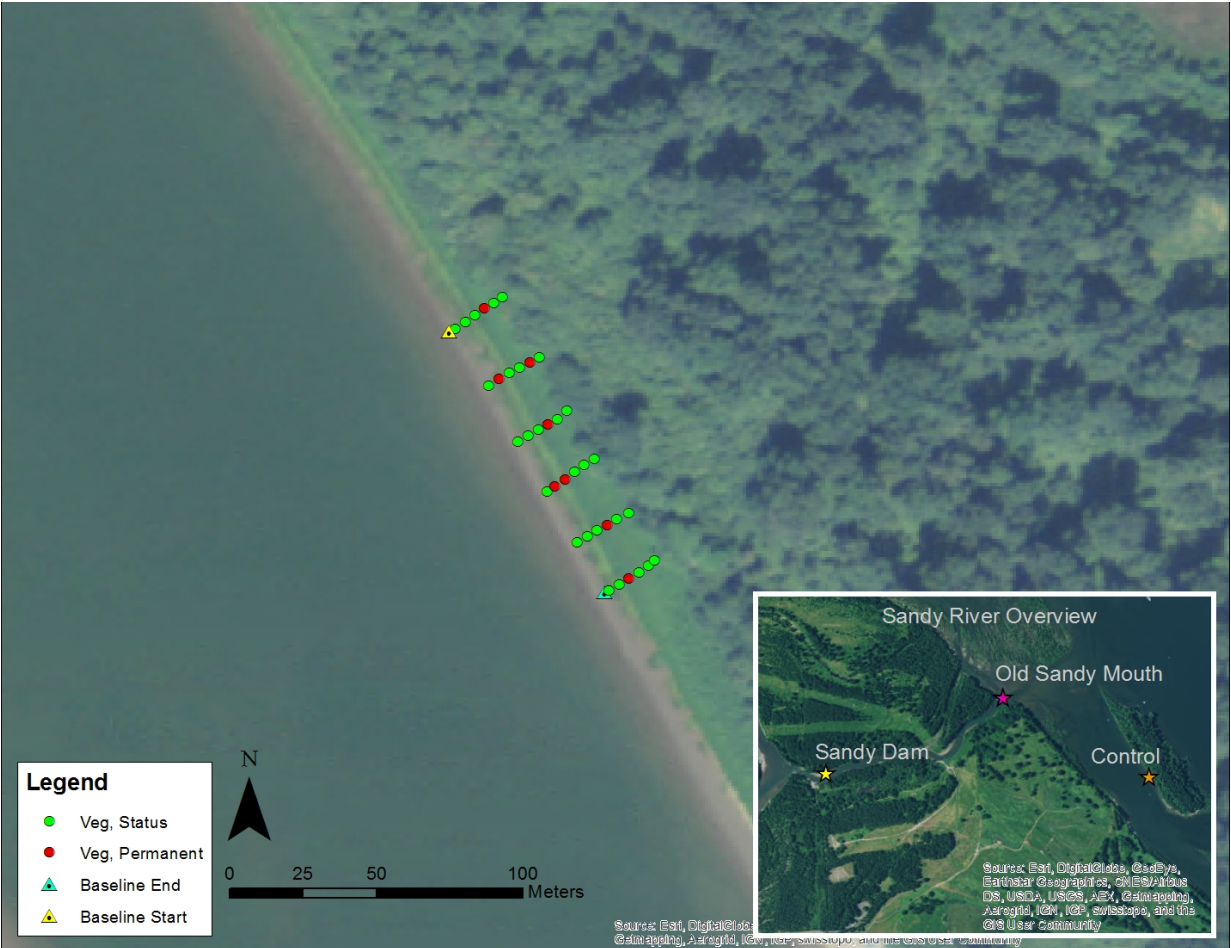
Figure 24. 2016 vegetation and macroinvertebrate sampling locations at the Gary Island control site.

We sampled the previously established 4 transects from 2008 to the extent possible to evaluate change historically. In addition we added 3 new transects to the east. In future years the former T-4 will be eliminated because it is very narrow, and only the remaining 6 transects will be surveyed. The permanent plots on these same transects will be monitored in the future to evaluate trends post-restoration.
