ACTION EFFECTIVENESS MONITORING AND RESEARCH (AEMR) – RESULTS REVIEW

SCIENCE WORKGROUP
MEETING JUNE 28, 2022

WALLOOSKEE, 3 YEARS (2020) POST-RESTORATION

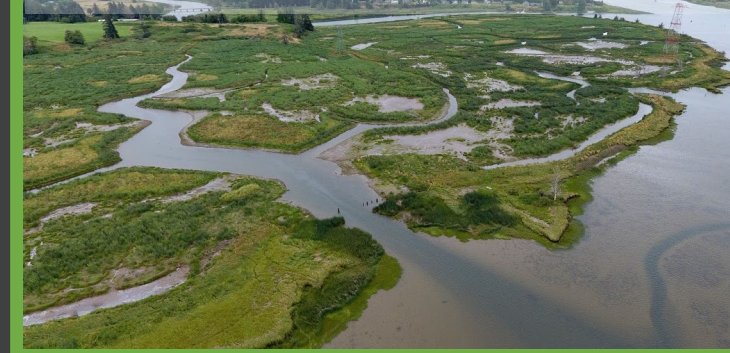
Wallooskee, Year 3, Cowlitz Tribe

- Looking great! Abundant native recovery

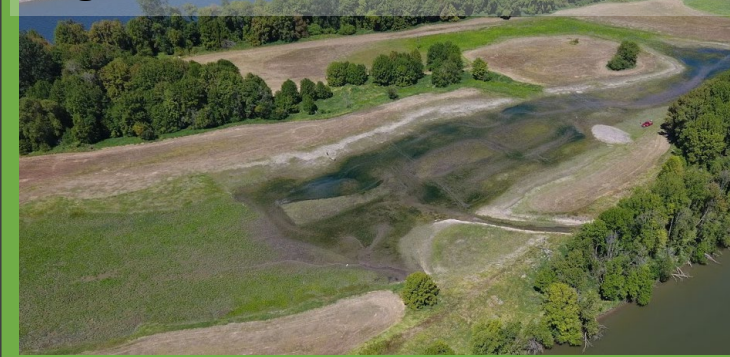
Flights End, Year 3, CREST & ODFW

- Progress slow and hard to access due to heavy mowing

- Recommend not mowing Flights End
- Recommend limiting Grazing at all Sites

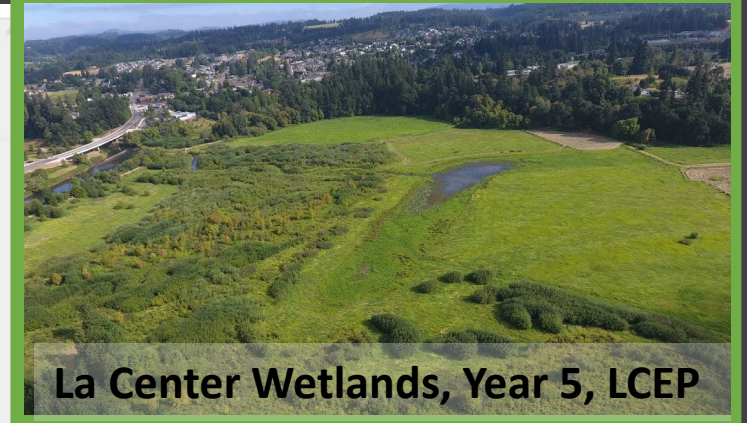
La Center Wetlands, Year 5, LCEP

- Shrub-scrub plantings doing well
- Low marsh zones dense with Wapato
- Reed canarygrass abundant in high marsh

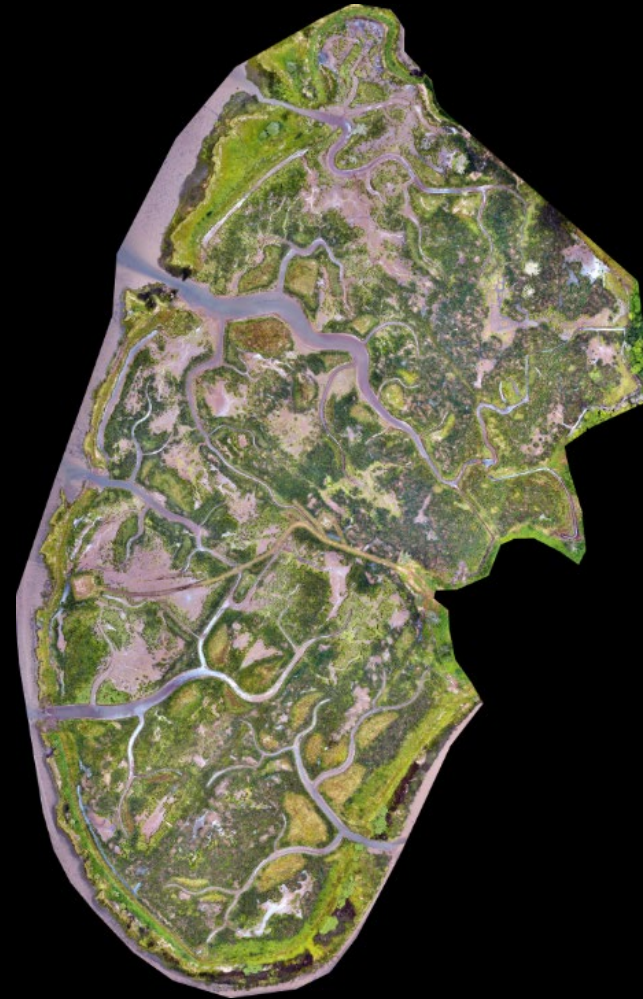
The Wallooskee restoration site is in Youngs Bay, near the City of Astoria in Oregon (Columbia RM 16, Reach A) .

The 200-acre tidal reconnection restoration project was funded by BPA and is currently owned and managed by the Cowlitz Indian Tribe. The overall goal for this project was to restore full tidal reconnection and provide juvenile salmonid access.

In July of 2017, tidal flooding was restored throughout the wetland through the removal and lowering of levees that bordered the site. Additional channel enhancements were conducted in areas to expand channel density and access to wetland habitat.

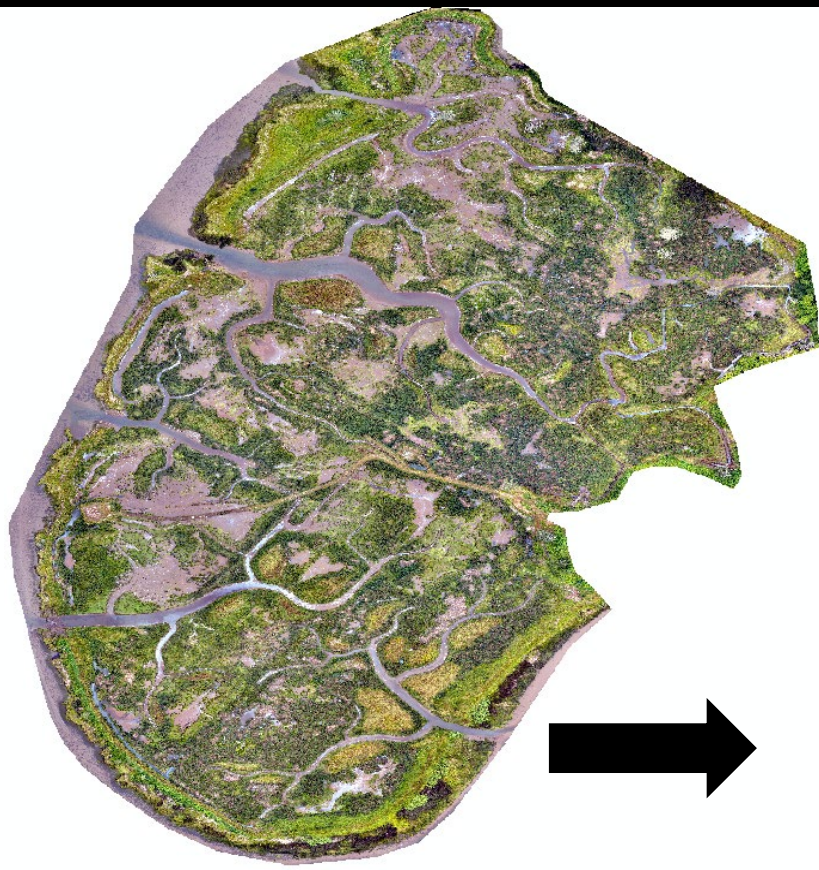
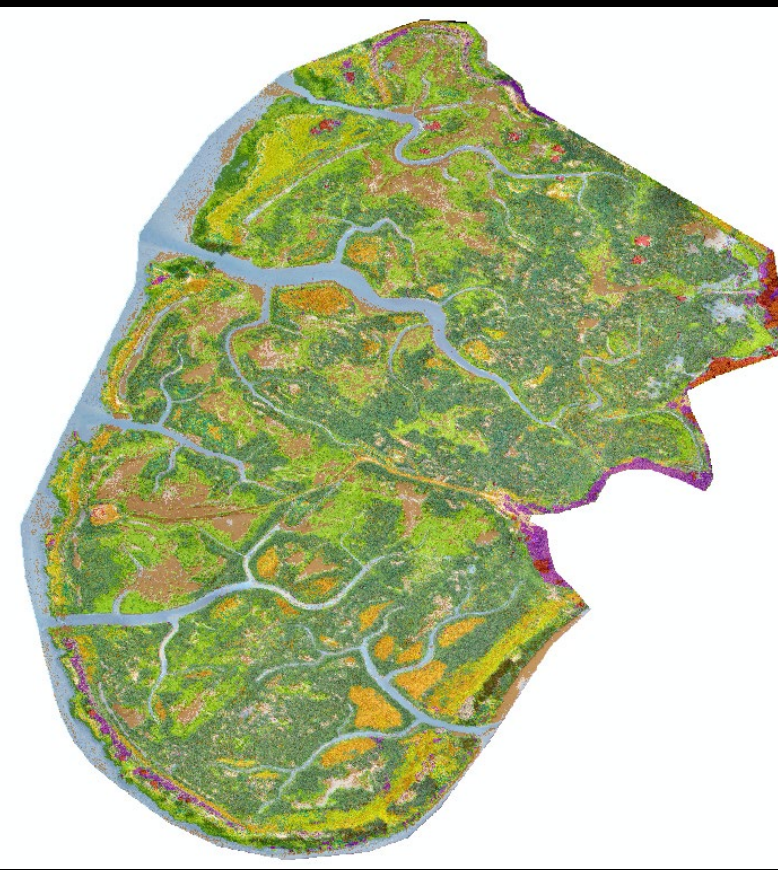
UAV IMAGERY MODELLING METHODOLOGY

Establishing a new method for Synthesizing and Evaluating Habitat Data integrating existing data collection methods and UAV drone imagery

- Multispectral Drone with RGB and Near Infrared Sensor
- Pix4D processing and ArcGIS image classification
- Datasets also include vegetation classification, elevation and hydrology
- Provide more robust habitat condition assessments
- Set the stage for modeling habitat shifts from climate change and future restoration efforts

- **>15 plant community and land cover classifications made across the 200 acres of wetland**
- **<0.25m² resolution**
- **High accuracy**

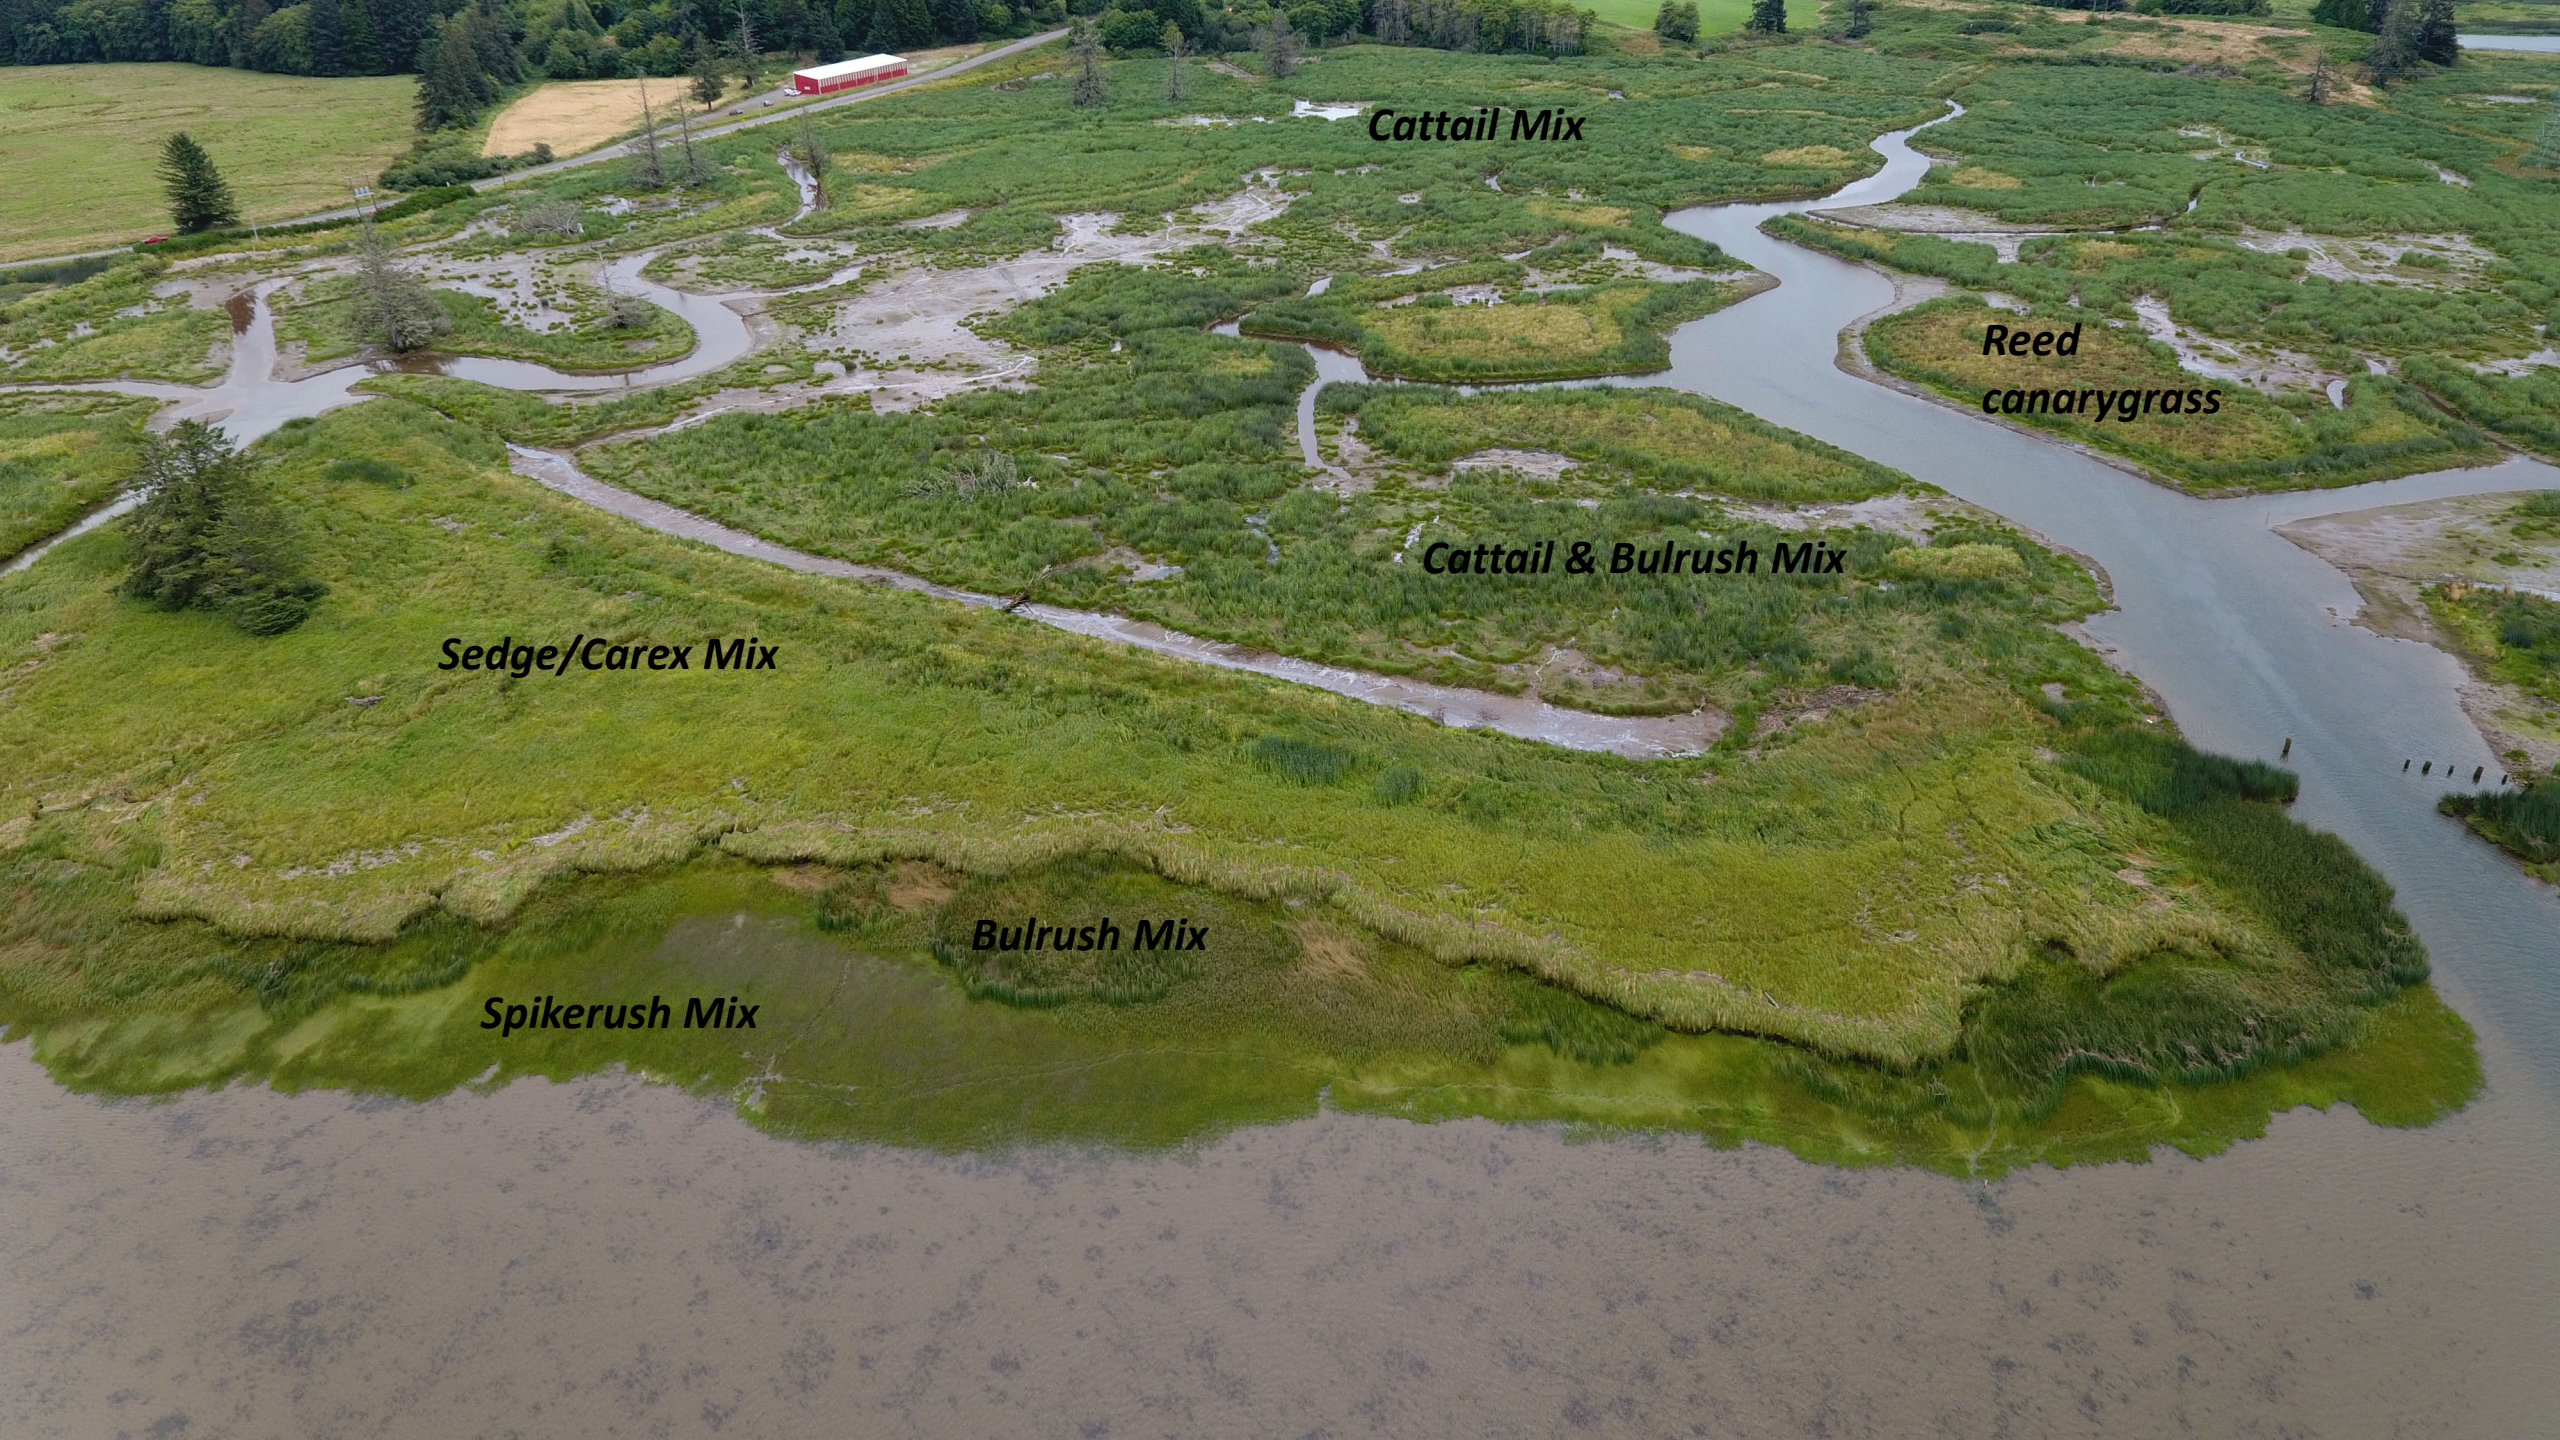
Cattail Mix

***Reed
canarygrass***

Cattail & Bulrush Mix

Sedge/Carex Mix

Bulrush Mix

Spikerush Mix

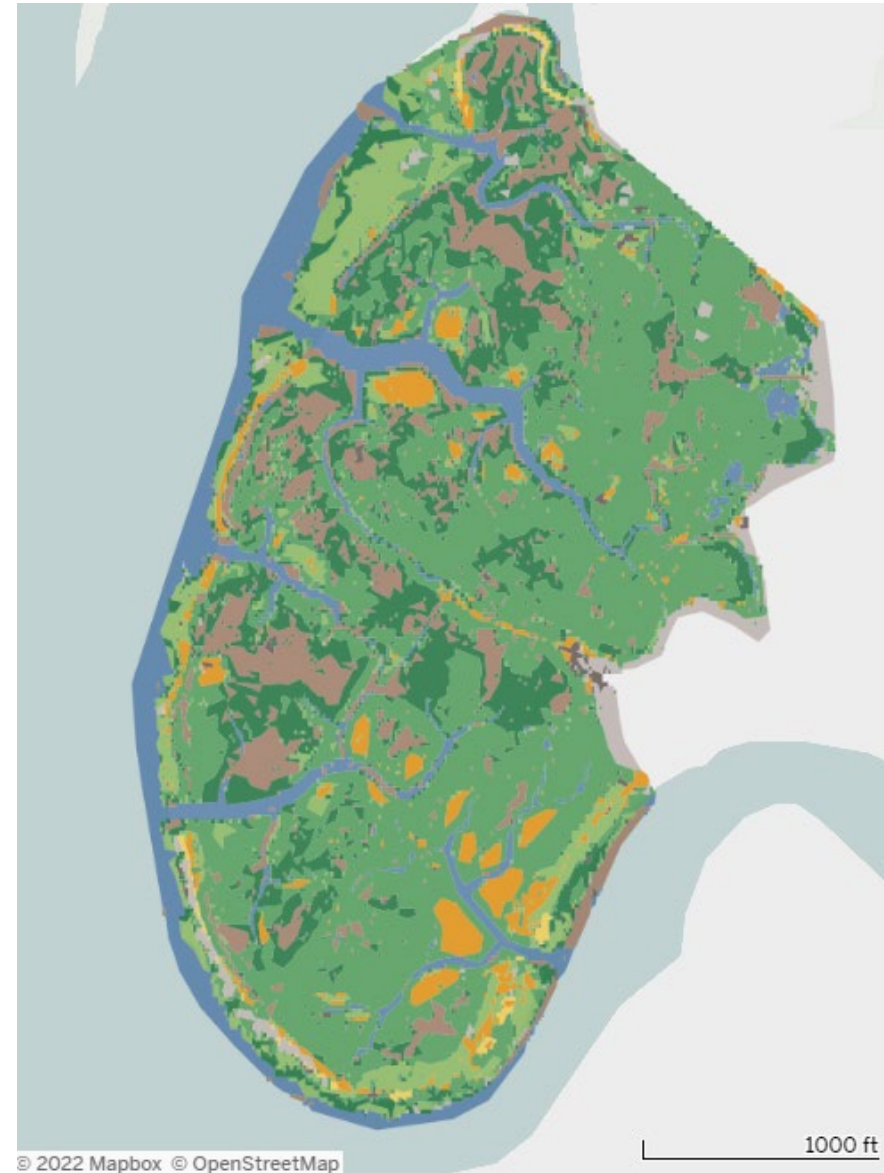
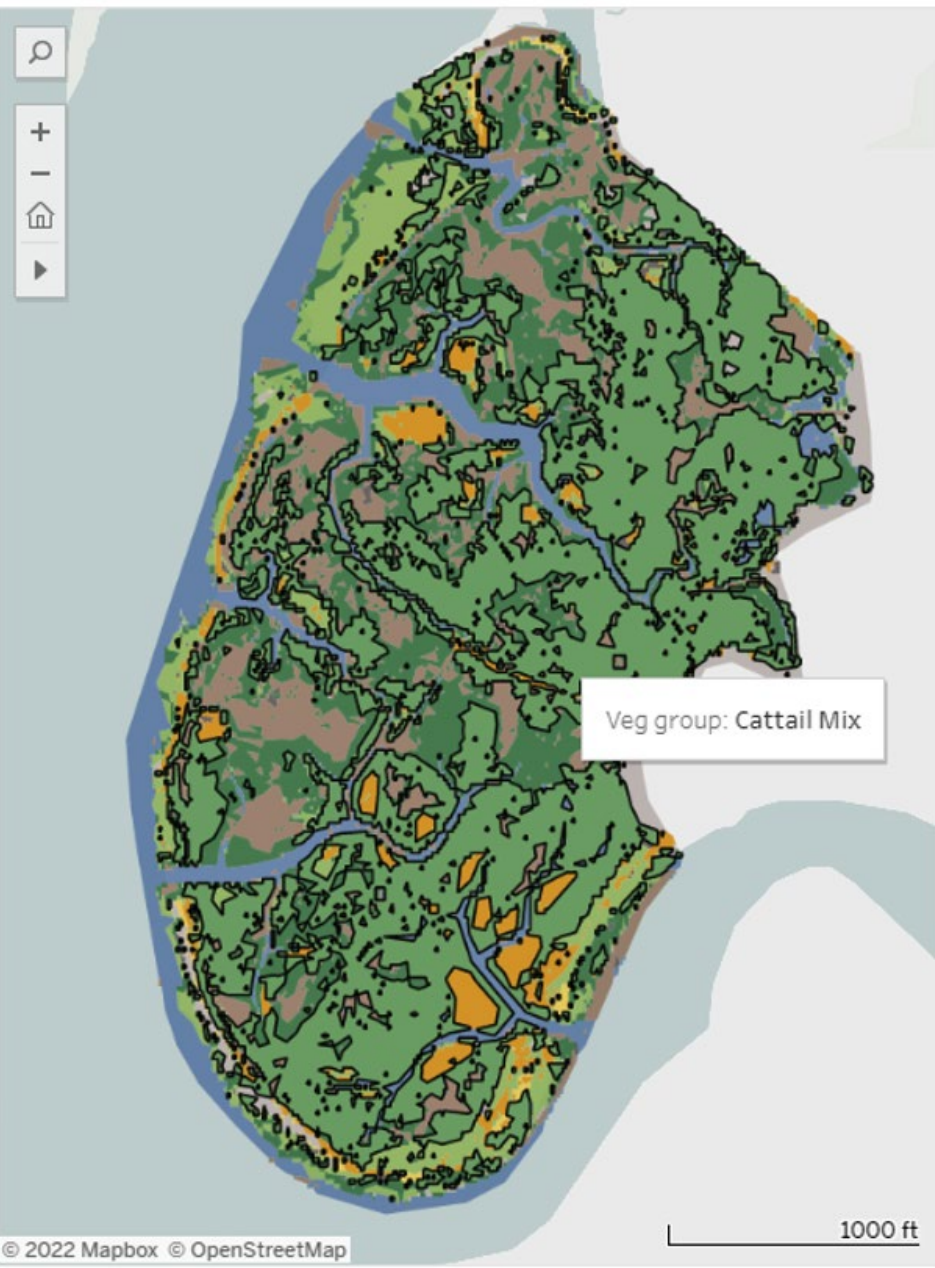
Acres of Cover by Native Status
2020 - 3 yrs Post Restoration

Channel and Mudflats	23%	47 acres
Native	69%	139 acres
Non-native	5%	10 acres
Riparian and Other	3%	7 acres

- Three years post restoration:
- ✓ native plant species - 69% of the site
 - ✓ diversity of channel and aquatic habitats - 23%
 - ✓ Non-native plant community abundance has dramatically declined, now representing a small 5% amount of the total landcover

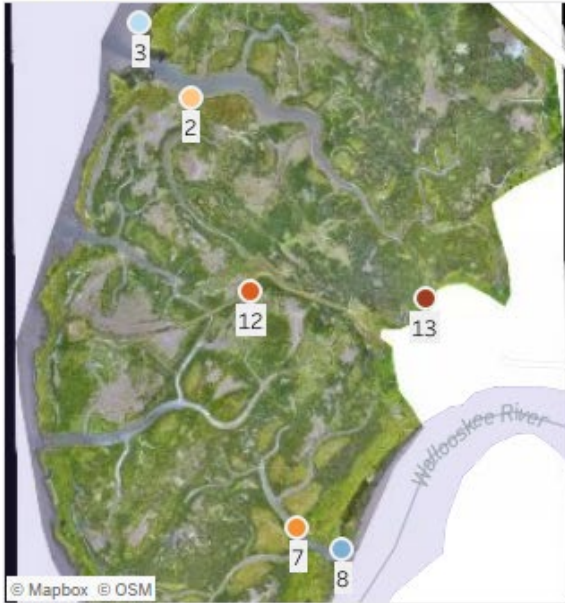
Data Logger Locations

- 2) Inner Channel - Youngs Bay Side
- 7) Inner Channel - Wallooskee Side
- 12) Inner Channel - Wallooskee Side Near Transmi...
- 13) Inner Channel - Youngs Bay Side Near Base of ...
- 3) Outer Mudflat - Youngs Bay Side
- 8) Outer Channel - Wallooskee Side
- 14) Astoria Tidal Gage (NOAA) Station #9439040
- 15) Daggett Point

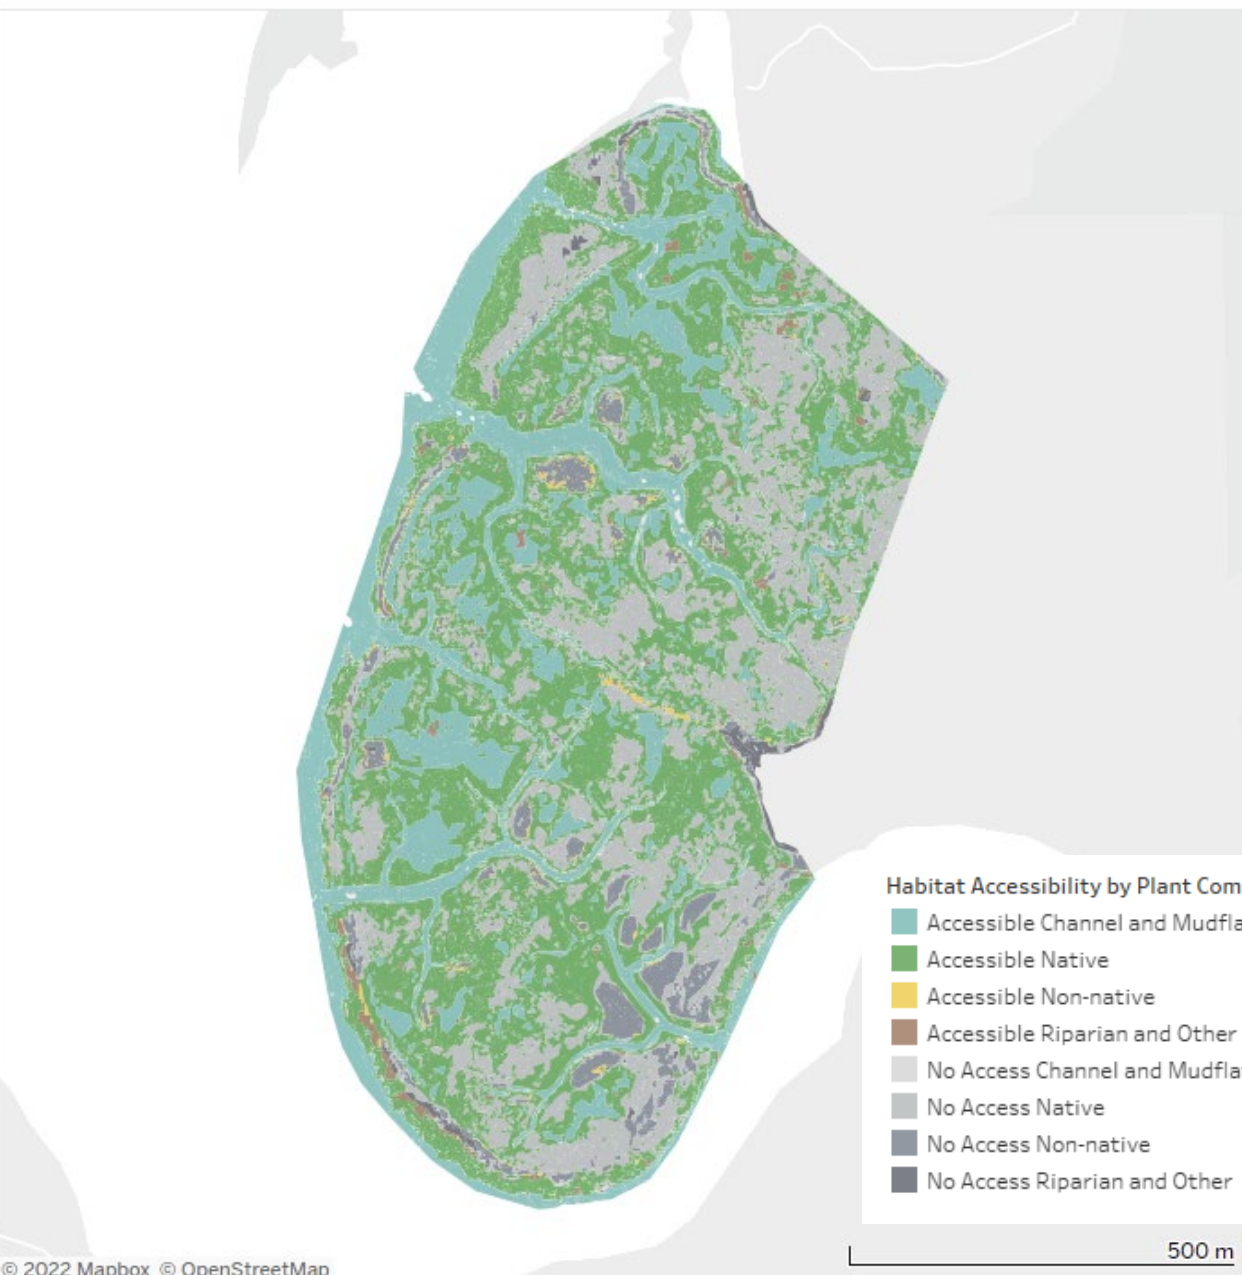
OVERALL SALMONID HABITAT

- ✓ Combined Modeled Habitat Access With Site-Wide Plant Community Conditions
- ✓ April 2021= 124 Acres of Native Habitat, Mudflats, and Channels – accessible Salmonid Habitat during High Tide

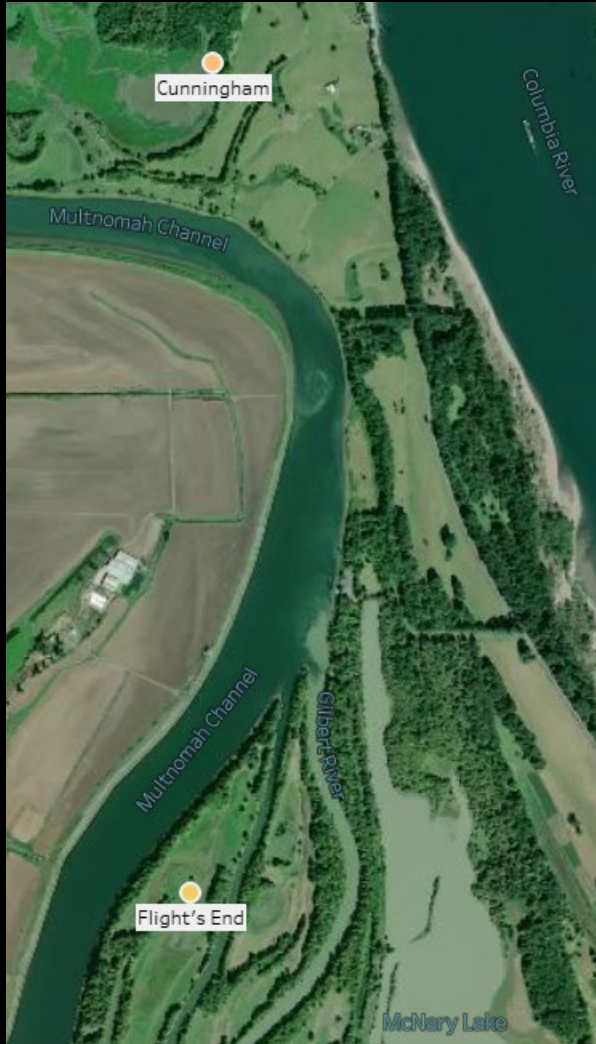
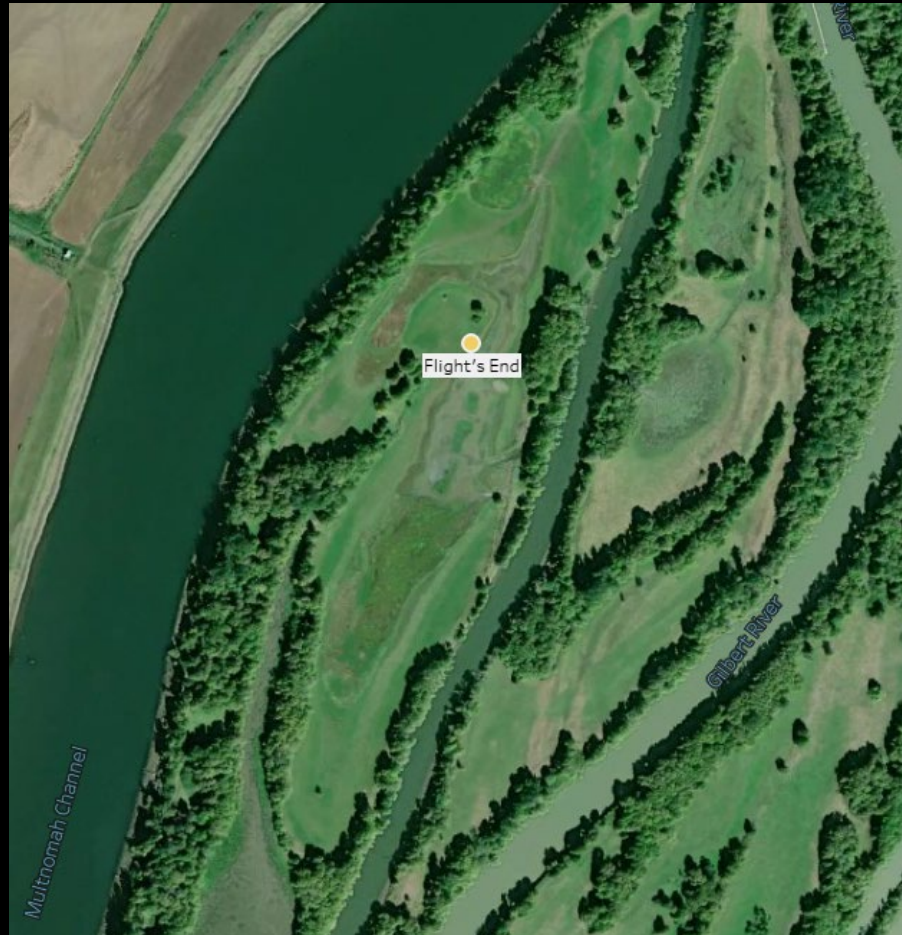
Flights End wetlands are located north of Crane Lake in Sauvie Island, OR (Col RM 92, Reach F).

This restoration project was part of a landscape effort to restore connectivity of Sauvie Island Wildlife Area to Multnomah Channel. This restoration project aimed to connect 42 acres of floodplain wetlands to the Columbia River to create natural wet prairie conditions.

Construction occurred in 2017, and construction actions included removal of two culverts, the artificial berm and marsh plain lowering.

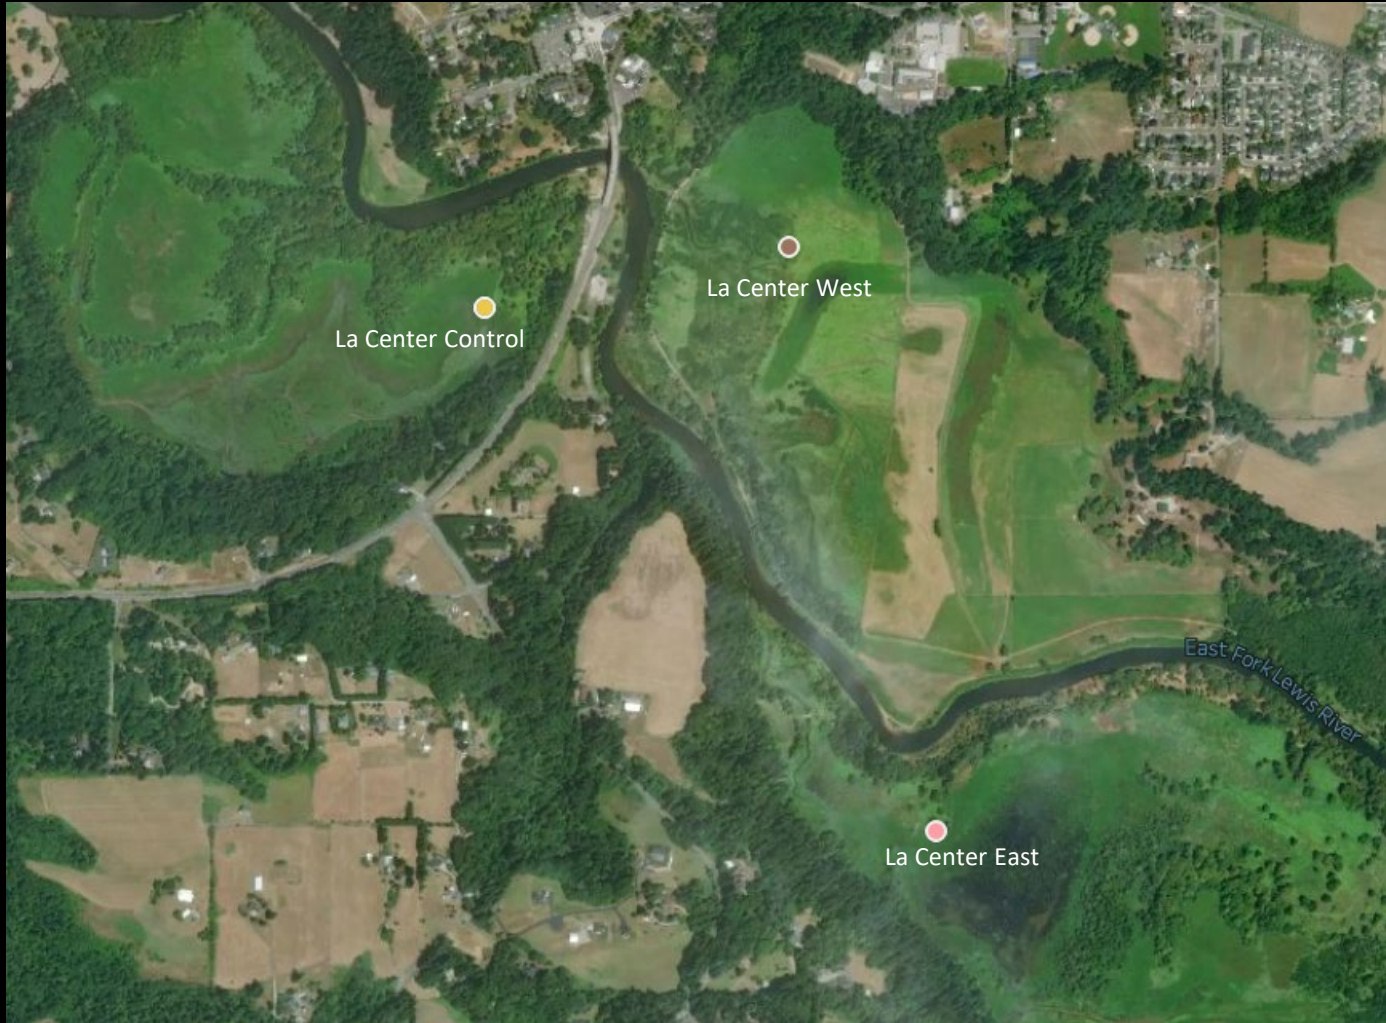
LA CENTER, 5 YEARS (2020) POST-RESTORATION

La Center Wetlands is a restoration site located in La center, Washington along the East Fork Lewis River (EFLR) (Columbia RM 88, Reach F).

The wetlands are a collection of two sites – La center West and La center East. La center Control was selected as the reference for monitoring.

The overall project goal was to restore hydrologic and geomorphic processes at the two sites.

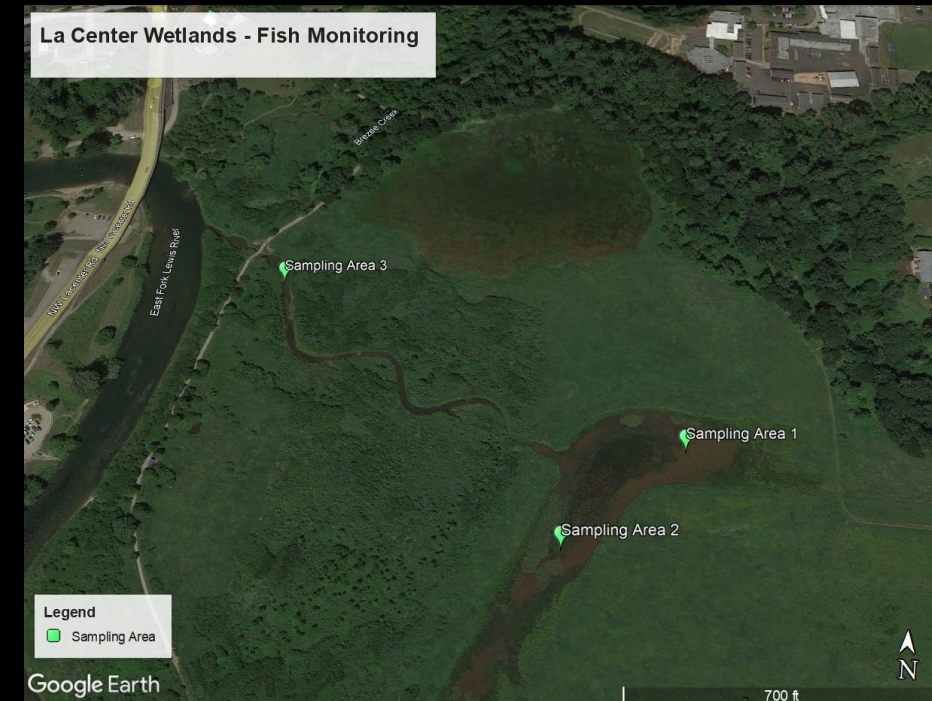
LA CENTER, 6 YEARS (2021) POST-RESTORATION FISH CHECK-IN

La center fish data was collected at year 6 post-restoration – this delay was caused due to COVID-19 lockdowns which prohibited the researchers to travel to the site. The site was sampled over two days in May 2021.

La Center West was sampled in the main channel and pond.

Chinook Salmon contributed to 20% of the community sampled at the site. 51% of the community at the site was comprised of Threespine stickleback and 10% Golden Shiner

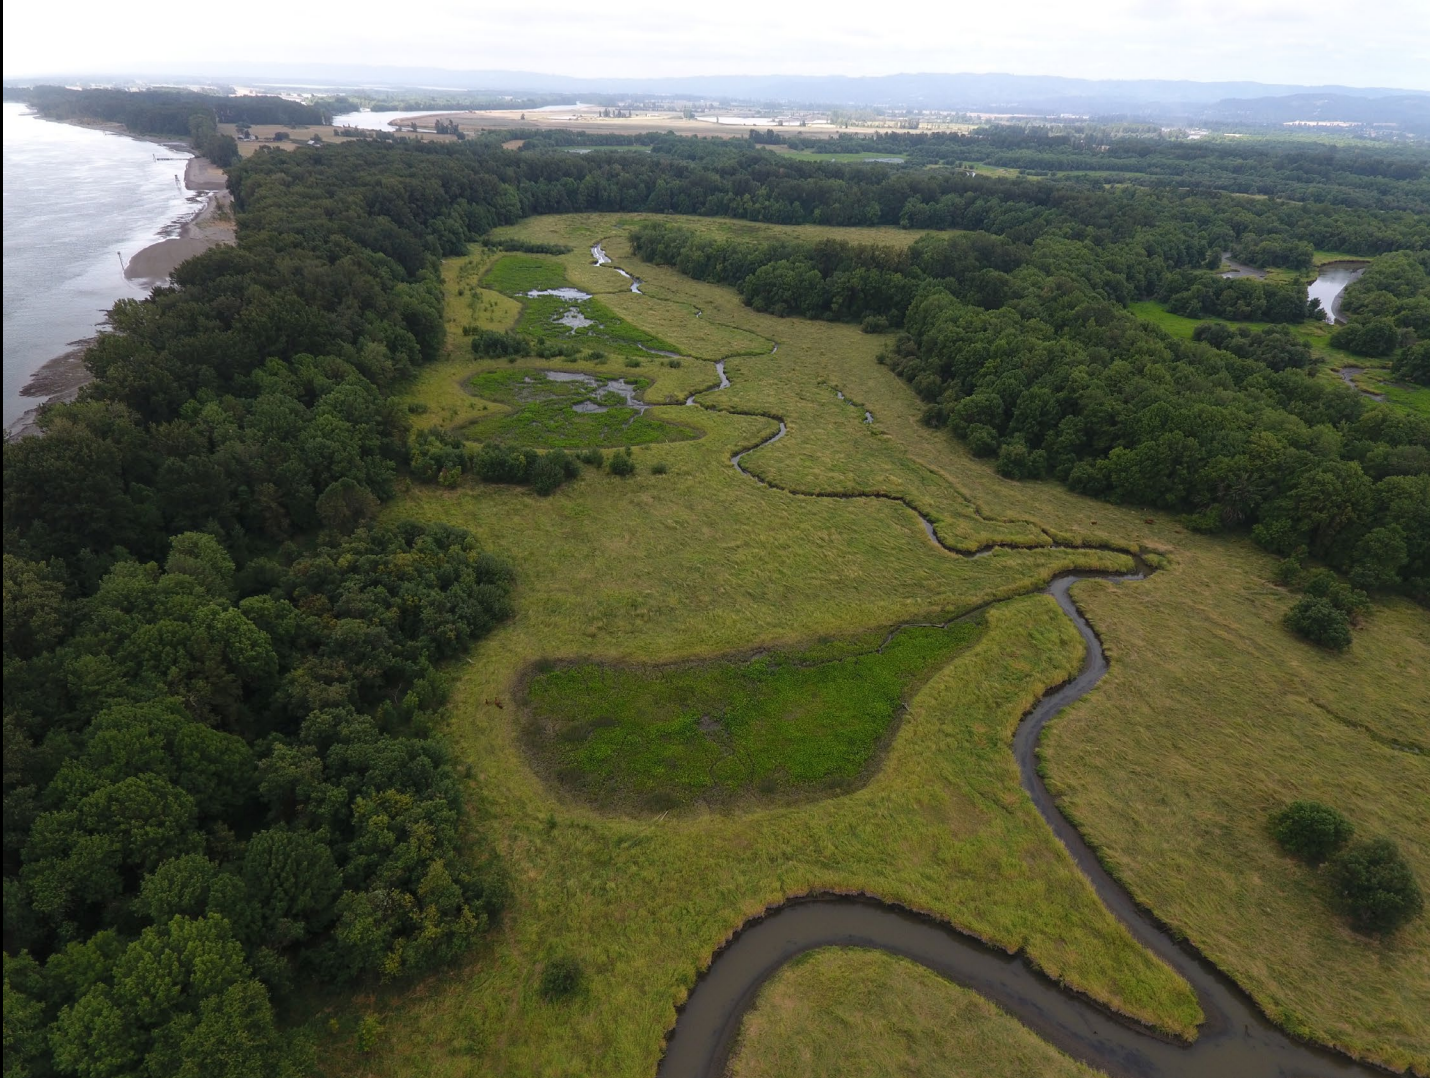
RUBY LAKE, 8 YEARS (2021) POST-RESTORATION

North Unit Phase 1 – Ruby Lake is a restoration site located in the northern portion of Sauvie Island, Oregon (Columbia RM 89, Reach F).

Ruby Lake restoration occurred in 2013, and construction actions included removing water control structure, channel enhancements, strategic marsh plain lowering and implementation of a vegetation enhancement plan. These techniques were aimed at increasing habitat opportunity at the site.

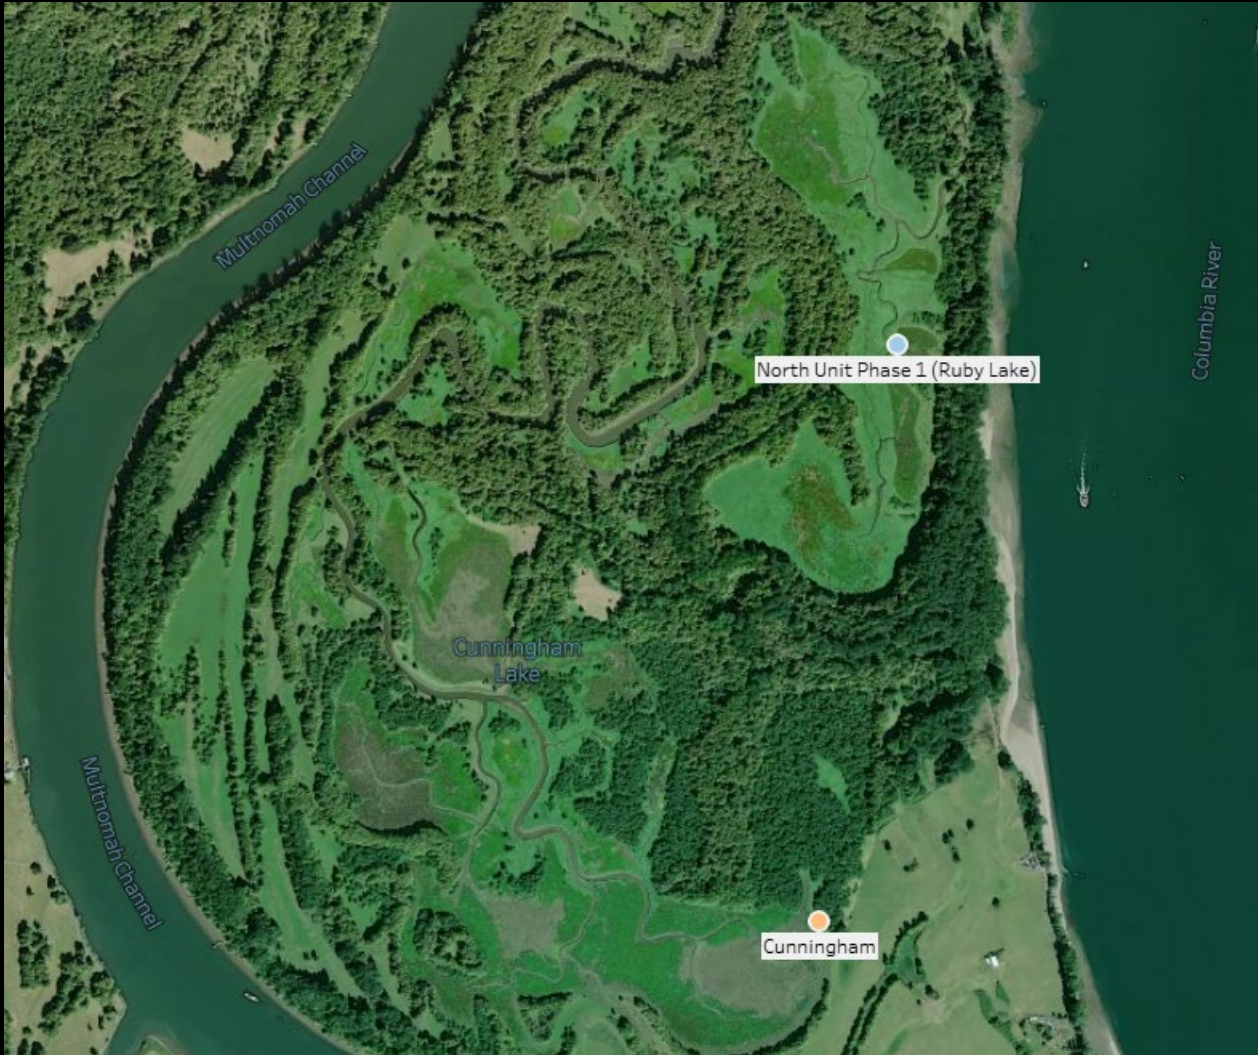
RUBY LAKE, 8 YEARS (2021) POST-RESTORATION

North Unit Phase 1 – Ruby Lake is a restoration site located in the northern portion of Sauvie Island, Oregon (Columbia RM 89, Reach F).
