WATER QUALITY MONITORING REPORT
COLUMBIA COUNTY SOIL AND WATER CONSERVATION DISTRICT
WATER QUALITY MONITORING PROGRAM
2017-2022 TRENDS

Lower Columbia Estuary Partnership (LCEP). 2023. Water Quality Monitoring Report Columbia County Soil and Water Conservation District Water Quality Trends Monitoring Program 2017-2022. Prepared by the Lower Columbia Estuary Partnership for the Columbia Soil & Water Conservation District. Available from the Lower Columbia Estuary Partnership, Portland, OR.

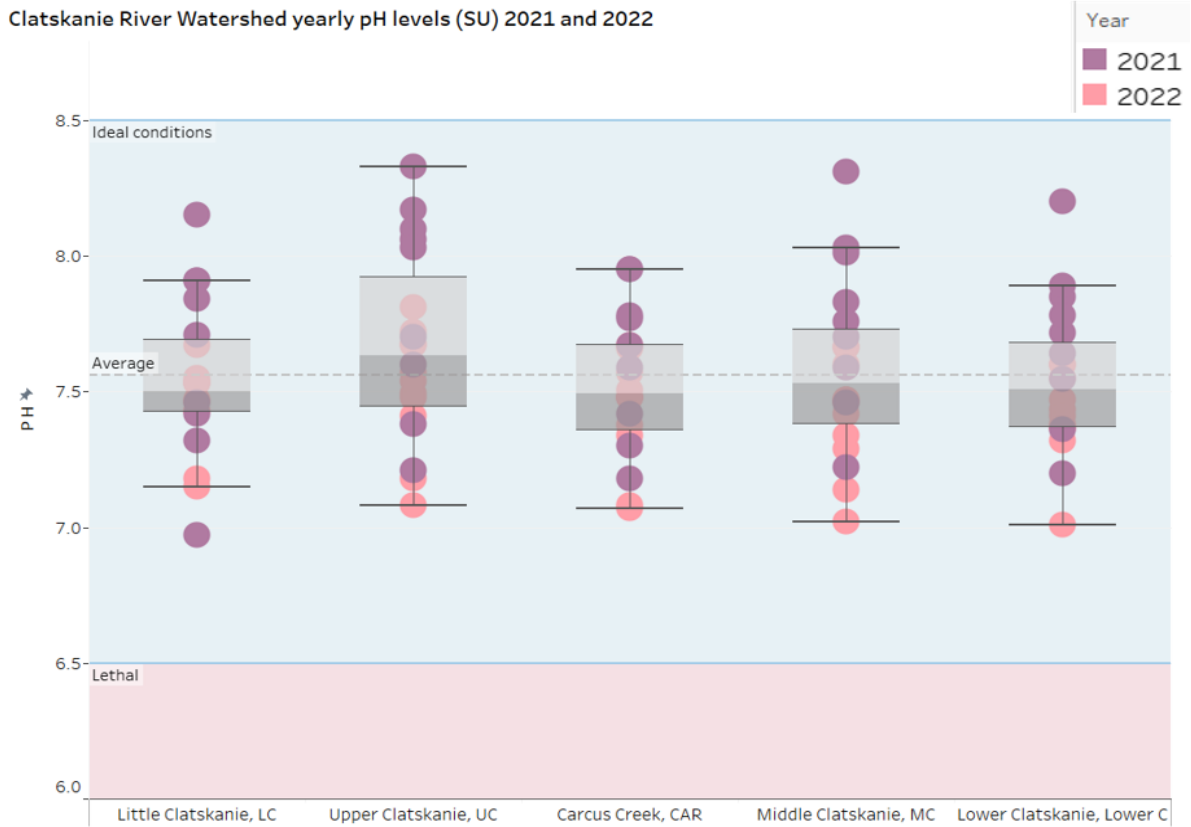
Figure 17: Yearly in-situ stream pH variation across sites in Clatskanie River watershed in 2021 and 2022. DEQ regulatory standards for lethal stream pH conditions for salmonids (<6.5) is represented as a red band. DEQ standards for ideal stream pH conditions for salmonids (6.5 – 8.5) is shown as blue band.

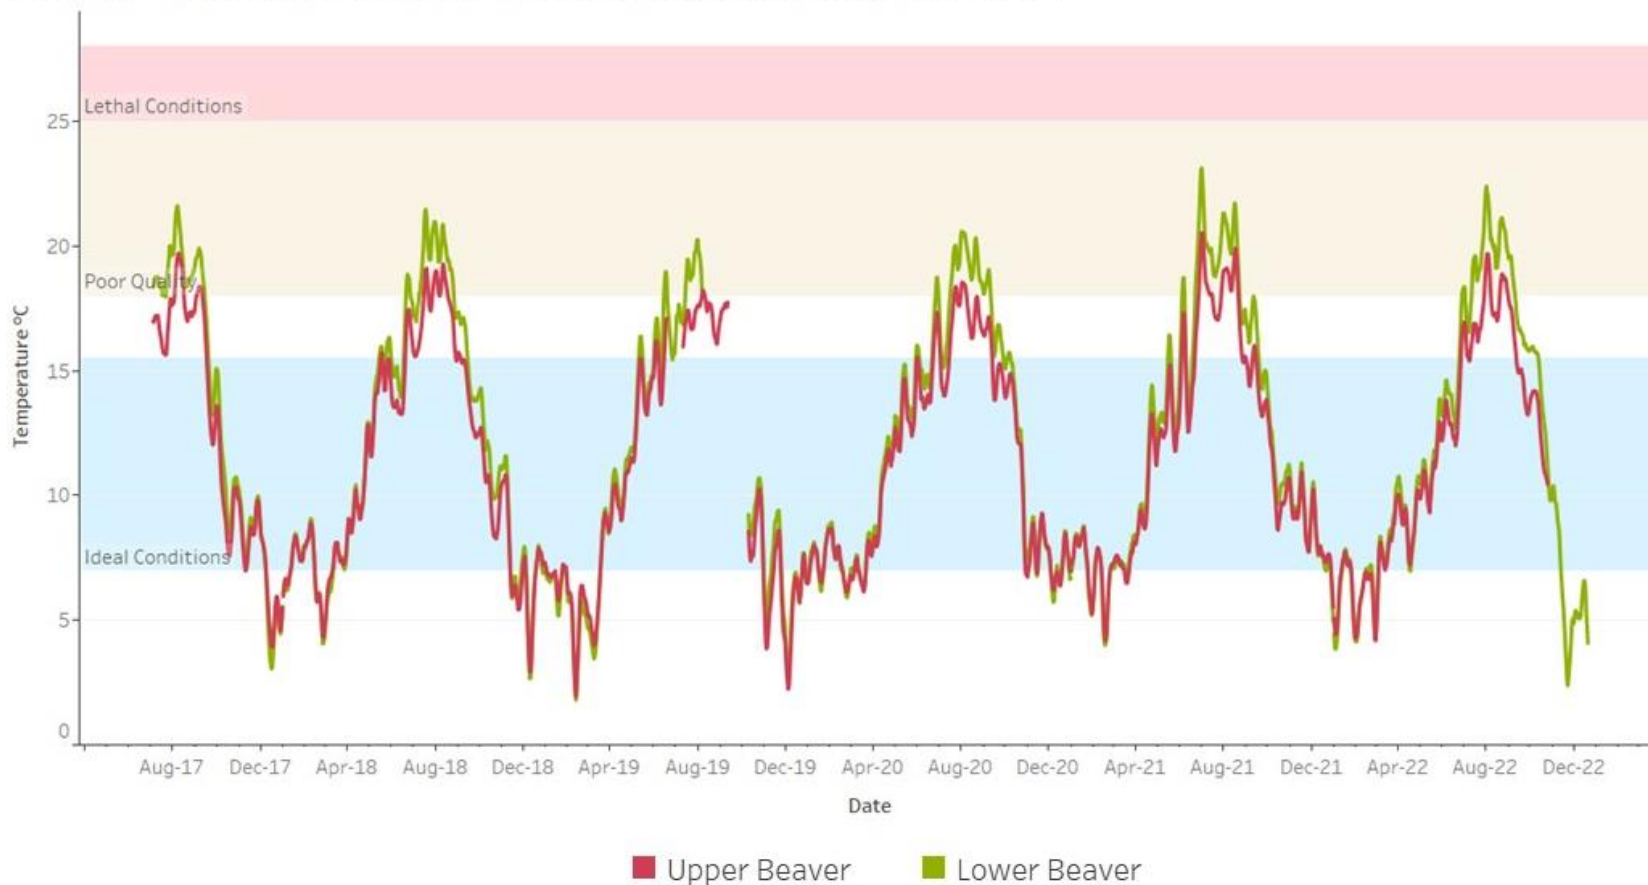
Figure 25: Beaver Creek Watershed 7-day average maximum temperatures (7dMAM) from 2017 to 2022 overlaid on salmonid temperature threshold ranges. See Table 4 for temperature threshold details.

DEQ temperature standard for salmon rearing habitat is less than 18°C, while streams with temperatures higher than 18°C are considered poor quality for salmon. In 2022, highest 7dMAM temperatures in Upper Beaver Creek were observed in July and August, exceeding 18°C. Summer temperatures in Lower Beaver Creek continued to exceed 18°C in July and August (Figure 24, Figure 25). The number of days over 18°C in summer 2022 was similar to summer 2021 at Lower Beaver but had reduced at Upper Beaver.

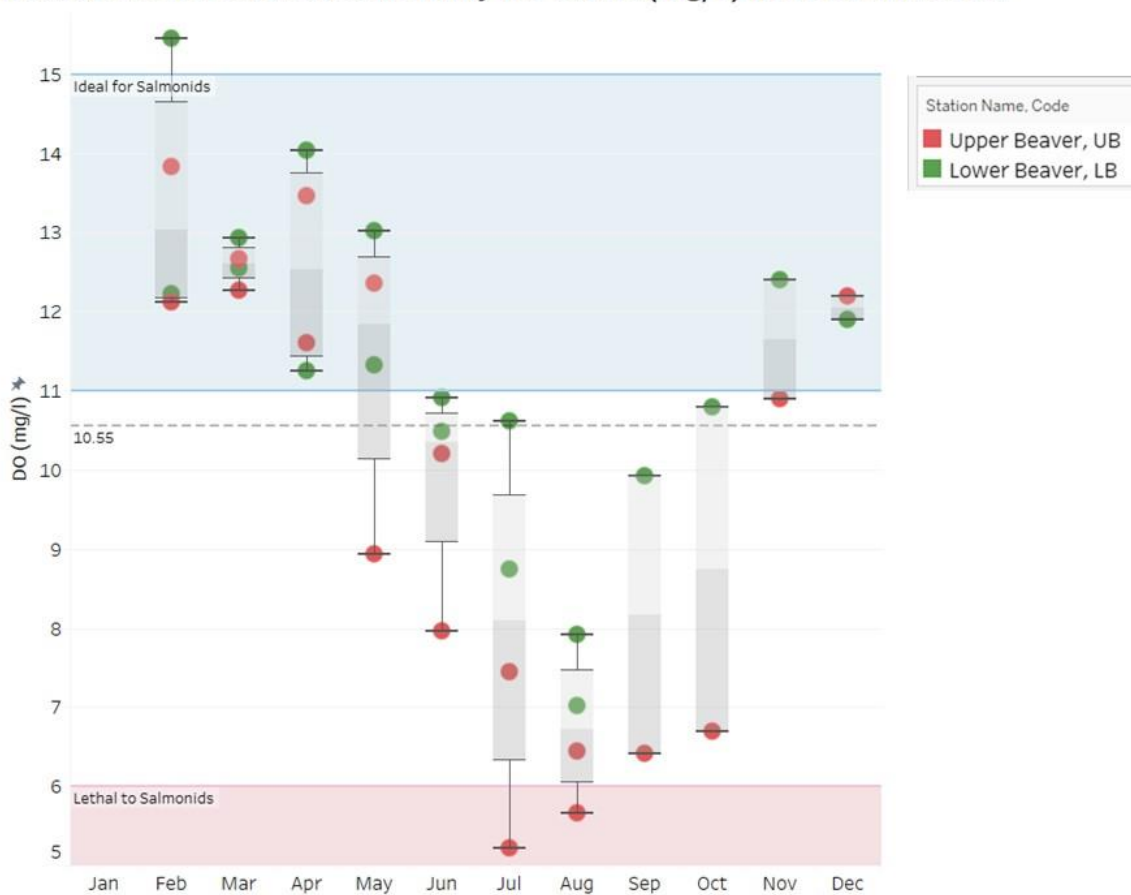
Figure 30: Monthly in-situ stream DO ranges across all monitoring locations in Beaver Creek watershed. DEQ standards for ideal DO conditions for salmonids(>11mg/l) is depicted as a blue band in the graph. DEQ standards for Lethal conditions (<6mg/l) is depicted as the red band.

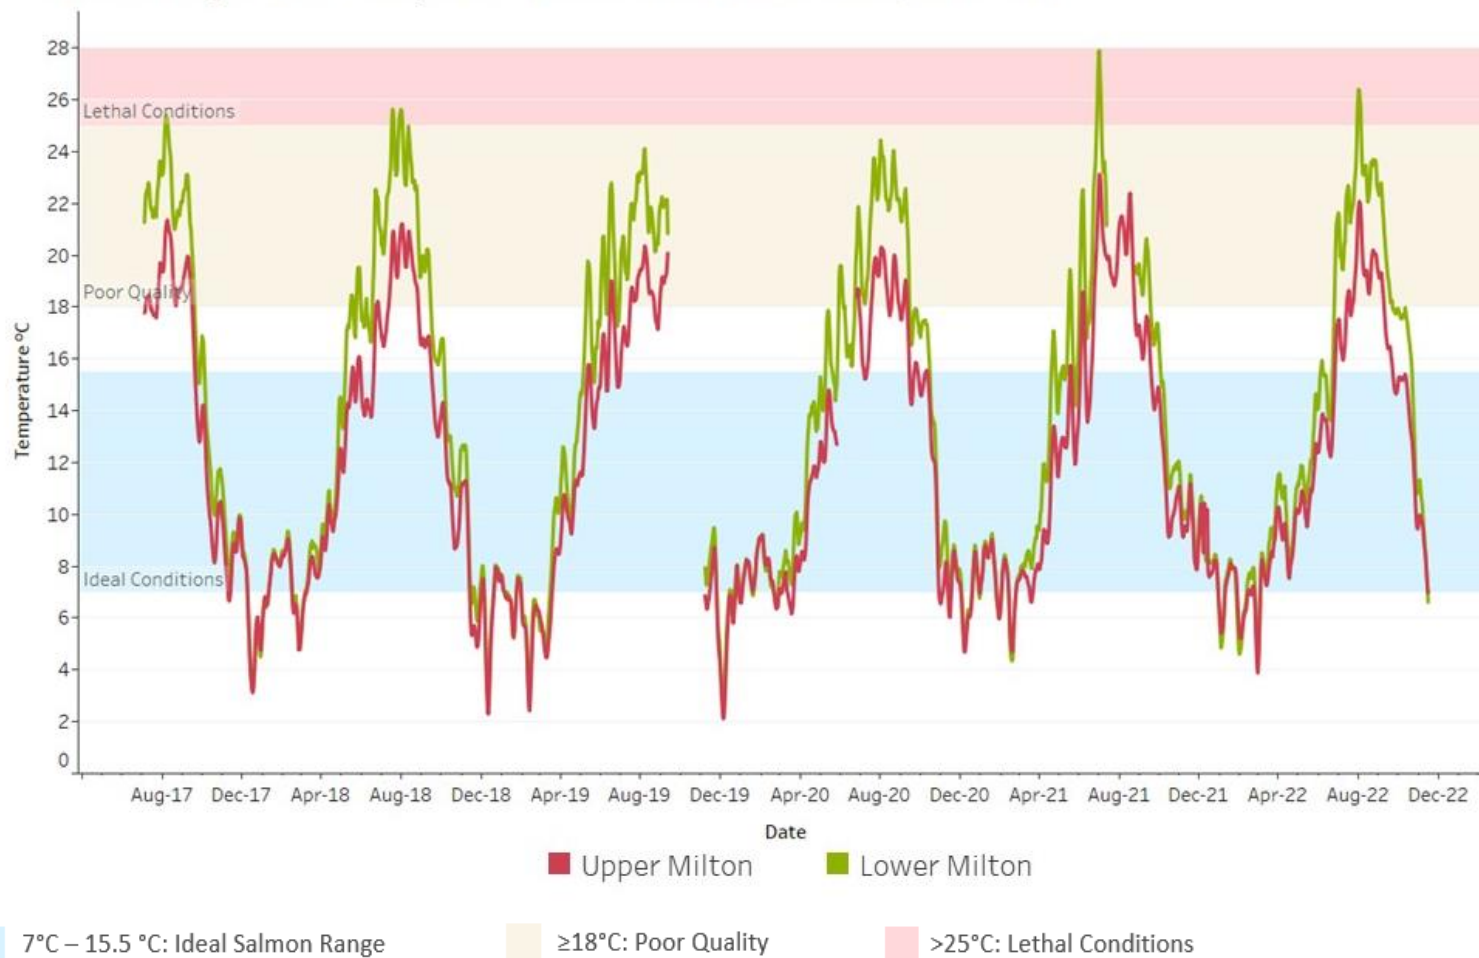
Figure 37: Milton Creek Watershed 7-day average maximum temperatures (7dMAM) from 2017 to 2022, overlaid on salmonid temperature threshold ranges. See Table 4 for temperature threshold details.

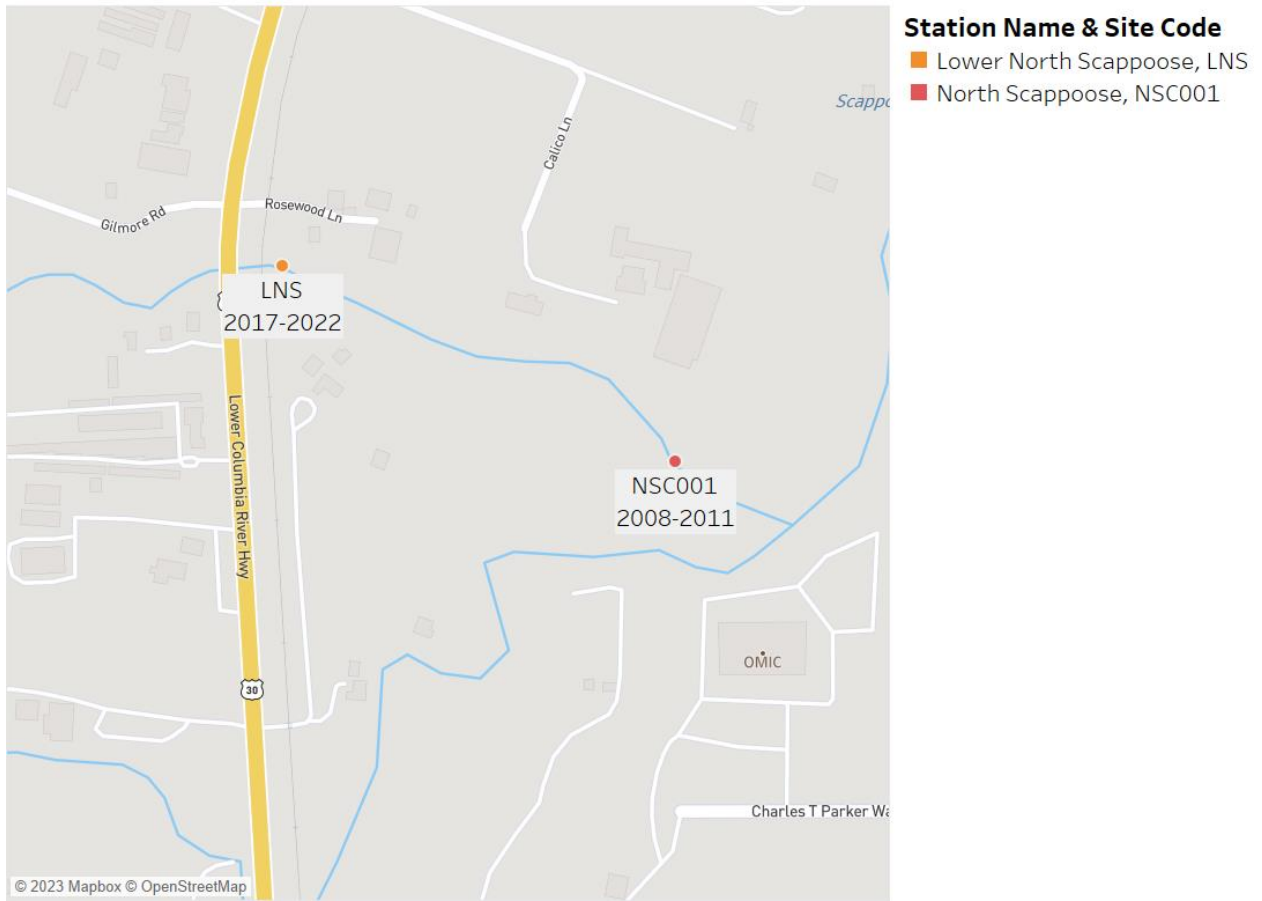
Lower North Scappoose Creeks Distribution of Monitoring Locations (2008-2011, 2017-2022)

Figure 49: Focus map of Lower North and South Scappoose Creek monitoring locations; for an overview map, see Figure 1 & Figure 47. For specific monitoring location details, see Table 1.

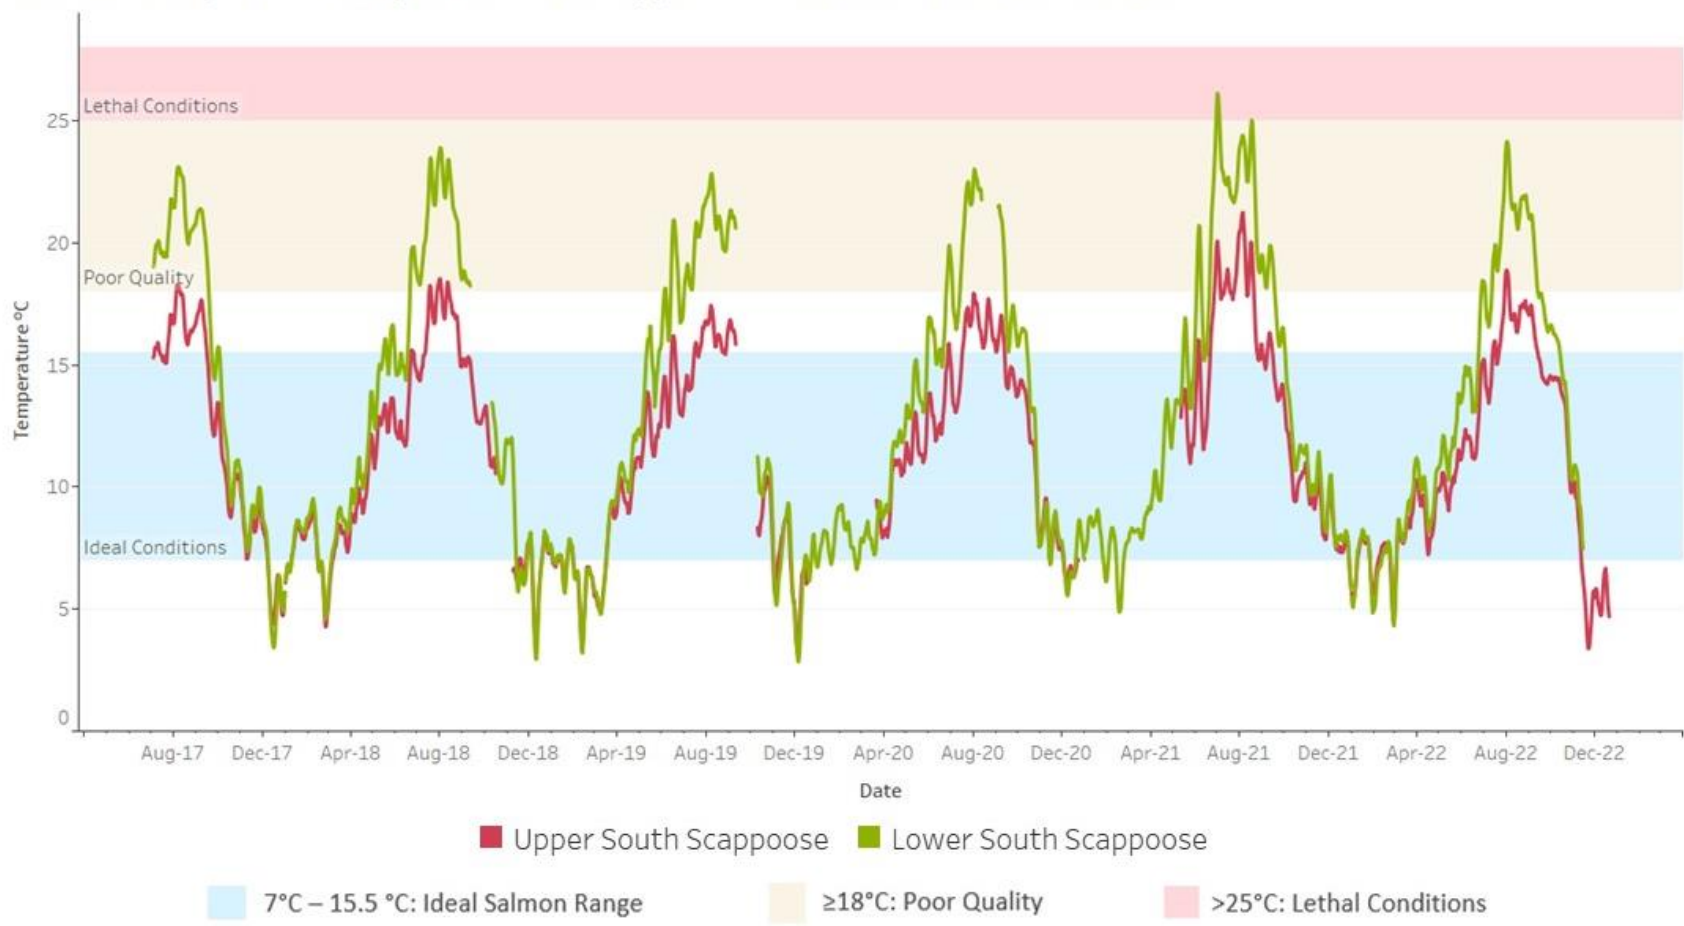
Figure 66: 7-day average maximum temperatures (7dMAM) for Upper South Scappoose and Lower South Scappoose creeks from 2017-2021 overlaid on salmonid temperature threshold ranges. See Table 4 for temperature threshold details.

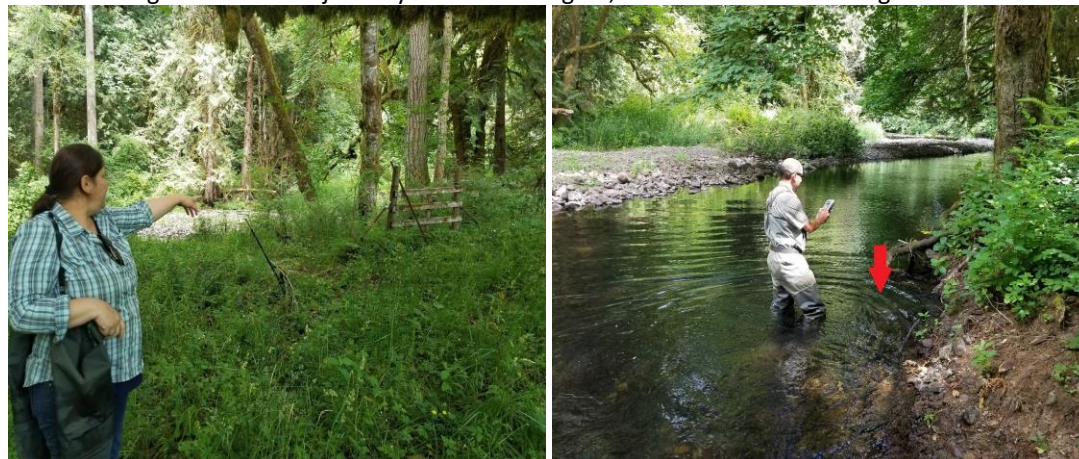
Location Image: River access just beyond old fence gate, near bank root overhang

Clatskanie Watershed						
Site Code	Site Name	Description	GPS Coordinates	Logger Serial Number	Installed Date/Time	Installed Temp °C
LC	Lower Clatskanie	Data: Bacteria, Temp/WL, Turbidity	Lat: 46.080002 Long: -123.166841	20112654	8/17/2017 15:30	19.8
Site Code	Site Name	Description	GPS Coordinates	Logger Serial Number	Installed Date/Time	Installed Temp °C
MC	Middle Clatskanie	Data: Temp/WL, Turbidity Private property (must notify owner ahead of time) off of Swedetown road, walk through field behind the home, then cross through an old gate to access river. Data logger placed near an undercut bank with some overhanging roots.	Lat: 46.045193 Long: -123.095813	20112657	6/28/2017 15:28	14.6

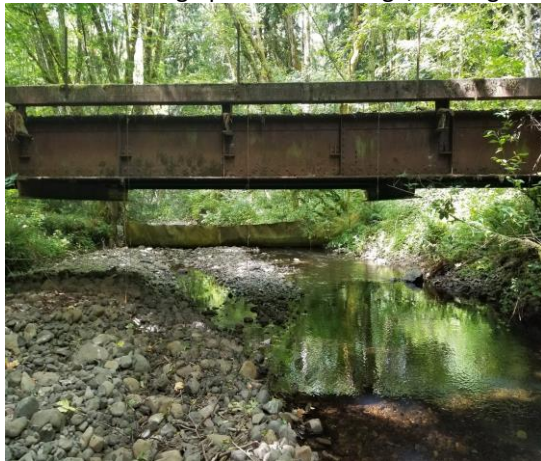
Location: Looking up stream at bridge, looking down stream towards data logger placement

Site Code	Site Name	Description	GPS Coordinates	Logger Serial Number	Installed Date/Time	Installed Temp °C
CAR	Carcus	Data: Temp/WL, Turbidity Stream accessed via private drive off Swedetown Rd, data logger placed a few meters upstream of the bridge (to be out of way of impending construction).	Lat: 46.038533 Long: -123.085543	20112662	6/28/2017 15:54	14.1

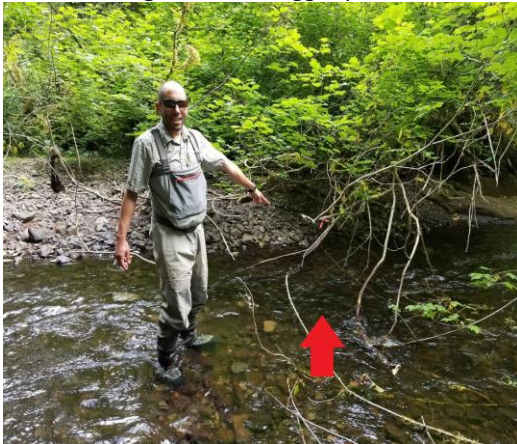
Matt standing near data logger placement location, under vine maple (flagged with pink tape)

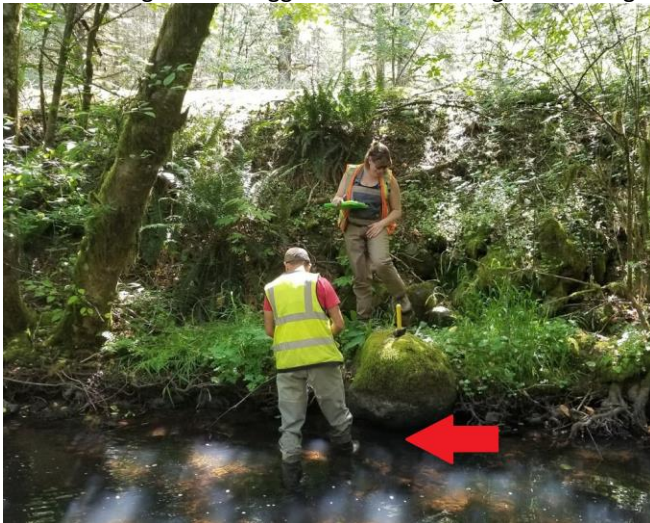
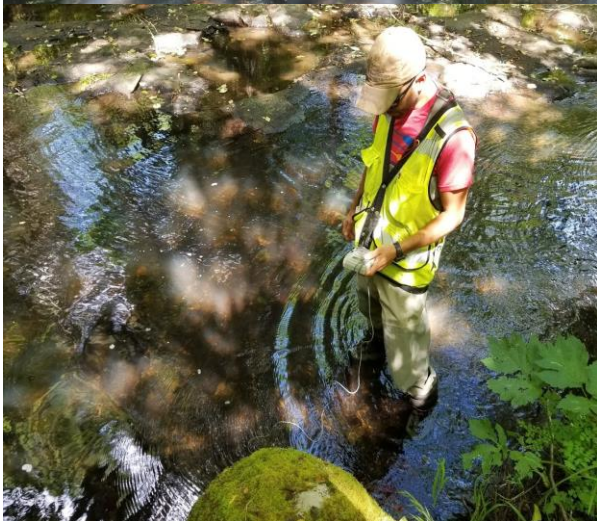
Location images: Data logger located near large rock along the river bank

Site Code	Site Name	Description	GPS Coordinates	Logger Serial Number	Installed Date/Time	Installed Temp °C
UC	Upper Clatskanie	Data: Temp/WL, Turbidity Just north of LC location on the other side of the Apiary road. Steep descent from road to stream. Data logger near large rock on road side of river bank.	Lat: 45.987717 Long: -123.040371	20112651	6/29/2017 11:43	12.8

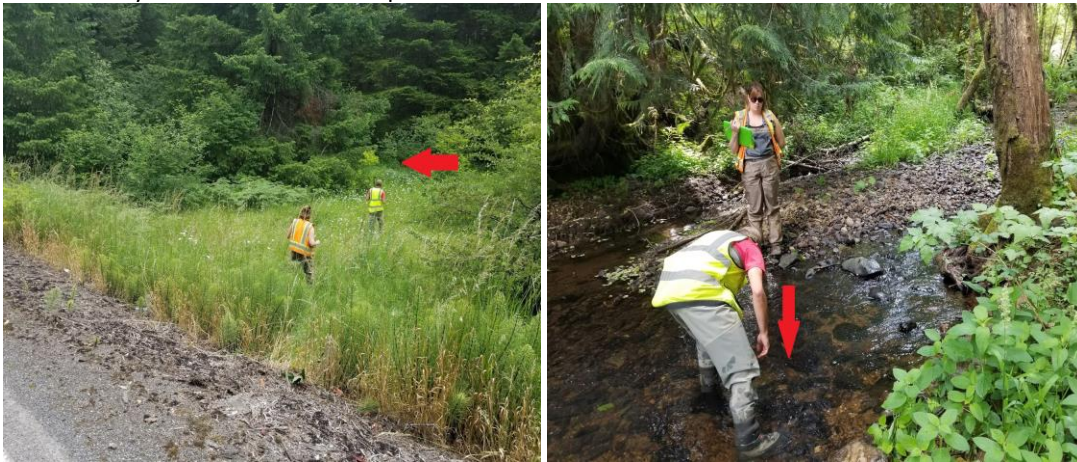
Grassy opening along right side of road side north of car pull out, data logger is located near flagging next to salmon berry shrub and cedar stump

Site Code	Site Name	Description	GPS Coordinates	Logger Serial Number	Installed Date/Time	Installed Temp °C
LitC	Little Clatskanie	Data: Temp/WL, Turbidity Park at pull out for logging road (on little Clat side of the road) along Apiary Market Rd and then access river via grassy opening along right side of roadside north of car pull out, follow pink flagging to data logger location (downstream of large data logger housing)	Lat: 45.987598 Long: -123.038492	20112659	6/29/2017 11:23	12.7

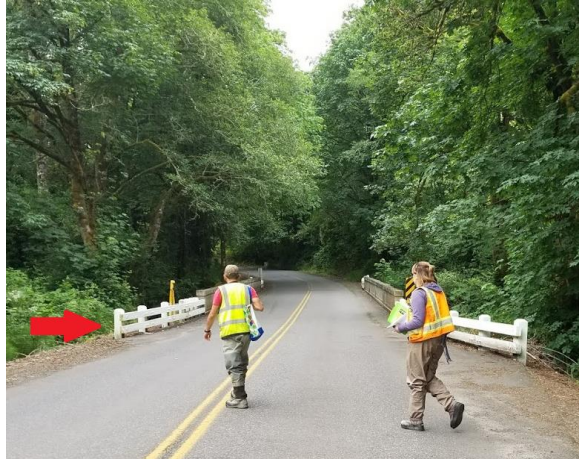
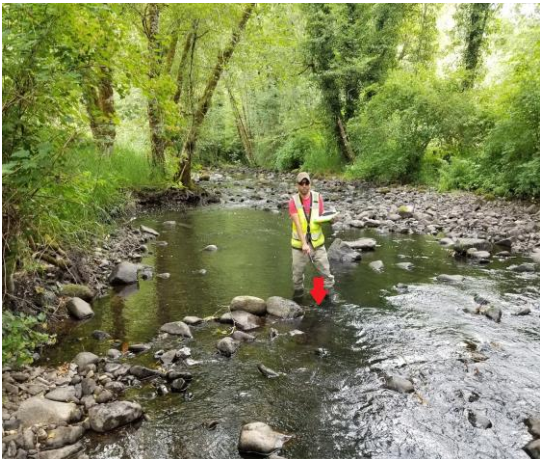
Beaver Creek Watershed						
Site Code	Site Name	Description	GPS Coordinates	Logger Serial Number	Installed Date/Time	Installed Temp °C
LB	Lower Beaver	Pull out before the bridge at Beaver Falls Rd, data logger placed at the end of a rock pile just upstream of the bridge (large current shrub on shore).	Lat: 46.108942	20112663	6/29/2017 10:09	14.3
			Long: -123.158919			
<p>Location images: Park on side of the road and access stream on upstream side of bridge, data logger placed at the end of a rock pile just upstream of the bridge (large current shrub on shore). Large rock near data logger placement marked with a black X.</p>

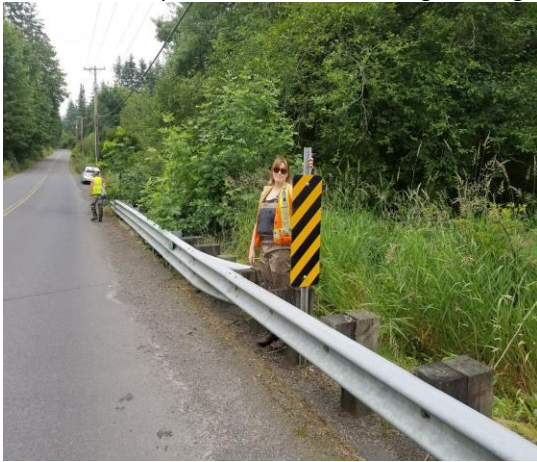
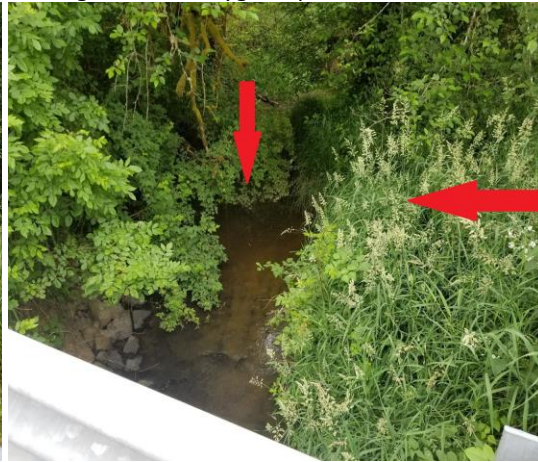
Location images: Park just past bridge on Fernhill Road (near 73723 Fern Hill Rd Rainier, Oregon), and walk down on the upstream side of the bridge through the large reed canarygrass patch.

Site Code	Site Name	Description	GPS Coordinates	Logger Serial Number	Installed Date/Time	Installed Temp °C
UB	Upper Beaver UB	Data: Temp/WL, Turbidity Park just past bridge on Fernhill Road (near 73723 Fern Hill Rd), and walk down on the upstream side of the bridge through the large reed canarygrass patch. Located upstream of bridge, under a large current shrub with pink flagging marking its location	Lat: 46.062373 Long: -122.965167	20112653	6/29/2017 10:44	14.0

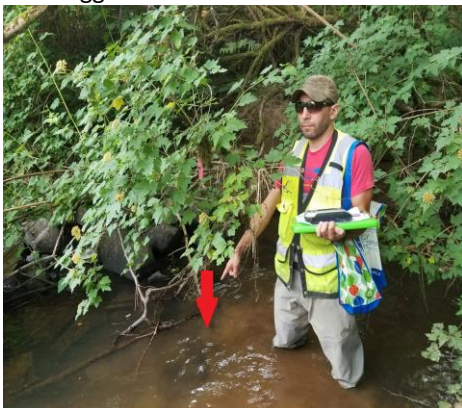
Data logger located under Currant shrub on far side of stream.

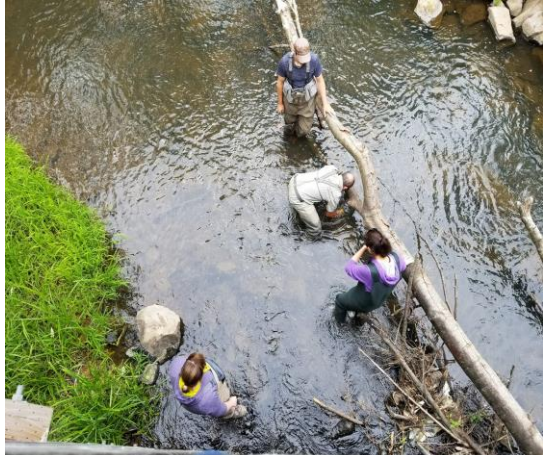
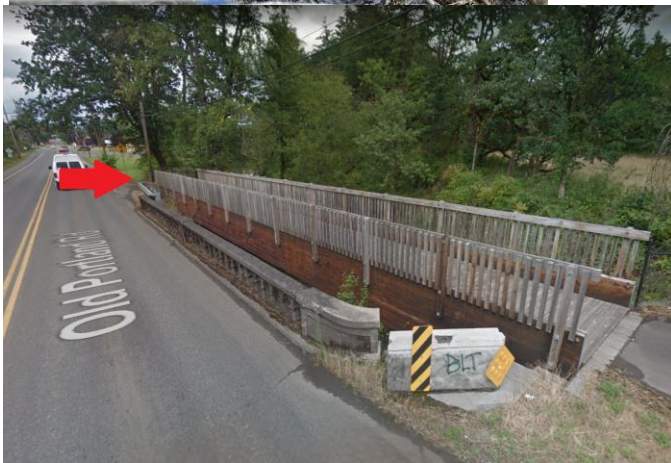
Location Image (looking down from the bridge, Matt is bending over data logger placement):

Scappoose Bay Watershed: Lower Milton Creek						
Site Code	Site Name	Description	GPS Coordinates	Logger Serial Number	Installed Date/Time	Installed Temp °C
LM	Lower Milton	Data: Bacteria, Temp/WL, Turbidity Located in McCormick Park on the downstream side of the Old Portland Road Bridge - under woody debris	Lat: 45.850289	20112656	6/28/2017 11:28	16.3
			Long: -122.816039

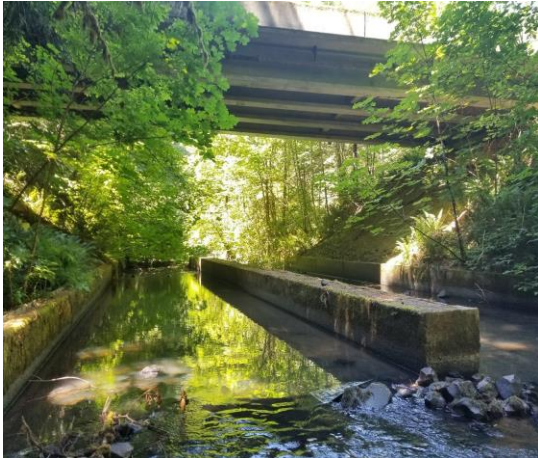
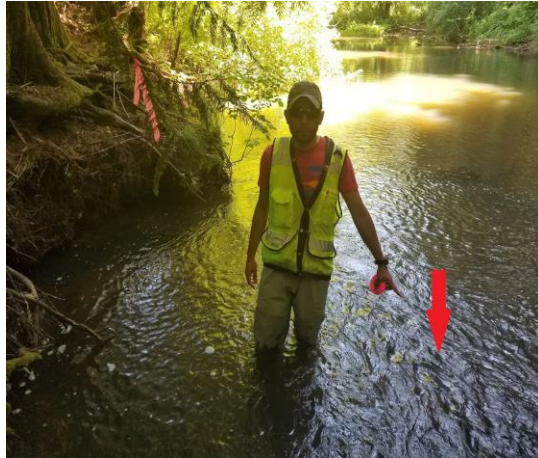
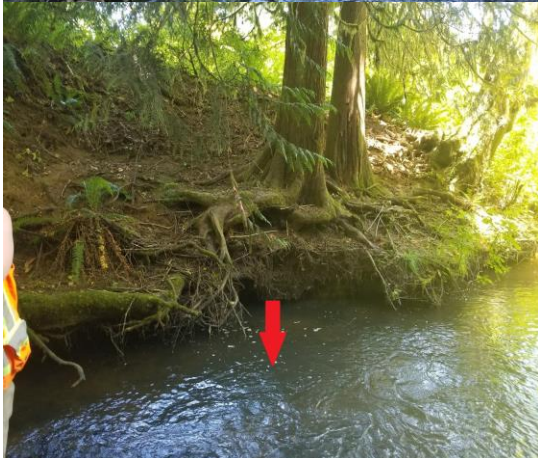
Location images: Downstream of bridge (a bit) near the north stream bank under flagged cedar tree in pool

Site Code	Site Name	Description	GPS Coordinates	Logger Serial Number	Installed Date/Time	Installed Temp °C
UM	Upper Milton	Data: Temp/WL, Turbidity Downstream side of W. Kappler Rd bridge (very steep), data logger located downstream of bridge under flagged cedar tree.	Lat: 45.864193 Long: -122.886893	20112650	6/29/2017 12:58	15.4

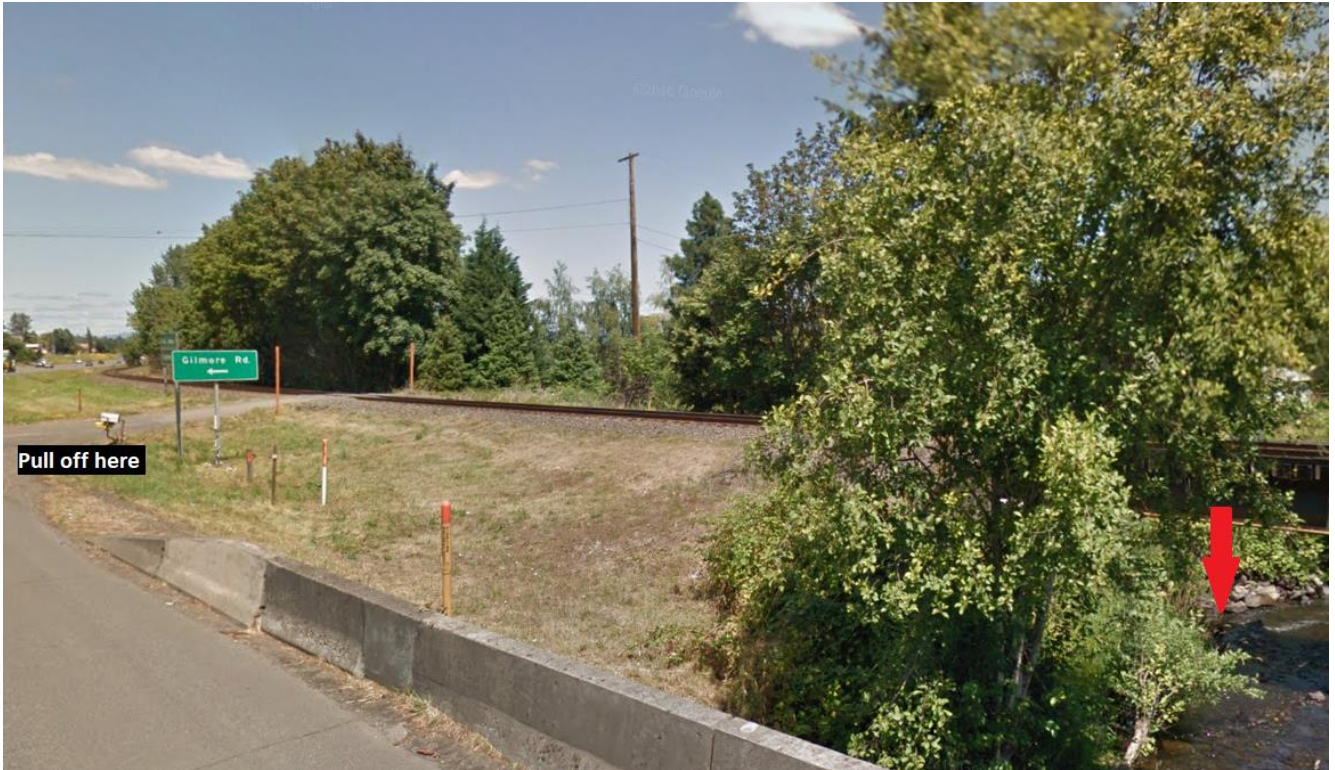
Location images: Pull off HWY 30 just north of bridge along Rosewood lane.

Scappoose Bay Watershed: North Scappoose Creek						
Site Code	Site Name	Description	GPS Coordinates	Logger Serial Number	Installed Date/Time	Installed Temp °C
LNS	Lower North Scappoose	Data: Bacteria, Temp/WL, Turbidity Pull off HWY 30 just north of bridge along Rosewood lane. Enter stream on the north bank at the railroad bridge (large patch of reed canarygrass) crossing. Data logger tided to old piling (flagged) on north bank of stream under railroad bridge.	Lat: 45.771786	20112652	6/29/2017 14:19	17.2

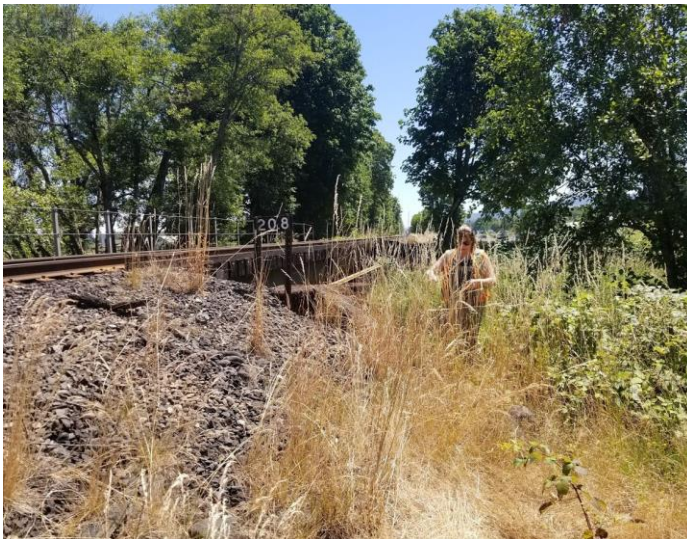
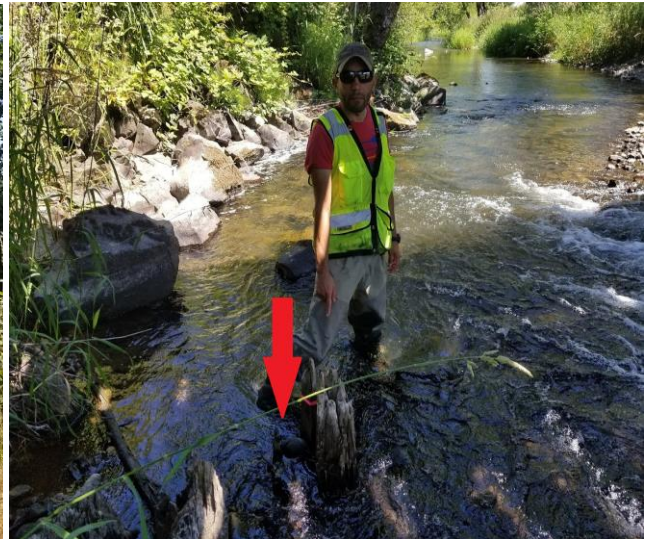
Enter stream on the north bank at the railroad bridge (large patch of reed canarygrass) crossing. Data logger tided to old piling on north bank of stream under railroad bridge.

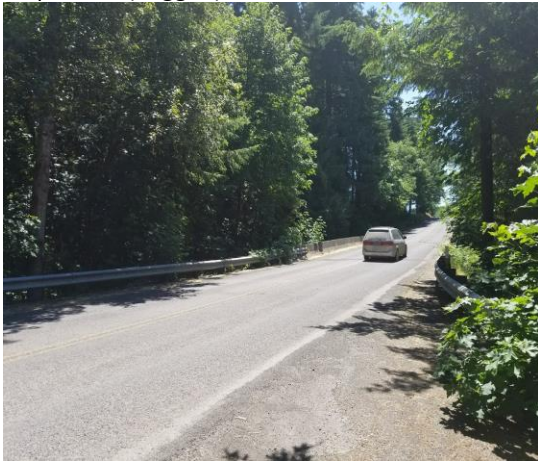
Location images: Descend on the upstream side of the bridge on the North bank. Data logger placed on North bank under maple tree (flagged).

Site Code	Site Name	Description	GPS Coordinates	Logger Serial Number	Installed Date/Time	Installed Temp °C
UNS	Upper North Scappoose	Data: Temp/WL, Turbidity Pull off close to the bridge crossing river near 30161 Scappoose Vernonia Hwy. Descend on the upstream side of the bridge on the North bank. Data logger placed on North bank under maple tree (flagged).	Lat: 45.823753 Long: -122.946923	20112655	6/29/2017 13:37	14.4

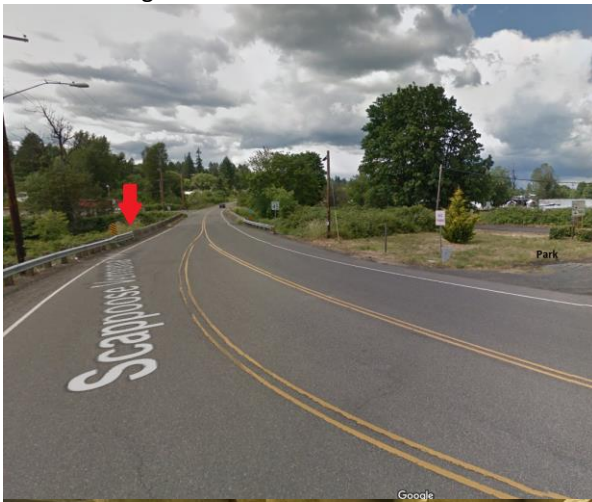
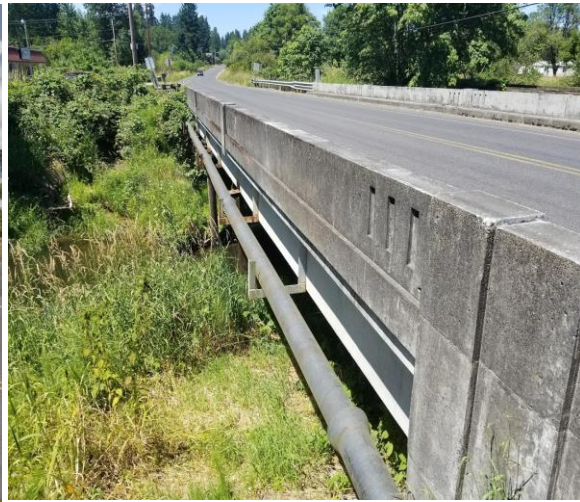
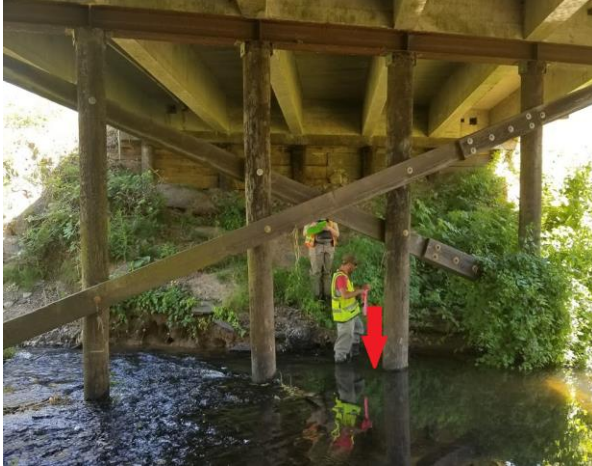
Location images:

Site Code	Site Name	Description	GPS Coordinates	Logger Serial Number	Installed Date/Time	Installed Temp °C
LSS	Lower South Scappoose	Data: Bacteria, Temp/WL, Turbidity Park at the CZ trail area just off HWY 30, then decent on the south side of the bridge on the upstream side. Data logger tied to piling under bridge on south bank. Piling flagged.	Lat: 45.762739 Long: -122.880973	20112658	6/29/2017 13:59	16.3

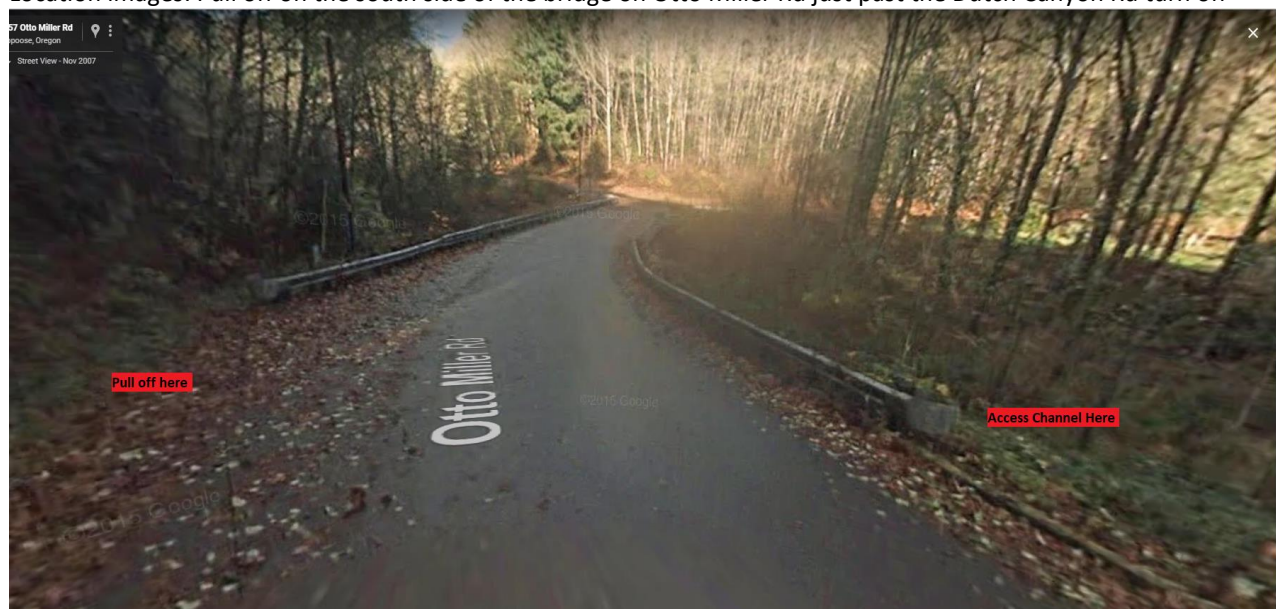
Location images: Pull off on the south side of the bridge on Otto Miller Rd just past the Dutch Canyon Rd turn off

Site Code	Site Name	Description	GPS Coordinates	Logger Serial Number	Installed Date/Time	Installed Temp °C
USS	Upper South Scappoose	Data: Temp/WL, Turbidity Pull off on the south side of the bridge on Otto Miller Rd just past the Dutch Canyon Rd turn off (see image). Data logger located downstream of bridge under an alder tree (flagged).	Lat: 45.744219 Long: -122.961964	20112664	6/29/2017 14:44	13.7

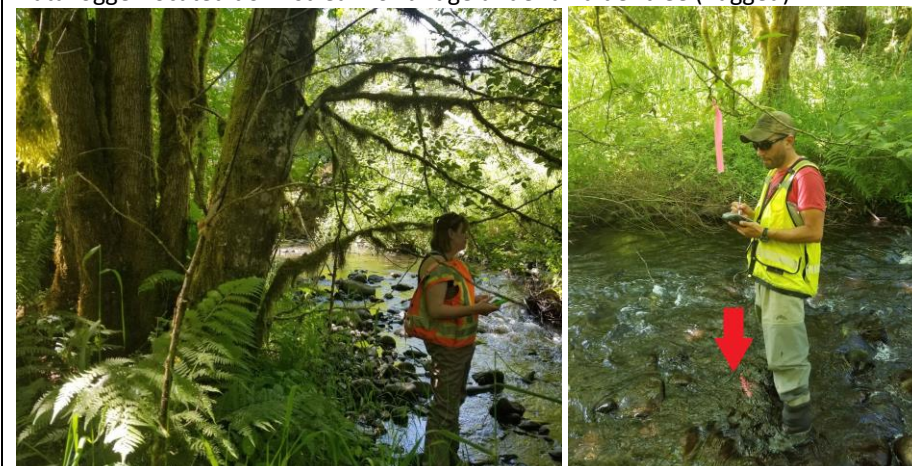
Data logger located downstream of bridge under an alder tree (flagged)
