# Lower East Fork Lewis River Thermal Assessment

Findings and Initial Thermal Refuge Project  
Concepts for the Lower East Fork Lewis River  
(RM 4 – 21)

June 2022

Lower Columbia Estuary Partnership

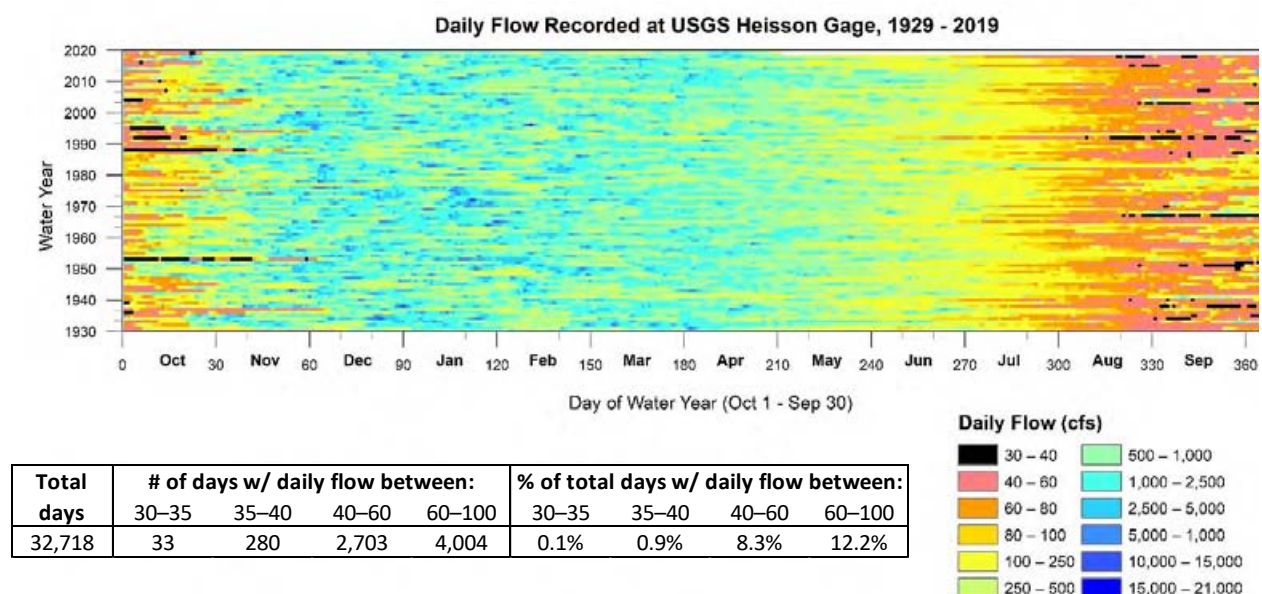
Figure 4. EFLR average daily flows (in cfs) recorded at USGS Heisson gage from 1929–2019, including low-flow statistics.

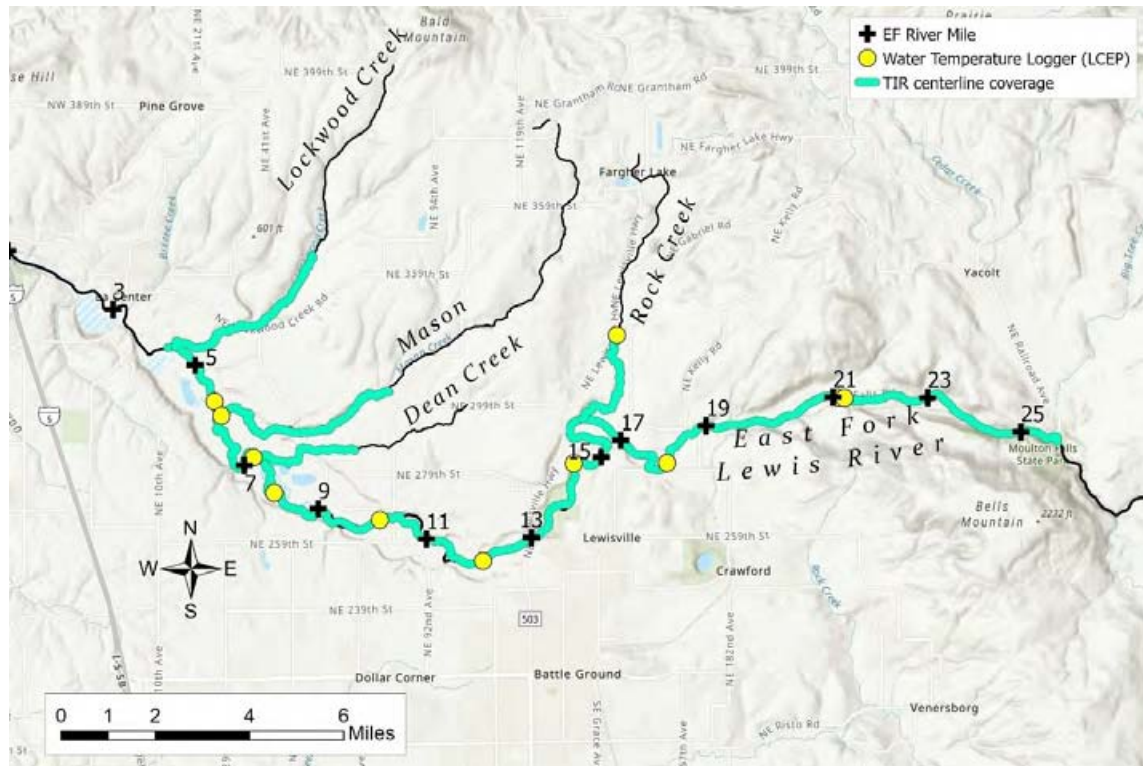
**Figure 6. Extent of coverage (shown as blue area) for the TIR airborne survey, including the lower EFLR from RM 4–25 and four primary tributaries. Locations of installed data loggers used for image calibration are also shown.**

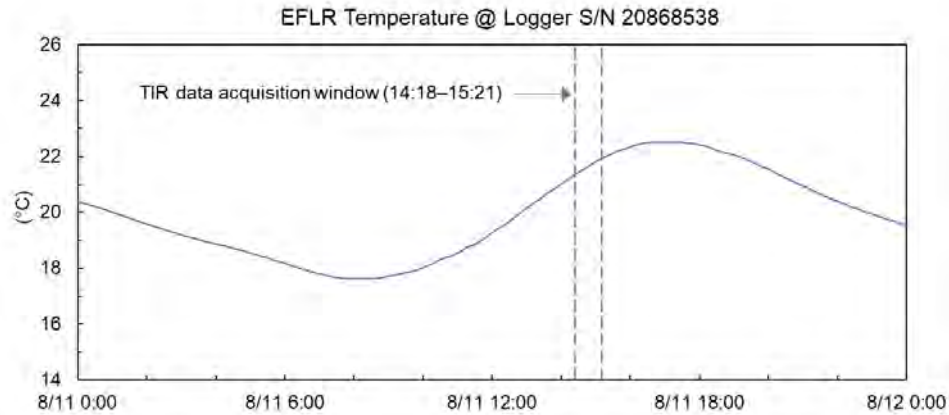
**Figure 12. Diurnal temperature increase at selected location in the lower EFLR relative to the duration of the TIR data acquisition flight. Temperature increase within the flight acquisition window averaged 0.55 °C throughout the reach.**

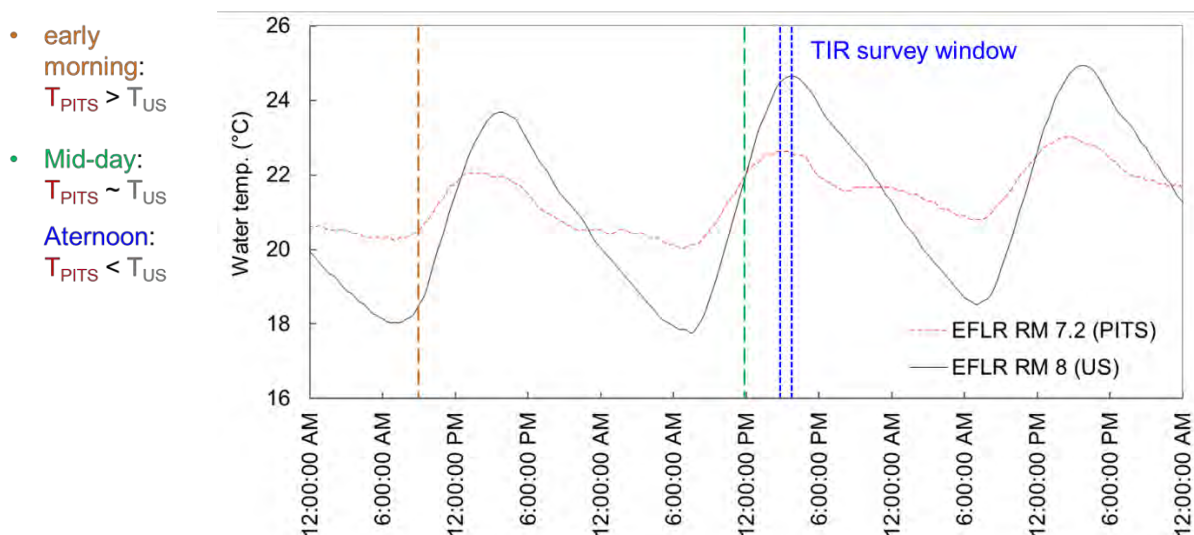
**Figure 15. Temperature data comparison between stations located upstream of Ridgefield Pits at RM 8 (US) and just downstream at RM 7.2 (PITS), collected during August 2020. Moderating effect of the high-volume, slow moving Ridgefield Pits reach on diurnal temperature fluctuations is illustrated by the smaller amplitude signal observed downstream. This effect results in higher morning temperatures and lower afternoon/evening temperatures to be observed downstream, relative to upstream, throughout the course of a summer day.**

While it is possible that some degree of cooling due to groundwater exchange may be occurring through the Ridgefield Pits reach, as suggested by Carey and Bilhimer (2009), the phenomenon observed and described above highlights the importance of examining localized temperature trends suggested by TIR imagery more closely. In this case, temporally varying information was needed to supplement the TIR imagery, which provided spatially varying information over essentially a single point in time. While a perceived decreasing temperature trend was observed from the standalone TIR image, the actual physical process resulting in this observation was something different. Long-term mean temperatures calculated from the 2018 loggers deployed at both ends of the reach confirm this, having shown an actual increasing temperature trend through the reach (19.8 °C @ RM 8, 20.3 °C @ RM 7.2).

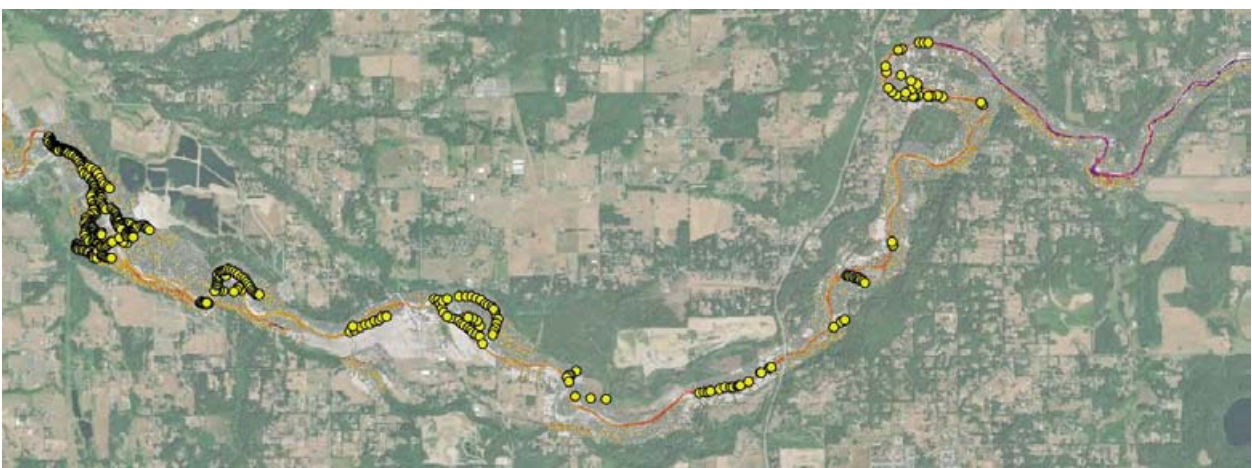
**Figure 16. Locations along the lower EFLR where water temperature was measured in July 2021 using handheld YSI meters. These include mainstem, side channel and off-channel areas. Tributaries were not surveyed using this method.**

Locations where we monitored water temperature in July 2021 using handheld YSI meters are shown in Figure 16. These include mainstem and off-channel areas where TIR imagery results were verified and additional locations that the TIR survey did not cover. Bed and surface temperatures were measured at each location and compared to average mainstem temperatures measured at that time and close by, to identify thermal anomalies. Most measurements were taken from late morning through afternoon after the mainstem had heated up sufficiently to make it easier to detect cold water. These measurements allowed us to eliminate false positive detections of cold water in the TIR imagery and determine what we believe is a comprehensive picture of existing cold-water locations within the lower EFLR floodplain. These areas are shown in Figure 17 and consist of off-channel and side-channel locations. They do not include any tributaries (even though most of the lower EFLR tributaries are colder than the mainstem), as we did not survey any tributaries using this method due to the limited scope of field time as well as property access issues. Absolute bed and surface temperature values recorded at all of the sampling locations shown in Figure 16 are available from the ArcGIS online results map for the project, available [here](#) (see Appendix B for list of included layers and full hyperlink).

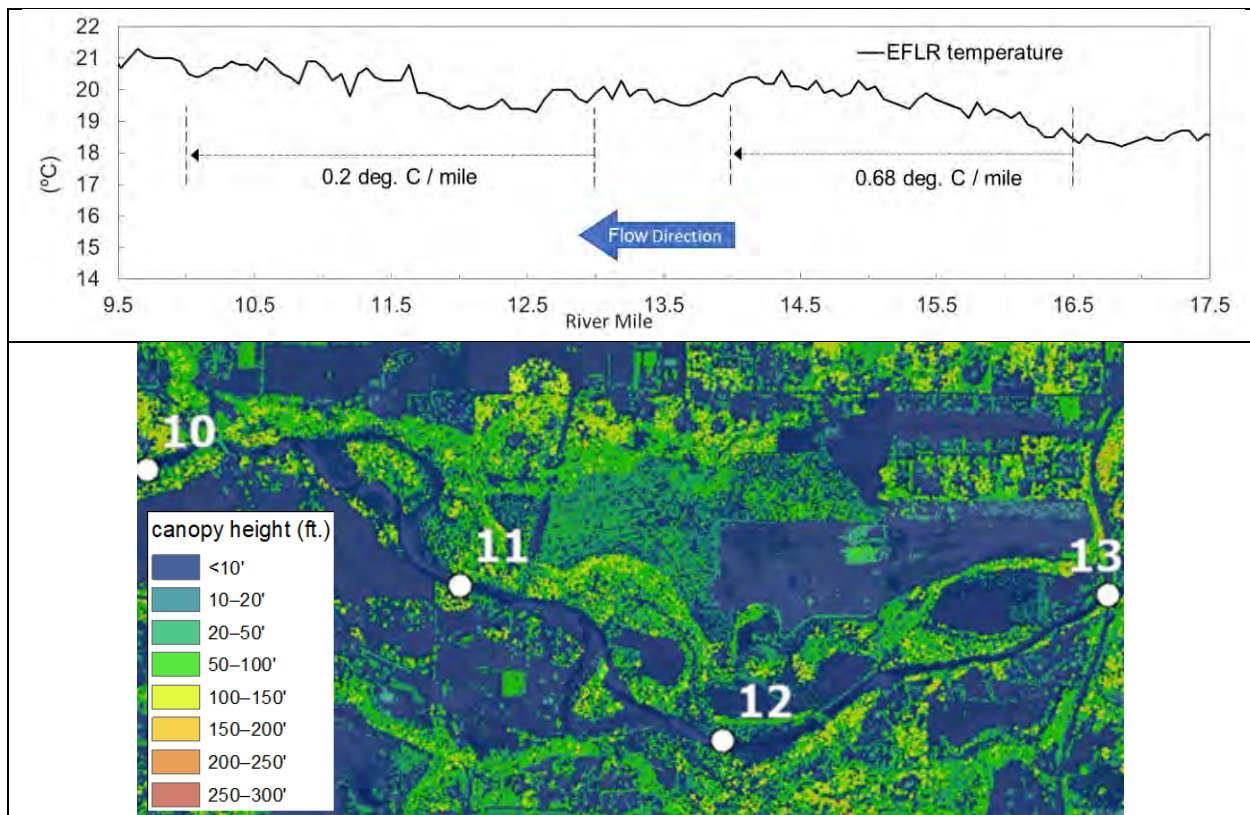
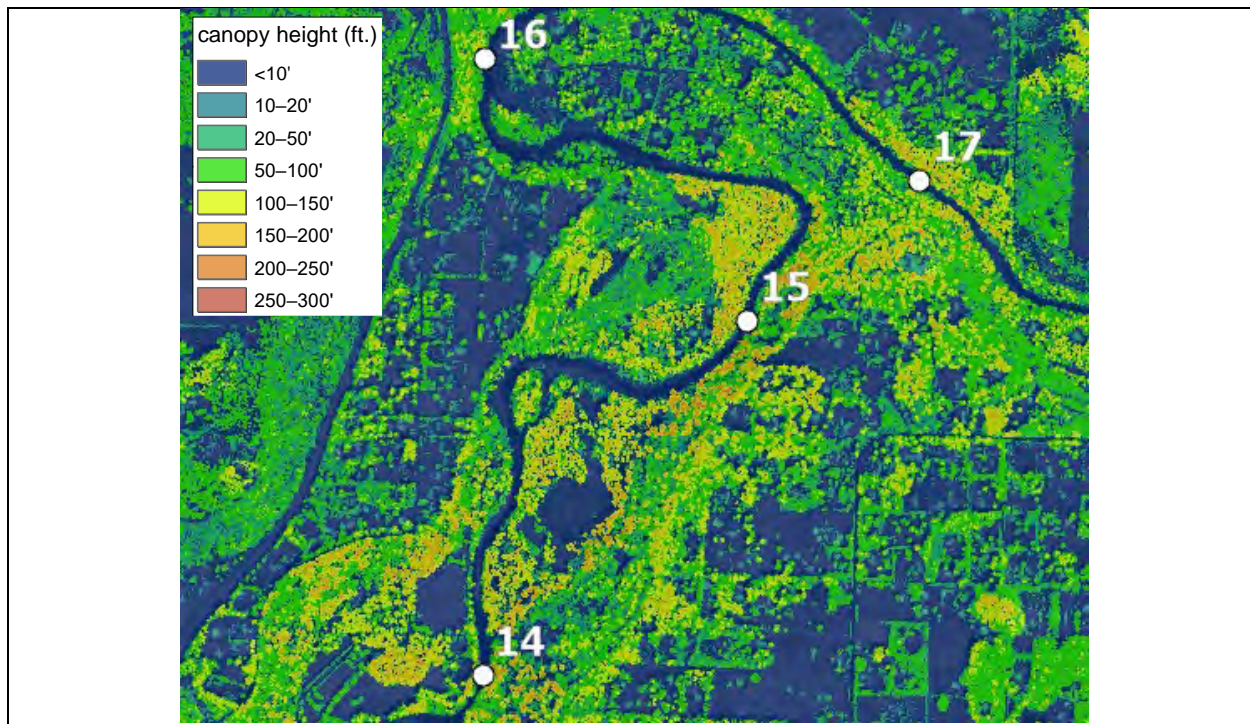
**Figure 22. Top: Longitudinal temperature plot for lower EFLR mainstem from RM 9.5–17.5 extracted from TIR imagery. Rates of temperature increase are shown for RM 16.5–14; and RM 13–10. Middle and bottom: Vegetation canopy heights derived from LiDAR data (USGS Cascades South 3DEP, 2019) for the RM 13–10 and RM 16.5–14 segments, respectively.**

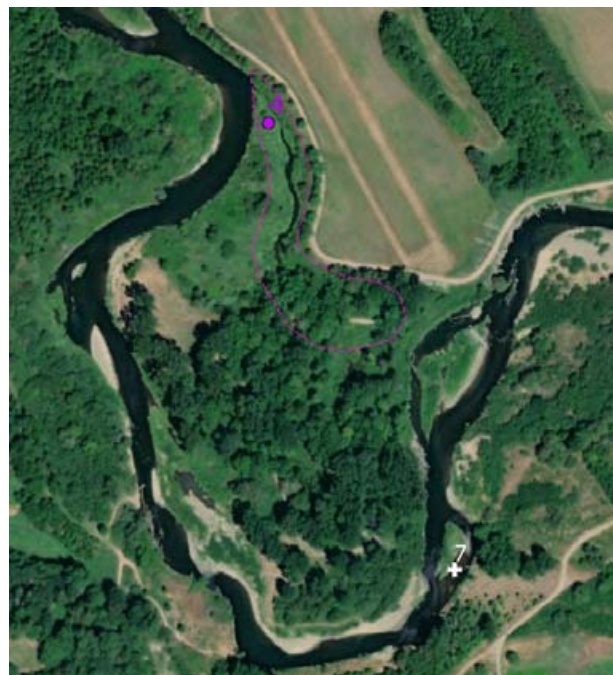
**Name/Location:** Off-channel RM 6.6 R bank

**Location Description:** Off-channel area along R bank, upstream of Mason Creek confluence. Privately owned. Within a WA DOE gaining reach. A chum channel restoration project was completed here previously by Friends of the East Fork.

**Site Description:** Off-channel location downstream of Dyer Creek. Identified as a potential project site in the EFL Habitat Restoration Plan (Site EF 38, HRP 2009)

**Site Thermal Conditions:** TIR imagery indicated cold water in the channel however this could be a false positive measurement (see discussion above in Section 4.1.1). On the ground measurements in summer of 2022 at location where feature enters the mainstem confluence were warmer than the mainstem at the time (22.5 versus 21.9 °C). Further up in channel was not measured.

**Project Objective:** Potentially improve downstream connection to mainstem to improve fish access during summer baseflow months (without compromising existing thermal conditions, if they are found to be favorable). Restore riparian bank vegetation along lower portion of the channel.

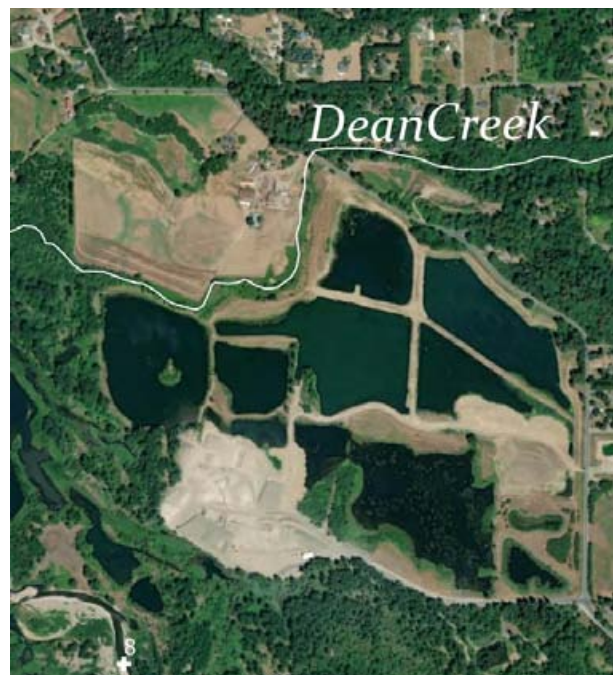
**Site Description:** In-active Daybreak gravel mining pit ponds which are no longer being mined.

**Site Thermal Conditions:** Monitoring results from the Storedahl Daybreak Mine Habitat Conservation Plan indicate that the deeper ponds (#5,3) are stratified during summer with cooler waters to 12 °C located at depth and warmer surface temperatures.

**Project Objective:** Enhance thermal conditions in the adjacent reach of Dean Creek through introduction of colder water from the Daybreak ponds. This could be accomplished by pumping.

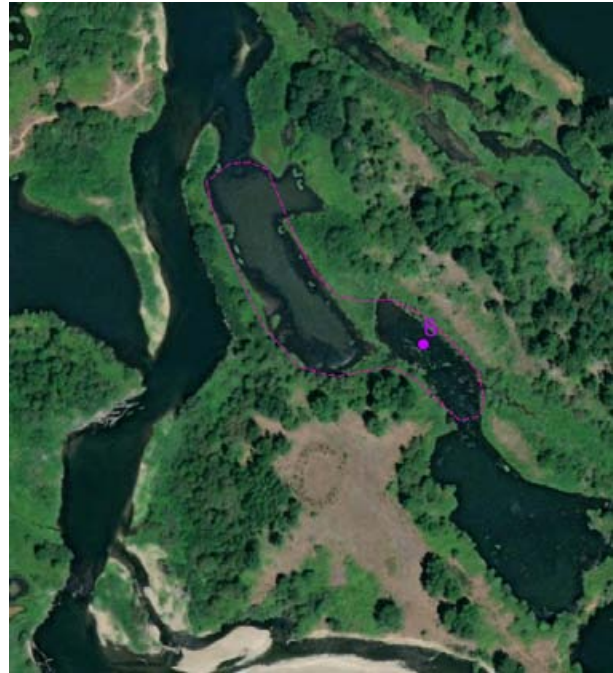
**Site Thermal Conditions:** Pond #7 is connected to the mainstem EFLR and is warm during summer. Pit #8 is disconnected from the mainstem during summer and remains cold from groundwater input.**Project Objective:** Increase flow from Pond #8 to Pond #7 through removal of beaver dam and re-grading. Add large wood to Pond #7 to enhance habitat and provide cover.**Special Considerations:** This site is located within the larger Ridgefield Pits Floodplain Restoration project area and thus will be included as part of that project's actions (see Ridgefield Pits Preliminary Design Report (LCEP 2021) for details). Stand-alone project objective identified above could be considered if the larger Ridgefield Pits Floodplain Project is not implemented.**Data Gaps/Needs:****Name/Location:** Off-channel RM 7.85 L bank**ID#:** 07**EF River Mile:** 7.85**EDT Reach Tier:** 1 (EF Lewis 6B)**Temperature Dependent Species Use:** Chinook (spawning, rearing); coho (spawning, rearing); steelhead (spawning, rearing) (HRP 2009).**Location Description:** Off-channel area in location of former Ridgefield gravel pit #2, where cold water was detected in TIR imagery and on the ground monitoring.**Site Description:** Cold water was detected here in TIR imagery and multiple summers of on the ground monitoring. The site has seen rapid change since the 1996 avulsion, through filling and channel migration. Private ownership.

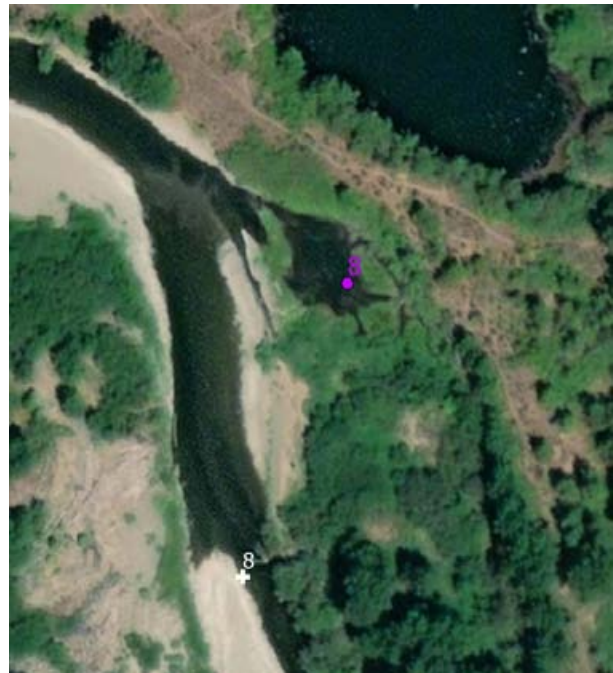
**Name/Location:** Off-channel RM 7.95 R bank

**Location Description:** Off-channel area in location of former Ridgefield gravel pit #1, where cold water was detected in TIR imagery and on the ground monitoring.

**Site Description:** Cold water was detected here in TIR imagery and multiple summers of on the ground monitoring. The site has seen rapid change since the 1996 avulsion, through filling and channel migration. Private ownership.

**Site Thermal Conditions:** Confirmed cold water. Little variation in diurnal temperature profile indicates likely groundwater presence.

**Project Objective:** As a stand-alone project this site would likely benefit from large wood placement and riparian revegetation.

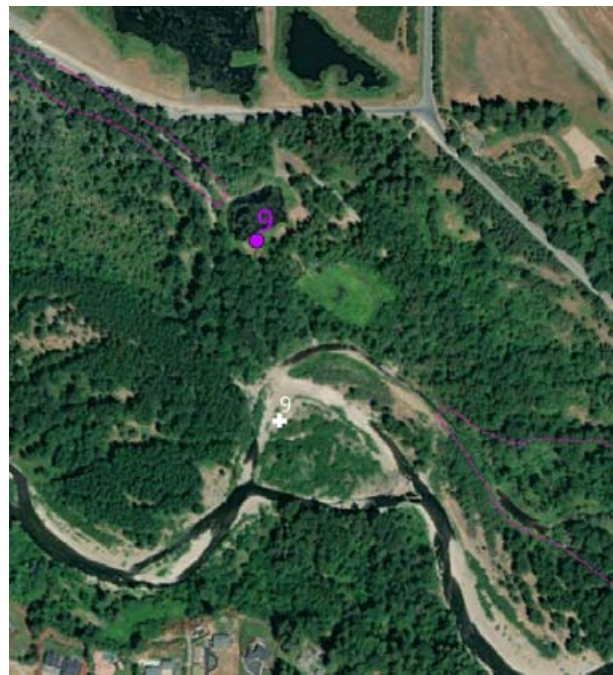
**Location Description:** Off-channel area north of EFLR mainstem adjacent to the Storedahl Daybreak mining operation.

**Site Description:** Ponded area, possible a former gravel mining pond remnant. Cold water was detected here while verifying TIR imagery with on the ground monitoring in 2022 (the site was not covered in the TIR survey, however). Poor current habitat quality with stagnant water and dense aquatic vegetation. Public ownership (Clark County).

**Site Thermal Conditions:** Cold water was detected here while verifying TIR imagery with on the ground monitoring in 2021 (the site was not covered in the TIR survey, however).

**Project Objective:** Connect to adjacent cold off-channel locations (potentially Sites #10 and/or #11) through grading to create a larger network of thermal refuge in this area. Additional enhancement through large wood placements.

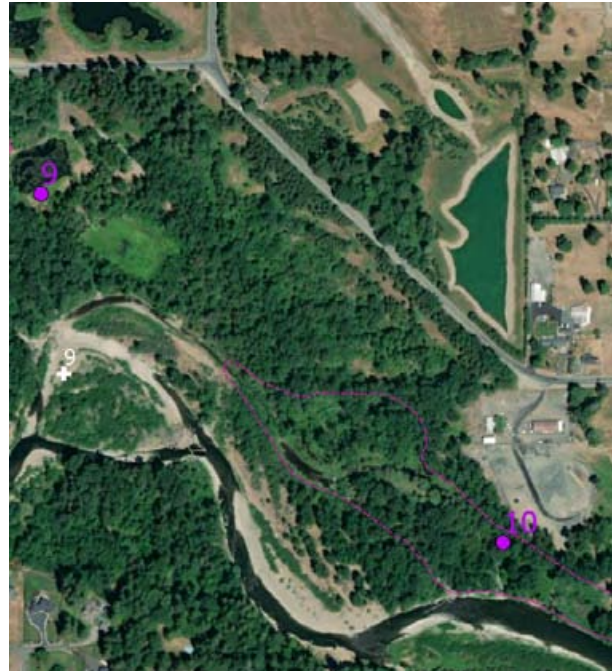
**Location Description:** Side-channel north of EFLR upstream of Daybreak mine operation.

**Site Description:** Relic channel location north of mainstem EFLR. Limited or no connection to mainstem during baseflow conditions. Unclear to what extent this channel receives groundwater, but it is heavily shaded so solar radiation is limited. Monitoring indicates surface water is maintained throughout the summer months. Habitat quality appears to be good. Public ownership (Clark County). Identified as a potential project site in the EFL Habitat Restoration Plan (Site EF 28, HRP 2009)

**Site Thermal Conditions:** Cold water was detected here while verifying TIR imagery with on the ground monitoring in 2021.

**Project Objective:** Enhancements could include large wood addition, grading, and beaver dam analogs. Apex log jams could be placed at the upstream connection to the mainstem EFLR to encourage scour and split flow into the side channel (at desired times).

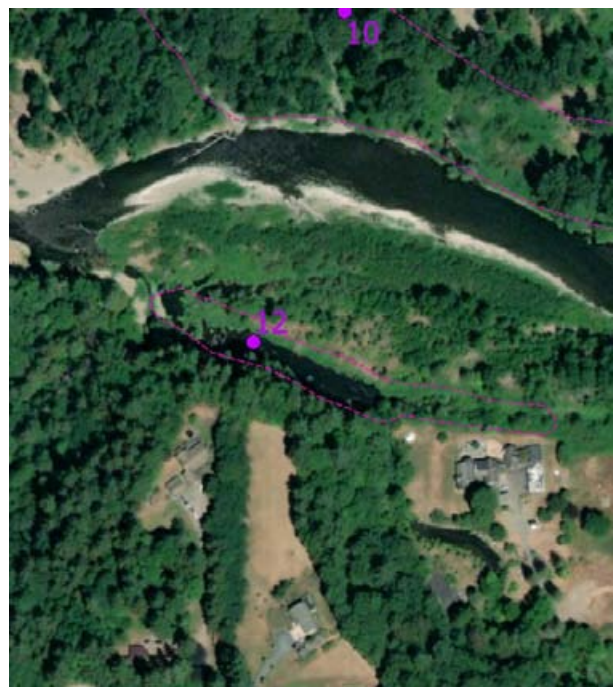
**Name/Location:** Off-channel RM 9.4 L bank. Mill/Manley confluence zone

**Location Description:** Confluence of Mill and Manley creeks with lower EFLR.

**Site Description:** Mill Creek flows directly to the lower EFLR, entering just downstream of a large partially vegetated gravel/cobble bar. Manley Creek enters a beaver dam complex with ponded off-channel areas that drain to Mill Creek just above the confluence with the mainstem. Both creeks, and the beaver dam complex, maintain cold water throughout the summer. Mill Creek is thought to be receiving large amounts of sediment due to WADOT roadwork upstream that has created stream diversions and rerouting. These impacts may degrade potential work done at this site. Private ownership in confluence

zone, some public land within the beaver dam complex. Identified as a potential project site in the EFL Habitat Restoration Plan (Site EF 27, 2009)

**Site Thermal Conditions:** Cold water was detected here in TIR imagery and in several on the ground monitoring studies. Known cold water source and juvenile rearing area.

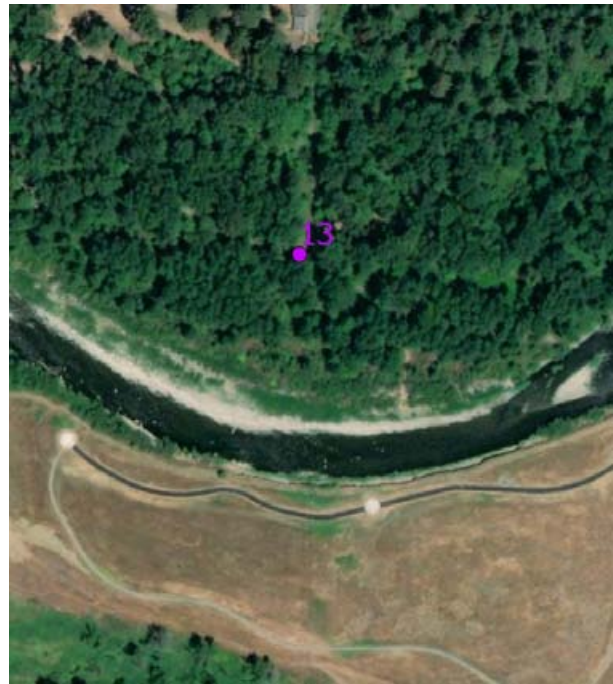
**Location Description:** River right across from West Daybreak floodplain area.

**Site Description:** Old channel locations, within 100' of existing mainstem channel Likely active at moderate winter flow levels but not active during summer baseflow conditions. This is an active channel adjustment, which needs to be considered during design. Identified as a potential project site in the EFL Habitat Restoration Plan (Site EF 25, 2009)

**Site Thermal Conditions:** Not studied. No water is typically present in summer.

**Project Objective:** Potentially create thermal refuge location by reactivating channel through grading and establishing groundwater/hyporheic connectivity.

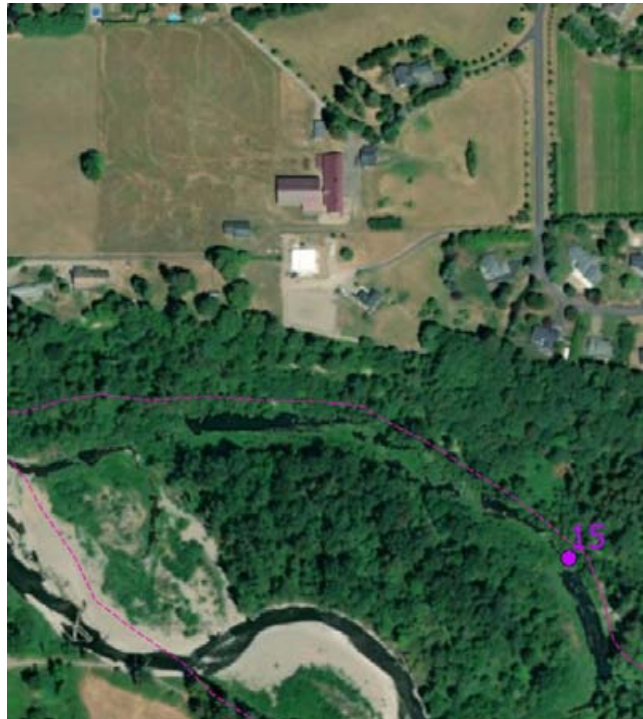
**Site Description:** Partially vegetated gravel and cobble bar with a small backwater area partially connected to the mainstem at the downstream end during base flow months. Frequency of upstream connection unknown. Public land owned by Clark County.

**Site Thermal Conditions:** TIR imagery indicated cold water presence here, which was verified with on the ground measurements. Extent of cold water was quite limited during field visit in summer 2021.

**Project Objective:** Enhance thermal refuge potential and access through grading, wood placement and riparian revegetation. Potentially add apex wood jams at upstream end to encourage split flow and increased inundation from the mainstem during high flow conditions, to promote scour and flushing.

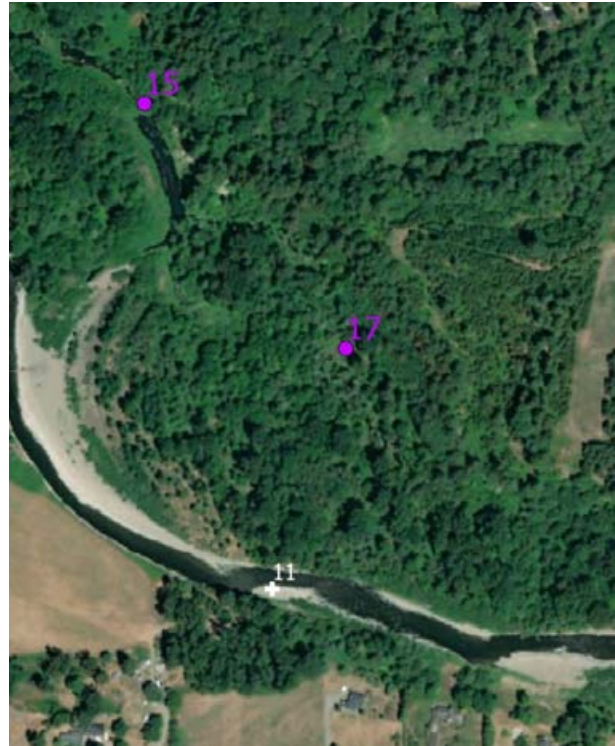
**Name/Location:** Off-channel RM 10.7 R bank

**Site Description:** This is an old meander scar/overflow channel, not connected at summer flow levels. There are good gravels and existing LWD present. Site temperatures suggest suitable groundwater connectivity. Identified as a potential project site in the EFL Habitat Restoration Plan (Site EF 22, HRP 2009) and a project was implemented by Clark County, who owns the property, in 2013-2015.

**Site Thermal Conditions:** TIR imagery was inconclusive, however prior studies supporting the EFL HRP indicated presence of cold water and potential groundwater connectivity. It was not visited as part of the present study.

**Project Objective:** Potentially create, or enhance existing, thermal refuge through grading to increase groundwater connectivity. Add large wood to further enhance rearing habitat. Any project actions should complement restoration work that has already been done at the site by Clark County.

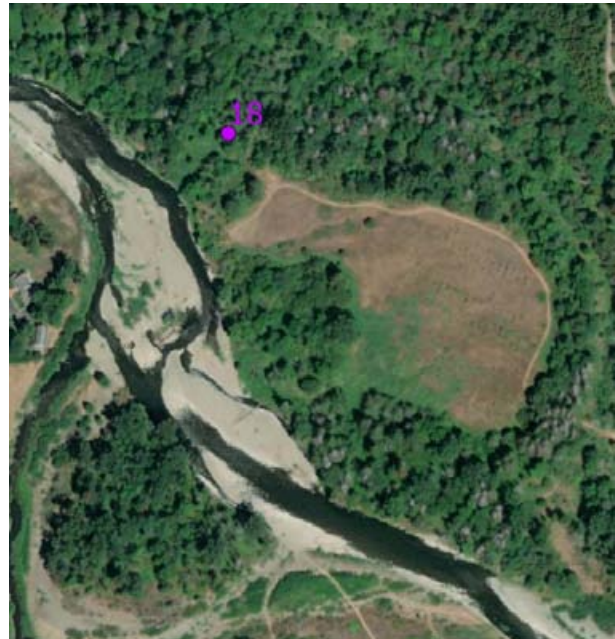
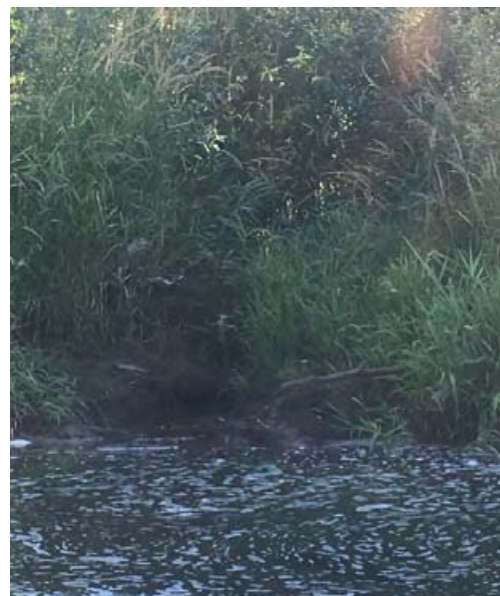
**Site Thermal Conditions:** TIR imagery was inconclusive, however on the ground monitoring in summer 2022 confirmed cold water presence in the restored side channel (temperatures ranging from 11.9 to 14 °C). Prior study supporting the EFL HRP also indicated presence of cold water and potential groundwater connectivity. It is unclear how the restoration project implemented by Clark County has impacted thermal conditions at the site since then.

**Project Objective:** Potentially create, or enhance existing, thermal refuge through grading to increase groundwater connectivity. Add large wood to further enhance rearing habitat. Improve connection to the mainstem at

downstream end of channel to improve fish access. Currently, the site drains through a small opening in a levee-like feature (shown in top photo, looking from mainstem). This must be done without compromising thermal characteristics of the site. Any project actions should complement the restoration work that has been done at the site by Clark County.

TIR imagery was inconclusive, however on the ground monitoring in summer 2022 confirmed cold water presence in the restored side channel (temperatures ranging from 11.9 to 14 °C). Prior study supporting the EFL HRP also indicated presence of cold water and potential groundwater connectivity. It is unclear how the restoration project implemented by Clark County has impacted thermal conditions at the site since then.

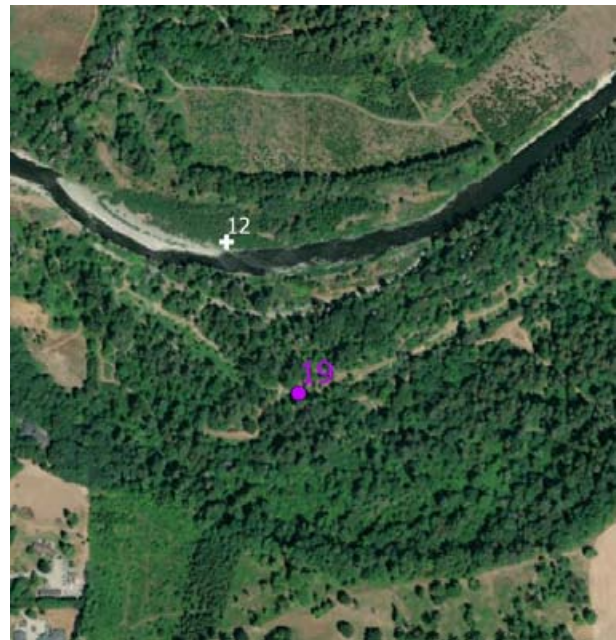
**Site Description:** Large network of abandoned meander scars. Small tributary with temperatures ~2° less than mainstem, according to the EFL Habitat Restoration Plan (Site EF 13, HRP 2009). The site was not visited during the present study. Private ownership.

**Site Thermal Conditions:** Unknown other than information provided in the EFL Habitat Restoration Plan. TIR imagery was inconclusive, and the site was not assessed on the ground in this study.

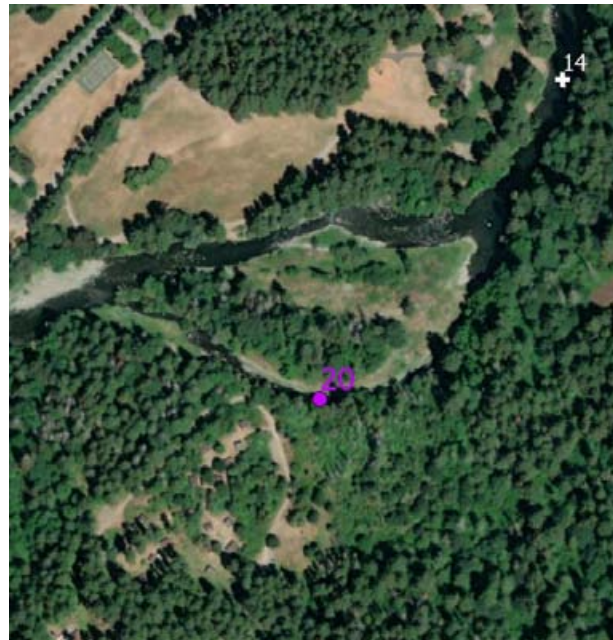
**Site Description:** Existing side channel, with lack of channel structure, complexity, and spawning size gravels. Identified as a potential project site in the EFL Habitat Restoration Plan (Site EF 07, HRP 2009). Public ownership (Clark County).

**Site Thermal Conditions:** TIR imagery indicated presence of cold water however ground assessments determined that these were false readings due to shadow and hillslope effects. Temperatures were found to be equivalent to the mainstem throughout the channel.

**Project Objective:** Utilize engineered streambed approach to create thermal refuge pockets by establishing hyporheic flow which re-expresses downstream as colder surface water. See Bakke et al (2020) for an example of successful implementation of this concept in an urban stream in Seattle. Potentially add spawning gravels and other habitat enhancements such as large wood placements.

TIR imagery indicated presence of cold water however ground assessments determined that these were false readings due to shadow and hillslope effects. Temperatures were found to be equivalent to the mainstem throughout the channel.

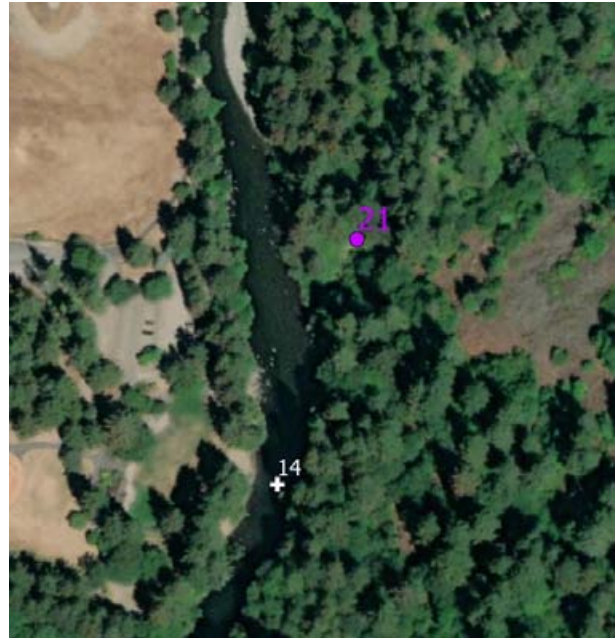
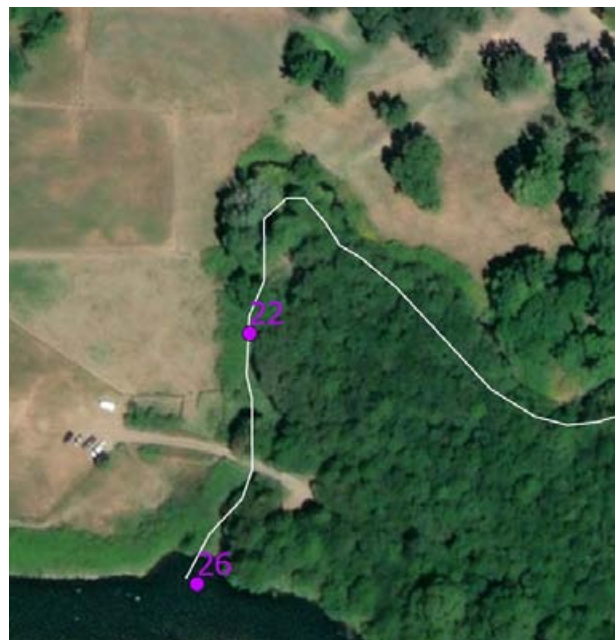
**Site Thermal Conditions:** Lockwood Creek is at least 2 degrees cooler than the mainstem where it enters the mainstem, creating potential thermal refuge habitat.

**Project Objective:** Riparian revegetation along the R bank to reduce solar heating during summer afternoons.

**Special Considerations:** Private ownership. Unclear if there is currently any shading provided by shrub canopy and steep banks along Lockwood Creek at confluence zone.

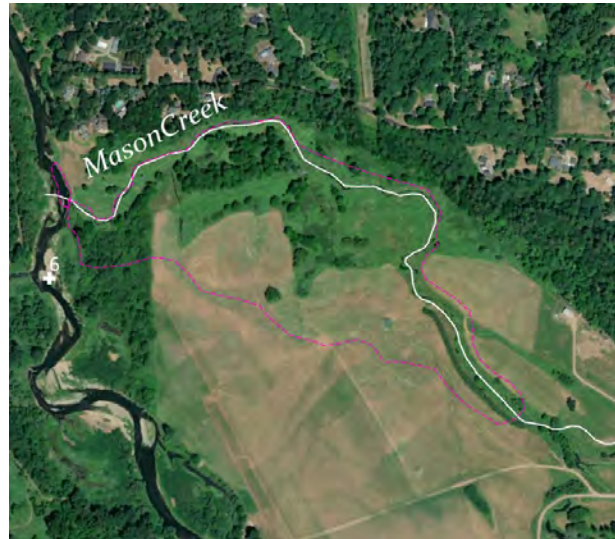
**Site Description:** The floodplain portion of Mason Creek has experienced channel simplification, incision, lack of wood cover and invasive vegetation growth over the last several decades, due to historical channel relocations, riparian clearing and agricultural use. The floodplain is a combination of private ownership and Clark County land.

**Site Thermal Conditions:** Mason Creek remains at least 3-4 °C cooler than the mainstem EFLR during the summer. This has been confirmed in this study as well as past monitoring efforts.

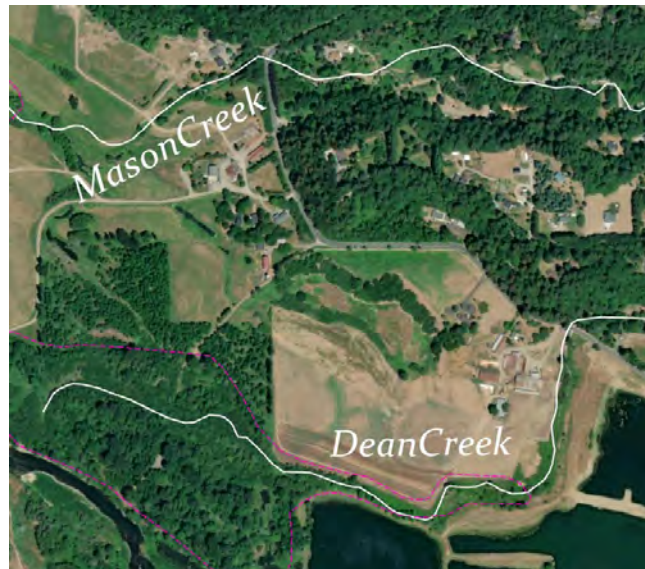
**Site Thermal Conditions:** Dean has little to no flow throughout much of the summer but is subject to high temperatures when flow is present during this period.

**Project Objective:** Enhance channel structure and habitat. Enhance the quantity and quality of habitat features including pools and riffles, bank complexity and cover, and instream wood placements. Increase availability of off-channel habitat that is connected to Dean Creek during summer flow levels. Look for opportunities to increase floodplain connectivity. Reforest riparian and floodplain areas with native and locally adapted species. Potentially re-route Dean Creek into Mason Creek through the Swanson Channel, a series of Beaver Ponds which are spring fed and thought to retain colder water during the summer months.

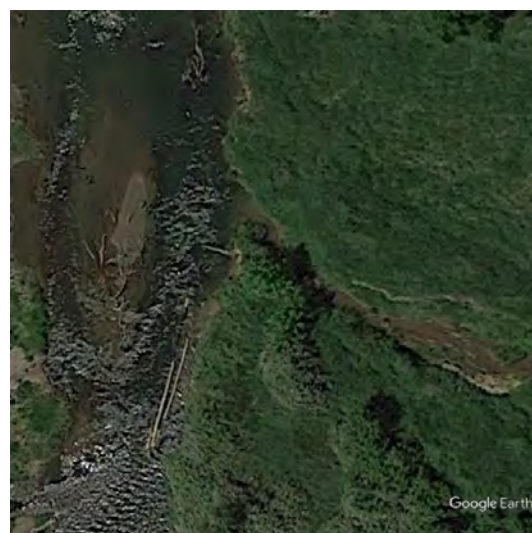
**Site Description:** The Mason Creek confluence with the lower EFLR has experienced channel simplification, incision, and lack of wood cover. Some wood is present in the mainstem

immediately upstream of the confluence, but this may not persist, and the confluence zone is devoid of cover. The R bank floodplain is privately owned, the L bank was recently purchased by Clark County.

**Site Thermal Conditions:** Mason Creek remains at least 3-4 °C cooler than the mainstem EFLR during the summer. This has been confirmed in this study and past monitoring efforts.

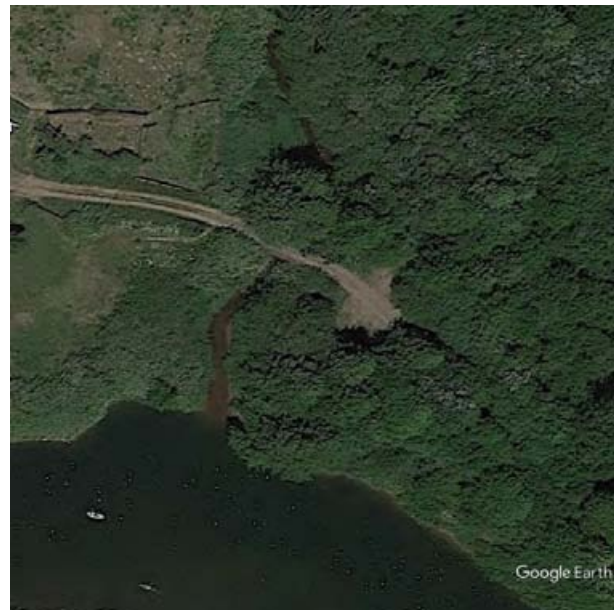
**Site Description:** The Lockwood Creek confluence with the lower EFLR has experienced channel simplification, incision, and lack of wood cover. The confluence zone is also devoid of cover. Both banks at the confluence zone are privately owned.

**Site Thermal Conditions:** Lockwood Creek remains at least 2 °C cooler than the mainstem EFLR during the summer at the confluence zone. This has been confirmed in this study and past monitoring efforts.

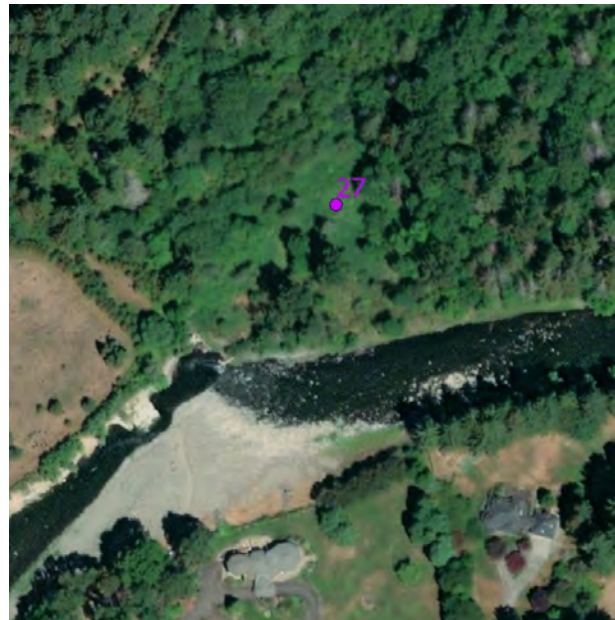
**Site Thermal Conditions:** TIR imagery did not indicate cold water here and no additional on the ground measurements were done for the present study. Monitoring completed for the EF HRP showed temperatures here being 5 °C warmer relative to the mainstem.

**Project Objective:** Potentially create thermal refuge through grading to increase groundwater connectivity. Add large wood to further enhance rearing habitat.

**Special Considerations:** Low gradient area with warm stagnant water may limit certainty of success. As a result, this project ranked low overall. Needs further assessment.

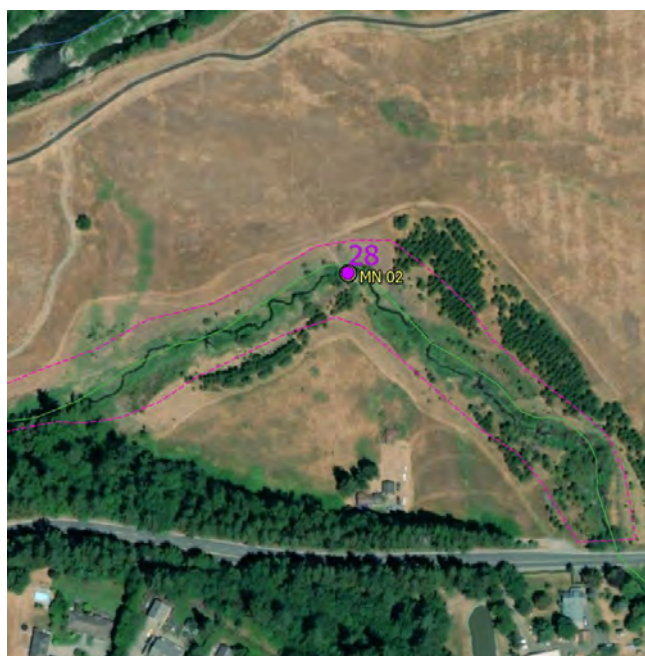
**Site Description:** This portion of Manley Creek has experienced channel simplification and incision, severe riparian degradation, channel relocations, reduced wood cover, and invasive species proliferation due to residential development, transportation infrastructure, agriculture, and upstream gravel mining. The property is owned by Columbia Land Trust,

with a memorandum of understanding that it will eventually be transferred to County ownership (HRP 2009).

**Site Thermal Conditions:** TIR imagery indicates presence of cold water. Although this was not verified on the ground during the study, monitoring results from further downstream in the beaver pond complex near the confluence with the EFRL, and other studies, suggest that lower Manley Creek remains cold enough throughout the summer to provide thermal refuge.

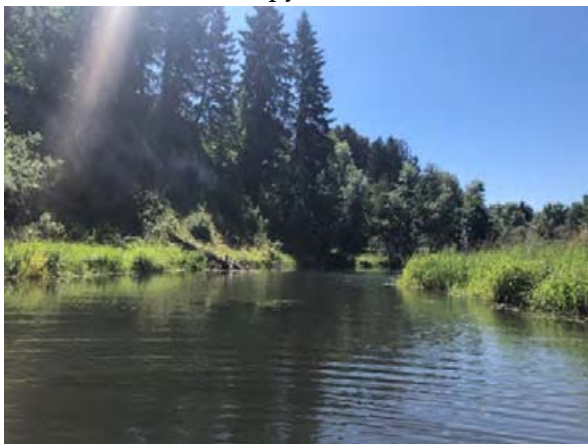
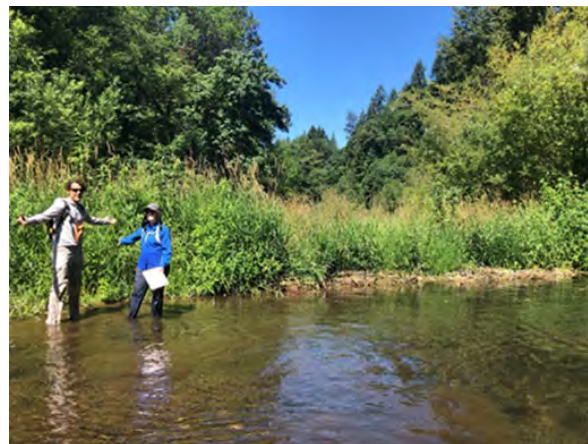
Large side-channel complex on river right just upstream of Daybreak Bridge and Daybreak Park. This was the former main channel location until the river began a gradual migration to a smaller side channel to the west roughly 20 years ago, which became the main channel approx. 10 years ago. The area is now a series of beaver dam complexes, fed by a small tributary (Charter Oak Creek). It is unclear to what extent this area receives inundation from the mainstem, but surface water appears to remain disconnected during summer months at the upstream end. A small downstream connection appears to be maintained at the outlet of the downstream pond. Property ownership extent within the wetted area is unclear. The adjacent hillside to the east is privately owned, while the wooded floodplain area to the west is owned by Clark County. Riparian cover over the wetted area is poor, with little mature canopy cover.

Confirmed cold-water throughout the site in both TIR imagery and in-stream measurements. A temperature logger was installed but was lost so an extended temperature record is not available. However, temperatures throughout the ponded areas ranged from 14–17 °C on afternoons when in-stream measurements occurred. Surface temperatures measured with TIR imagery generally ranged from approximately 16–19 °C. All these values are at least 2 °C less than EFLR mainstem temperatures that exceeded 21 °C during those times. We estimated a total of approximately 1.2 acres of wetted area that may currently be suitable as thermal refuge for this site.

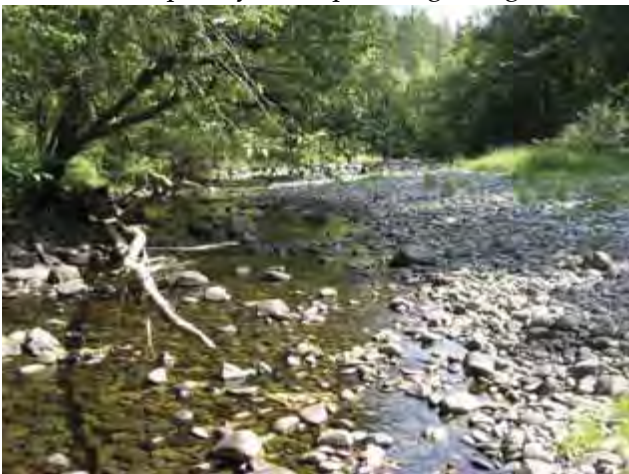
Large side-channel on river left across from Lewisville Park. The site was also identified in the HRP as a possible habitat project (Site EF07 in East Fork Lewis River Habitat Restoration Plan) and was ranked in the mid-to-high range (final benefit score of 109, versus scores of 140 and 83 for the highest and lowest ranked projects respectively) in that plan. The site currently lacks channel structure, complexity, and spawning size gravels. The site is owned by Clark County.

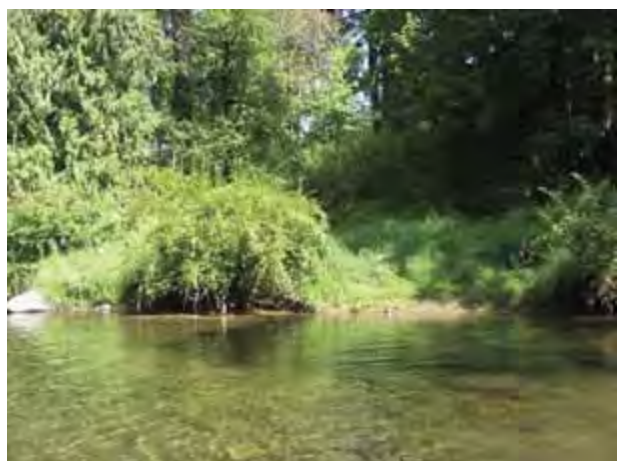
The site is located on Boy Scouts of America property. There is a small tributary that enters the mainstem here which contains cold-water during the summer. Good adjacent mainstem spawning habitat. The site was also identified in the HRP as a possible habitat project (Site EF05 in East Fork Lewis River Habitat Restoration Plan) and was ranked in the low-to-mid range (final benefit score of 96, versus scores of 140 and 83 for the highest and lowest ranked projects respectively) in that plan. Despite the relatively low score it was selected for a preliminary concept design in that plan, possibly due to the thermal refuge opportunity it may offer.

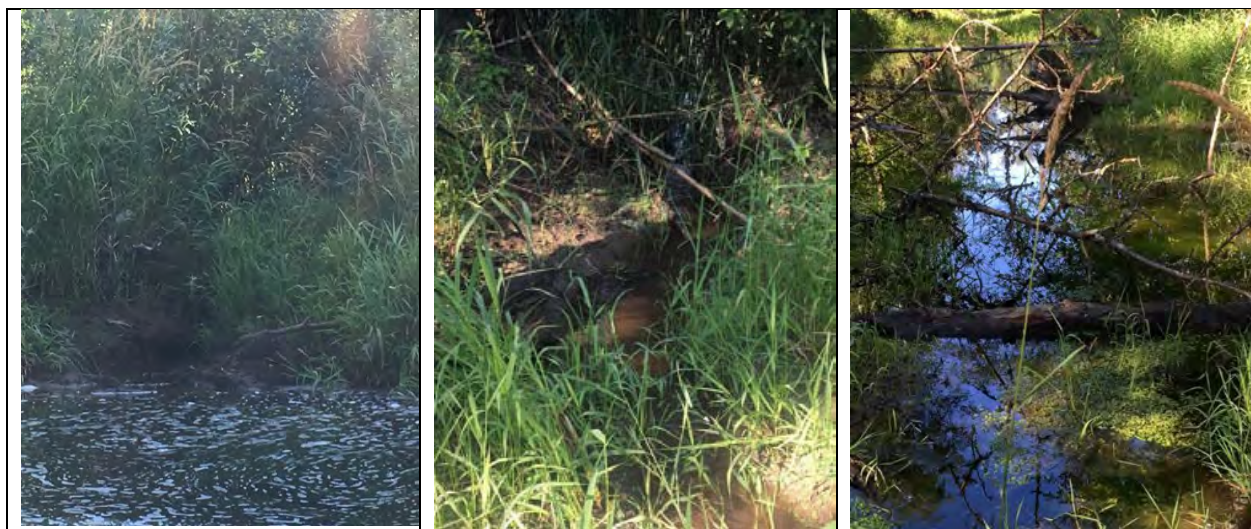
This is an old meander scar/overflow channel. The site was identified as a potential project site in the EFL Habitat Restoration Plan (Site EF 22, HRP 2009) and a project was implemented by Clark County, who owns the property, in approximately 2015 (SalmonPort Proj ID 11-1313). That project added large wood in the off-channel area. The site has a small connection to the mainstem at the downstream end through a small opening in a levee-like feature (shown in left photo below viewed from mainstem looking into site, and middle photo below viewed from inside site looking towards mainstem). It is unclear if this connection is maintained for the duration of the summer.
