# Lower East Fork Lewis River Thermal Assessment

Findings and Initial Thermal Refuge Project  
Concepts for the Lower East Fork Lewis River  
(RM 4 – 21)

June 2022

Lower Columbia Estuary Partnership

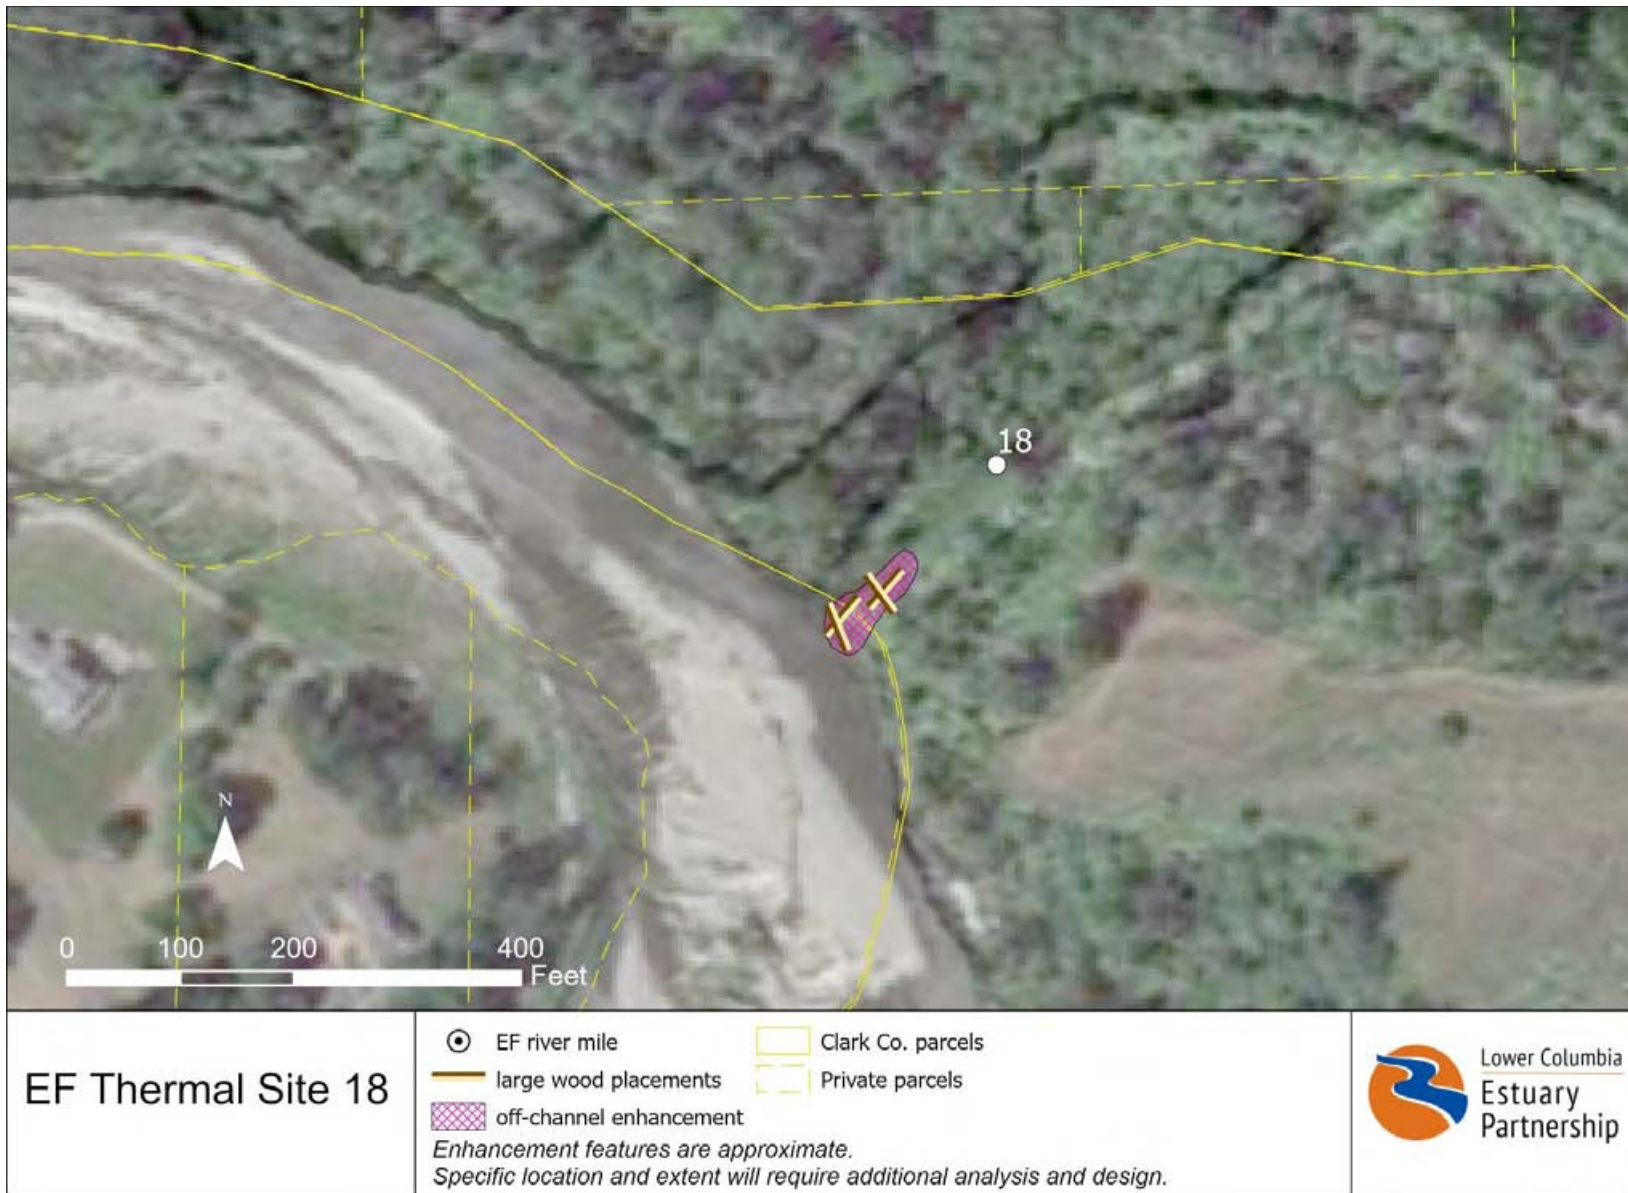
Figure A4. Preliminary concept design for lower EFLR thermal refuge project site #18.

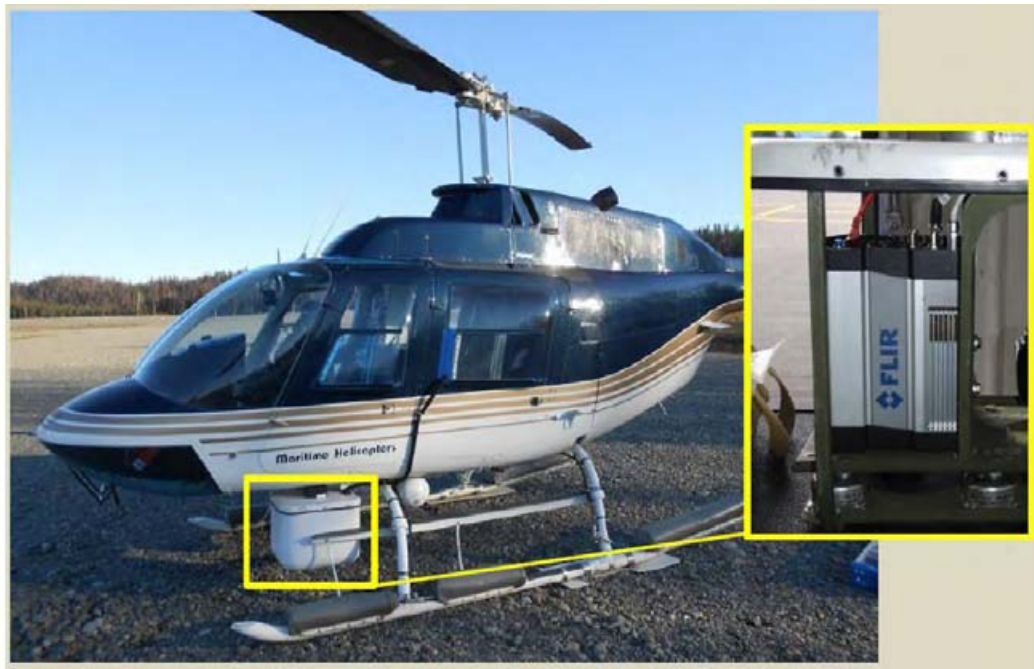
Thermal infrared images were collected using a FLIR SC6000 sensor (8 – 9.2  $\mu\text{m}$ ) mounted to Bell 206 Long Ranger helicopter (tail number N801CL). The sensor was installed in an enclosed fiberglass capsule mounted at the bottom of the helicopter with a designated opening for the down facing lens (Figure 1). The FLIR SC6000 sensor uses a focal plane array of detectors to sample incoming radiation based on the technology of Quantum Well Infrared Photodetector (QWIP). The sensor's array records the change of state of electrons in a crystal structure reacting to incident photons. This technology is faster and more sensitive than polymer thermal detectors. A cooling mechanism is required for this sensor to stabilize its internal temperature and minimize thermal drift during acquisition. To resolve the challenge in achieving uniformity across the detector array, a factory scheme is generated to reduce non-uniformity across the image frame; nevertheless, differences in temperature (typically  $<0.5^\circ\text{C}$ ) might be observed near the edge of the image frame. Flight planning ensures sufficient image overlap so that frame edges can be excluded from the river channel in the TIR image mosaics. The resulting thermal infrared image frames were recorded directly from the sensor to an on-board computer as raw counts which were then converted to radiant temperatures. Sensor and acquisition specifications for the East Fork Lewis River TIR study are listed in Table 3.

**Figure 1: Sensor and aircraft setup (similar to the setup used for the project)**

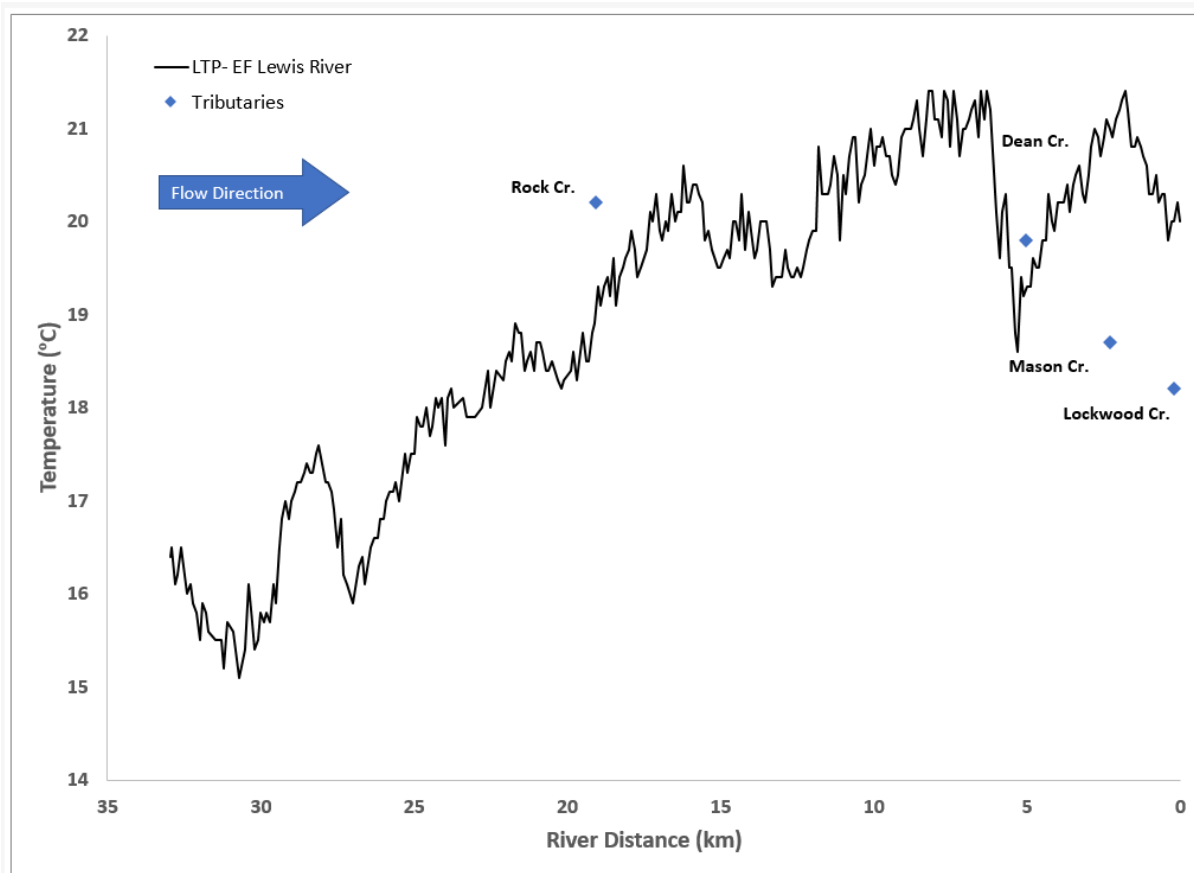
**Figure 10: Longitudinal temperature profile (LTP) and inflow points from tributaries plotted against river length along the EF Lewis River. Both datasets represent mean sampled stream temperatures.**

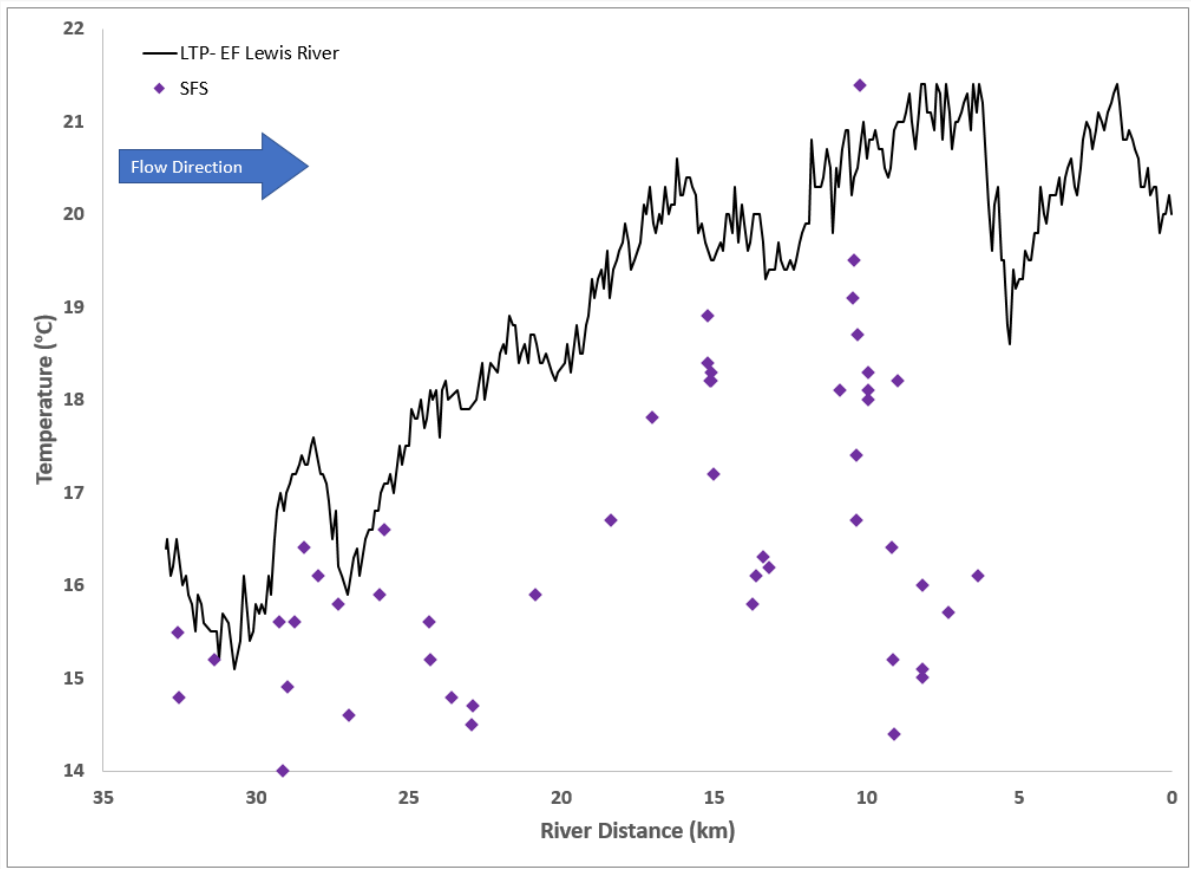
**Figure 11: Longitudinal temperature profile (LTP) and significant feature sites (SFS) plotted against river length along the EF Lewis River. both datasets represent the mean sampled water temperature.**
