Tracking Soil Dynamics to Understand Plant Community Development in Restored Tidal Wetlands

May 13, 2025 Columbia River Estuary Conference

AUTHORS: DEREK MARQUIS, IAN EDGAR, SNEHA RAO MANOHAR, SARAH KIDD

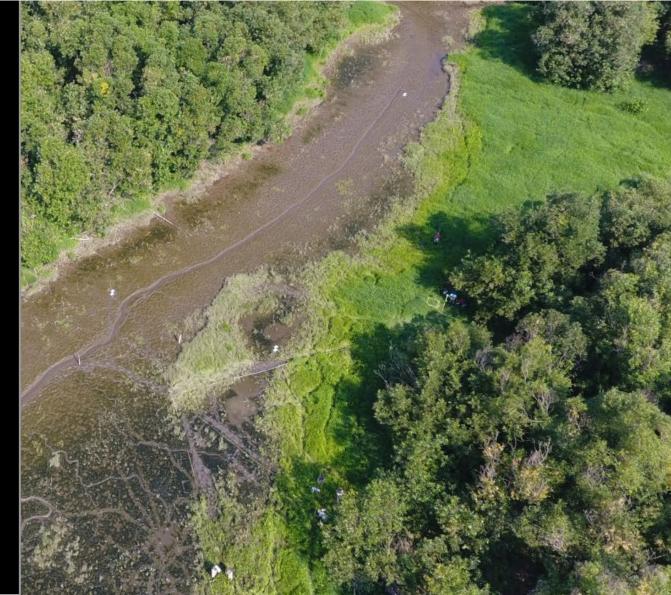
MCNA South Unit

#### Vegetation Model: July 2018

Classifications	Acres	% Cover
Open Water	5.6	4%
Emergent Wapato, Aquatic Mix	16.6	11%
High Marsh Mix Rushes, Sedges, Reed Canarygrass	13.9	10%
Reed Canarygrass	63.4	44%
Riparian Forest/ Shrub Scrub	45.1	31%

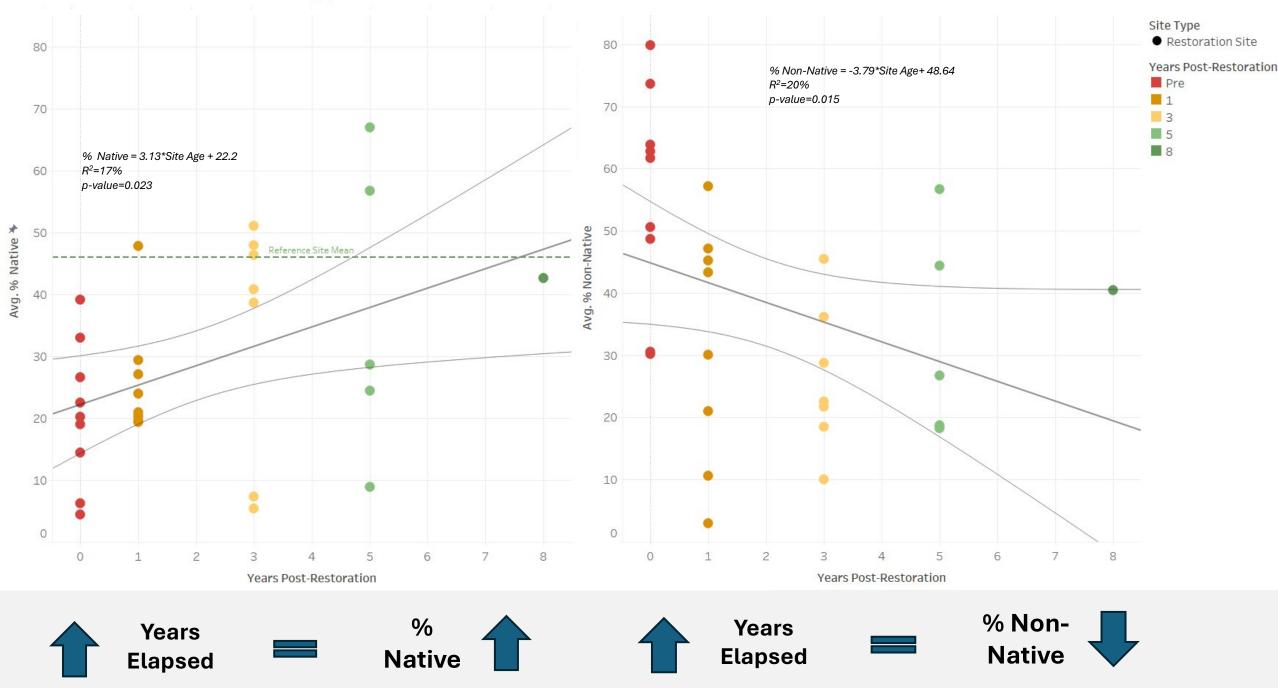
Total Native and Non-native Relative Cover (%) vs Years Post-Restoration

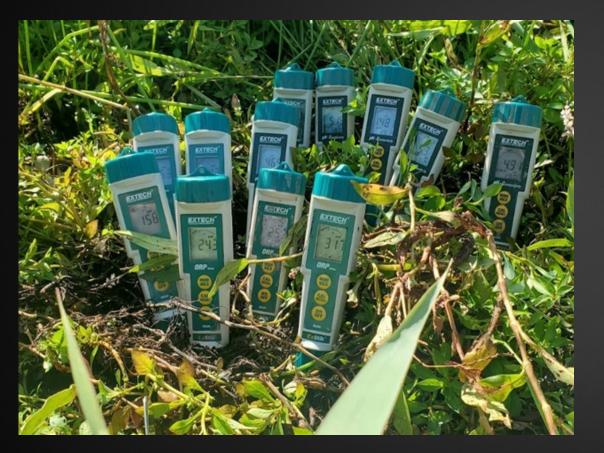
# Why monitor soil?

- Pre-restoration sites = typically have welldrained soils with high oxygen concentrations
- Wetland restoration often including reintroducing or shifting flooding regimes
- This causes a cascade of biogeochemical and microbial reactions in the soil, ultimately driving plant community development

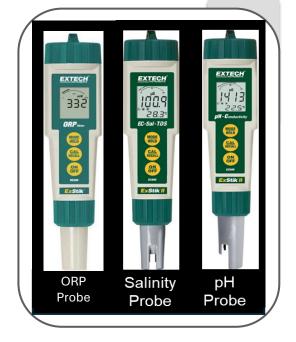
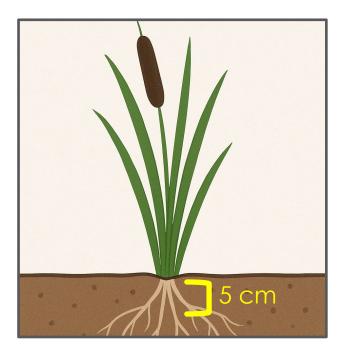
Materials: ExTech soil probes

Method: Probes are inserted ~5cm deep into the soil. Measurements are taken within vegetation quadrat.

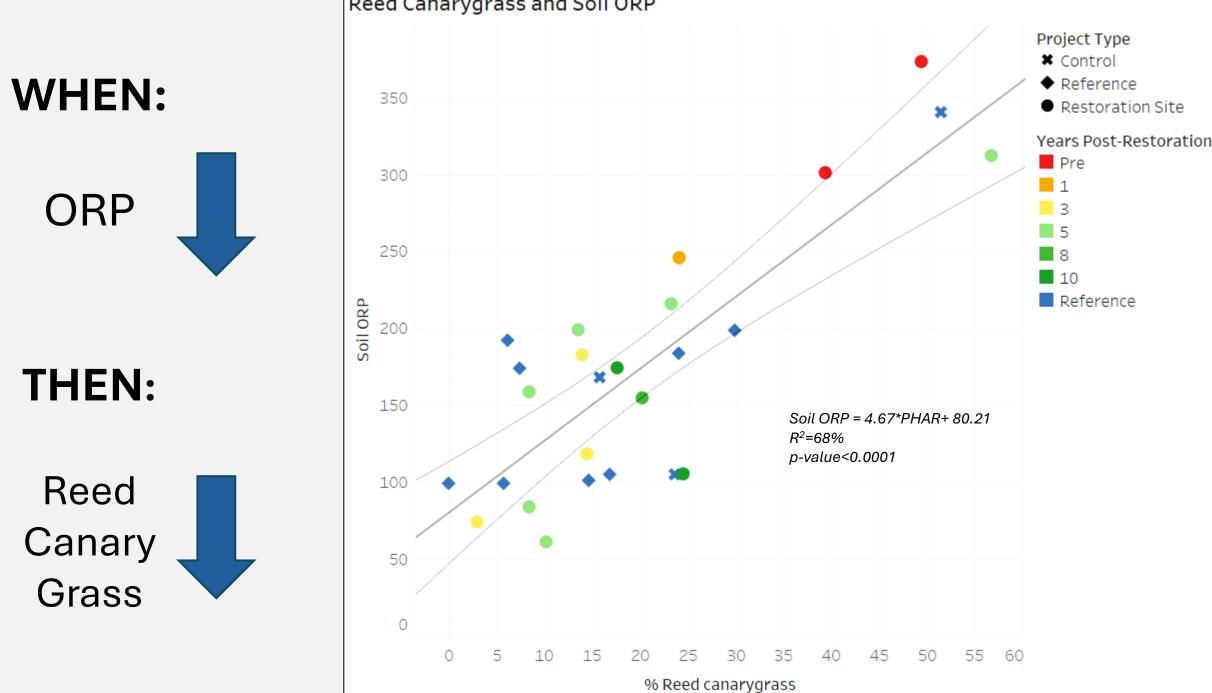
Soil ORP vs Years Post-Restoration

- With the reintroduction/shifting of flooding regimes:
  - ORP decreases
  - ▶ pH increases
  - Salinity increases
- The shift of these parameters correlates with a reduction of Reed Canarygrass and other non-native species
- Further understanding soil dynamics and the impact on microbial communities and nutrient cycling postrestoration can offer insight into plant community development and adaptive management postrestoration

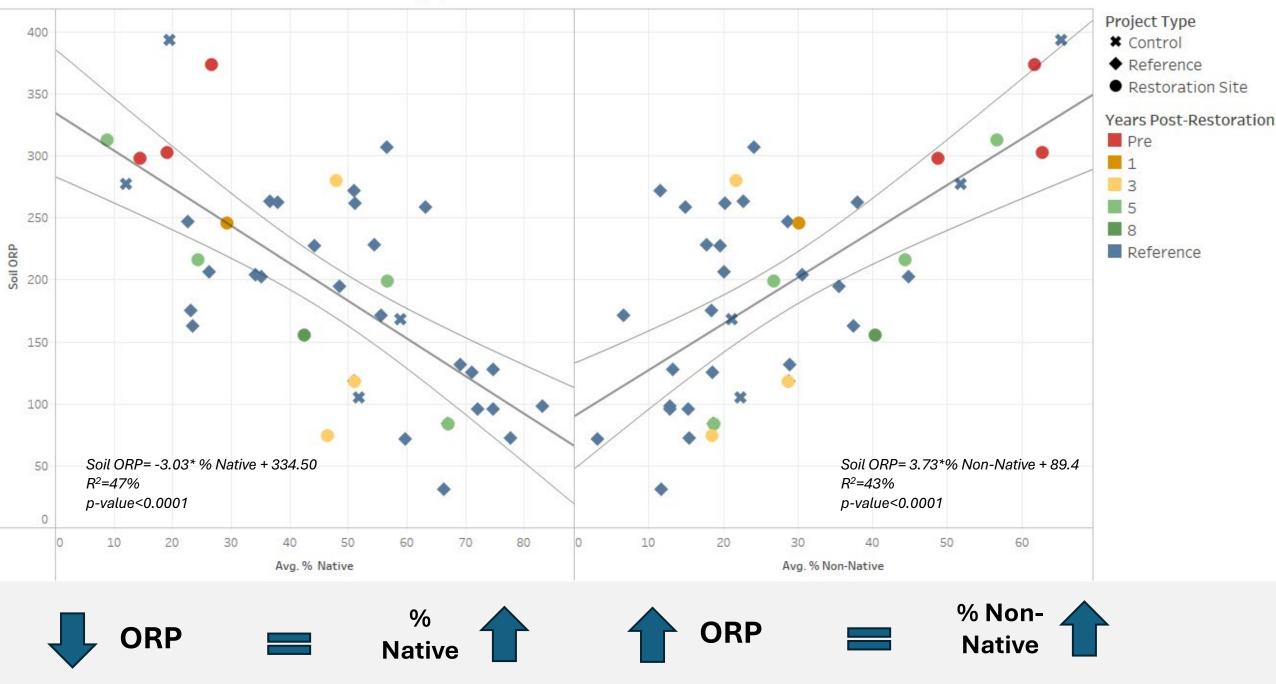
Reed Canarygrass and Soil ORP

#### Total Native and Non-native Relative Cover (%) vs Soil ORP

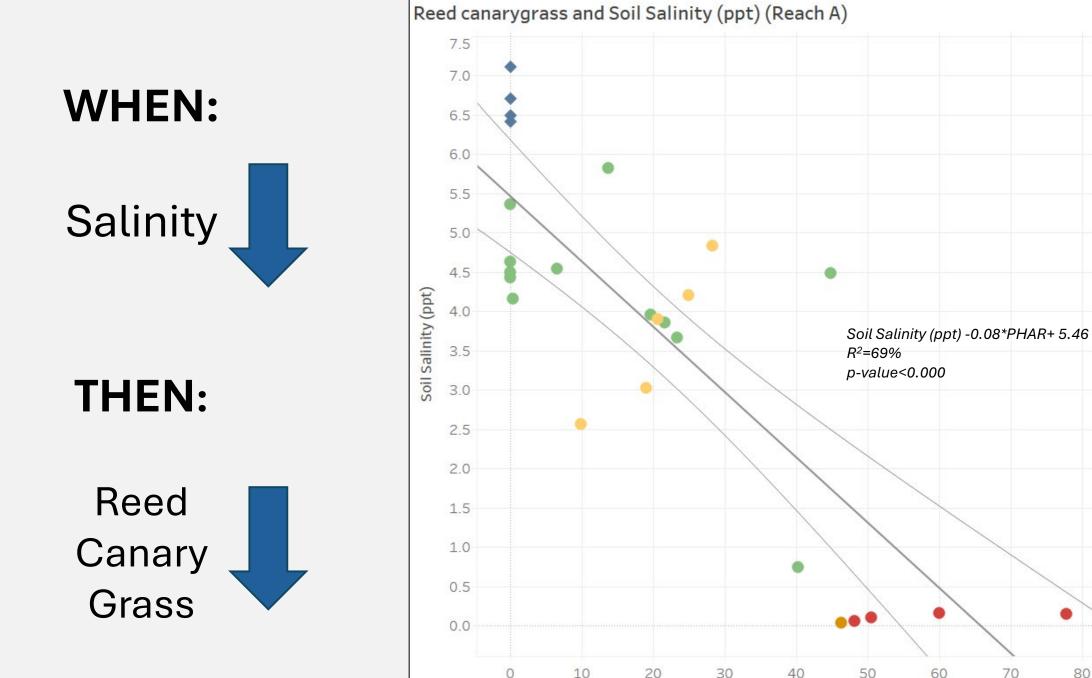
Reed canarygrass and Soil Salinity (ppt) (Reach A)
