**Action Effectiveness Monitoring in the
“Implement Habitat Restoration in the Lower Columbia River and Estuary” Contract**

Annual Report

BPA Project Number: 2003-011-00

August 2010

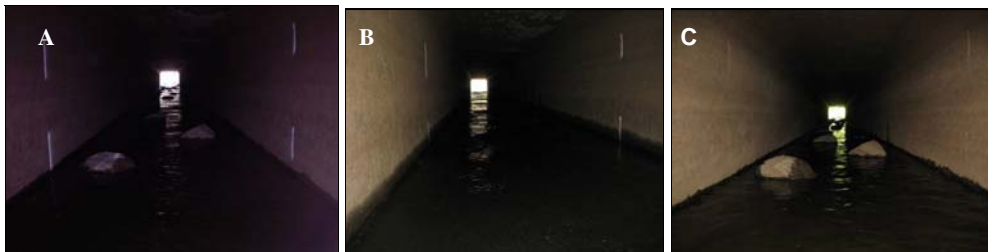
During all three events, the field staff noted that the force of the flowing water was lower behind the boulders than in the unobstructed flow area. These observations were qualitative and provide no quantitative scale of the difference in velocities.

Figure 2-1. Photos of boulder monitoring locations at the west culvert, Mirror Lake. A) View facing upstream in west culvert, November 2008; B) View facing upstream in west culvert, March 2009; and C) View facing upstream in west culvert, July 2009.

Based on the monitoring results, all of the boulders in the culverts and at the outlet appear to be stable and providing hydraulic refugia for fish passage. Furthermore, regrading at the outlet of the west culvert appears to be stable and maintaining an adequate depth of flow during the lower flows observed in July 2009.

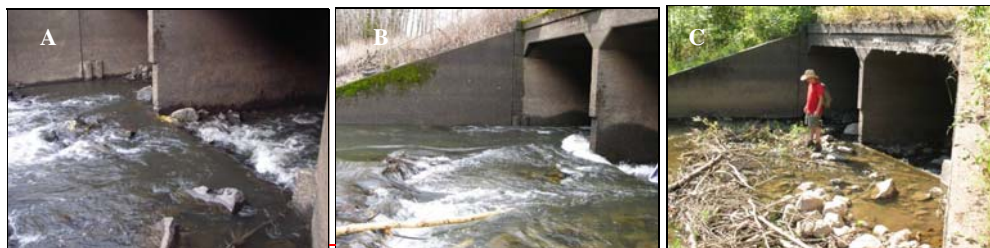
Based on the observations taken during baseline and season monitoring visits, the low flow diversion structure did appear to be diverting a greater portion of the flow to the west culvert. Figure- 2-3 shows the diversion structure during each monitoring event. It is estimated that approximately 60 to 90 percent of flow was being diverted to the west culvert on any given site visit, depending on the overall flow present. Timing of the monitoring events, however, likely did not coincide with the lowest flows of the year; however, observations of flow during the July 2009 site visit estimated that at least 90 percent of flow was diverting to the west culvert. Visual observations of the water level at the outlets of each culvert showed a difference of about 3 to 5 inches, with the west culvert having the higher water level. During all monitoring site visits, at least 6-inches depth of flow was present in the west culvert.

Figure 2-3. Photos of the low flow diversion structure monitoring, Mirror Lake. A) Diversion structure, November 2008; B) Diversion structure, March 2009; and C) Diversion structure, July 2009.

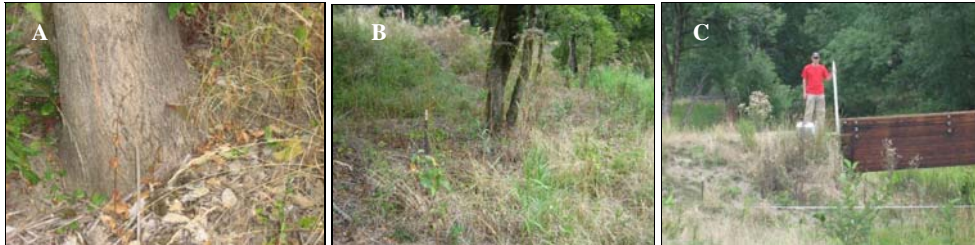
set of cross sections were monumented during the November 2008 sampling event, as well. Figures 2-4 shows the locations of the benchmarks.

Figure 2-4. Photos of LWD monitoring. A) Nail set into tree base as benchmark for cross sections 1–5. Tree located on right bank to east of cross section 1. Reference elevation of 30 ft; B) Nail set into tree base as benchmark for cross sections 6–10. Tree located on right bank adjacent to cross section 6. Reference elevation of 25 ft; and C) Benchmark for cross sections 11–20 is in northwest corner of retaining wall on Young Creek Bridge. Reference elevation of 20 ft.

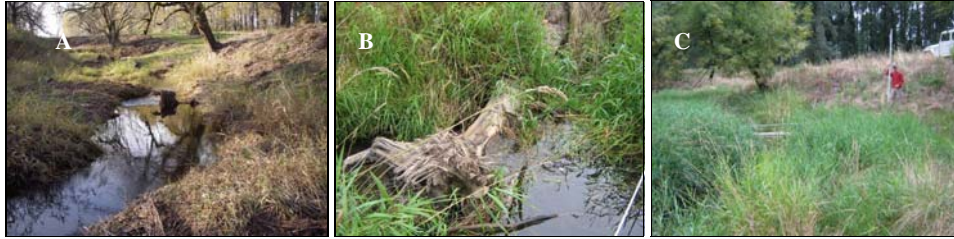
- Cross section 3 (see Figure 2-5; Appendix 1) showed significant differences between the two monitoring events. This cross section is located directly downstream of LWD. A beaver dam appears to have been constructed on the LWD, creating pooling upstream (see Figure 2-5 B). Flow bypassed the sides of the beaver dam and scoured both banks, creating slope failures and widening the downstream active channel. The right bank rebar stake was undercut over the course of the winter and spring of 2008- 2009. During the August 2009 site visit, this was replaced with a tee post as close to the position of the original rebar stake as possible. While more bank failures are probable, the LWD does not appear to have moved and is likely anchored sufficiently into the adjacent slope to prevent future movement.

- Cross section 4, located about 7 feet downstream of cross section 3, also showed signs of bank failure, with a large portion of the left bank having recently sloughed into the channel.

- Cross section 5, taken about 12 feet downstream of cross section 3, showed signs of the left and right banks being undercut.

6Figure 2-5. LWD monitoring at Mirror Lake. A) View of cross sections 1–5 facing downstream, November 2008; B) LWD at cross section 3 showing beaver dam activity, August 2008; and C) View of cross sections 1–5 facing downstream, August 2009.

Results from the cross sectional survey of LWD in Young Creek suggest that the structures are serving their intended purpose. Lateral scour pools appear to be forming under and directly downstream of all structures surveyed, suggesting that habitat diversity is being created by their addition. Furthermore, some of the structures (most notably the LWD adjacent to cross section 3) are providing for recruitment of some small woody debris. There were no off-channel pools observed likely because the incision of the stream and the density of streamside vegetation. In the long term, hydraulic forces may begin to create these features, but further monitoring would be required to confirm this. Because the Mirror Lake site is routinely flooded during the winter months (submerging the LWD) and no movement of LWD has been observed to date, it is expected that the LWD will remain in place.

All LWD was installed on the right bank of Young Creek due to constraints related to equipment access to the other side of the creek. Some of the cross sections showed signs of scour occurring on the bank opposite the LWD installation. While this will likely create more meandering of the stream, this also suggests that the long-term stream geomorphology may cause the channel to realign around the LWD, making them ineffective. It is suggested that future installations of LWD be done in a staggered pattern on either side of the creek to minimize the chances of stream realignment around the structures.

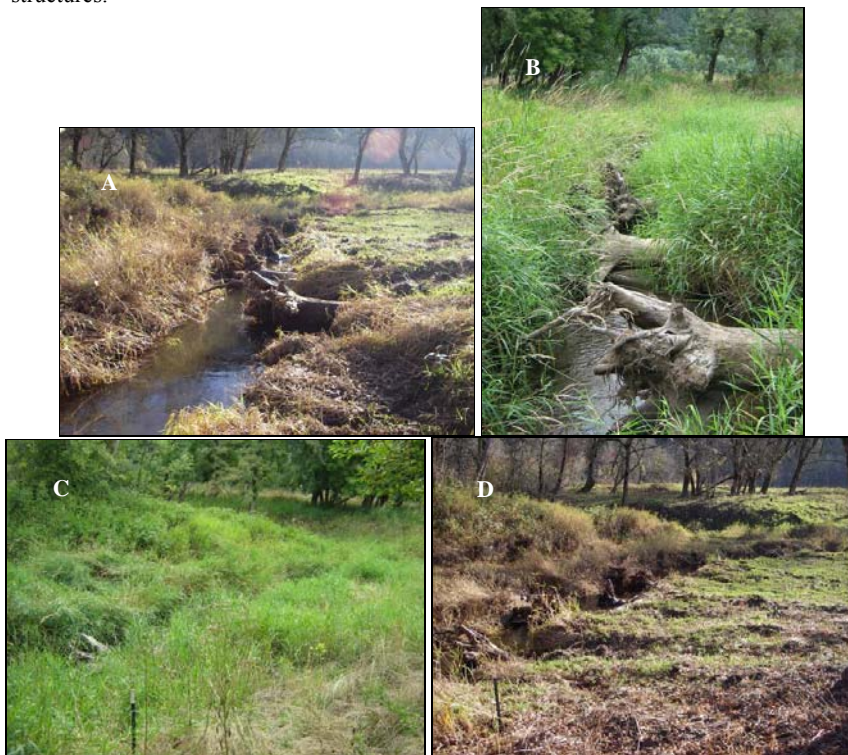
- Cross section 6 (see Figure 2-6) was taken about 20 feet upstream of the first piece of LWD and showed very little change between monitoring events.
- Cross sections 7–10 (see Figure 2-6) were all taken directly downstream of individual LWD and showed similar patterns of the channel becoming wider and deeper in the vicinity of the LWD structures.

7Figure 2-6. LWD monitoring at Mirror Lake. A) View of cross sections 6–10 facing downstream from cross section 1, November 2008; B) View of cross sections 6–10 facing downstream from cross section 1, August 2009; C) View of cross sections 6–10 from the benchmark, November 2008; and D) View of cross sections 6–10 from the benchmark, August 2009.

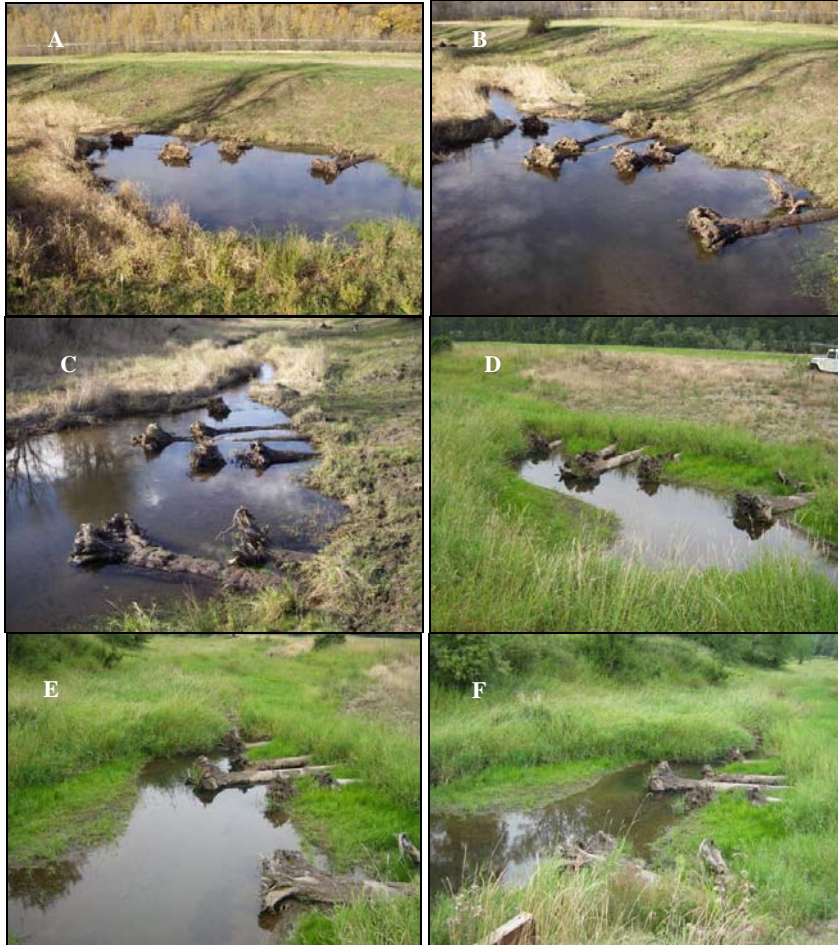
Figure 2-7. LWD monitoring at Mirror Lake. A) View of cross sections 11-15 from south side of bridge, November 2008; B) View of cross sections 11-15 from center of bridge, November 2008; C) View of cross sections 11-15 from north side of bridge, November 2008; D) View of cross sections 11-15 from the south side of the bridge, August 2009; E) View of cross sections 11-15 from center of bridge, August 2009; and F) View of cross sections 11-15 from north side of bridge, August 2009.

Differences observed in the cross sections outside the active channel were minimal, with the exception of cross sections 13 and 14. Data collected for these two cross sections was reviewed to determine if data entry errors had occurred. Since no errors were found for the data entry review, deviations in the right bank readings from the two cross sections suggest that errors were made in field measurement and recording during one of the sampling events. Future monitoring at these locations will attempt to address these discrepancies and determine a reason for the differences observed.

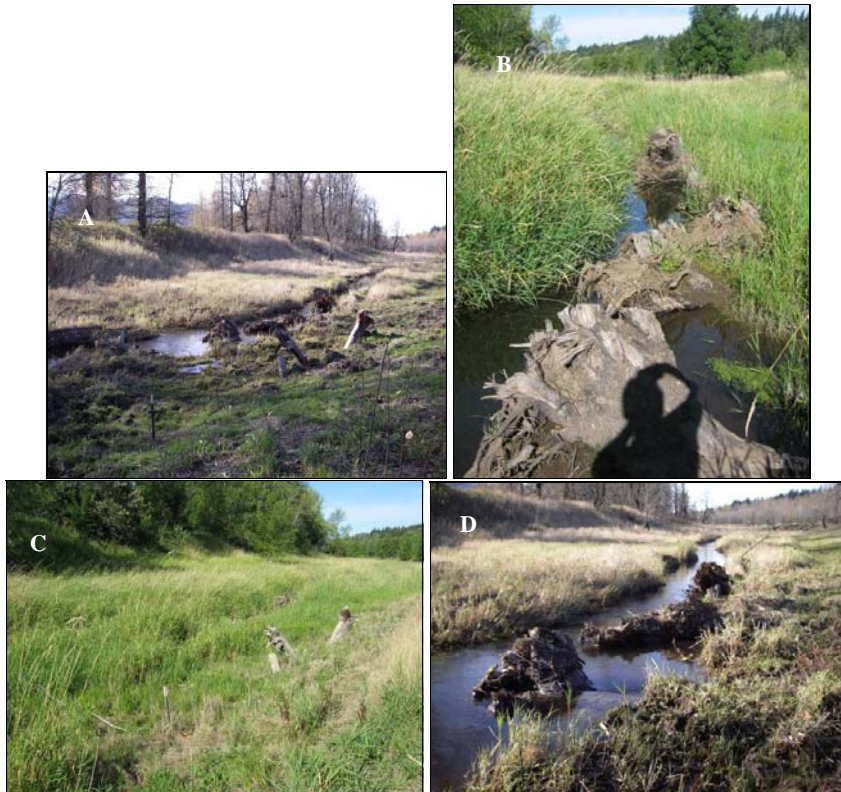
Figure 2-8. LWD monitoring at Mirror Lake. A) View of cross sections 16-20 from top of slope on north side of creek, November 2008; B) View of cross sections 16-20 facing downstream from cross section 16, August 2009; C) View of cross sections 16-20 from top of slope on north side of creek, August 2009; and D) View of cross sections 16-20 facing downstream from cross section 16, November 2008.

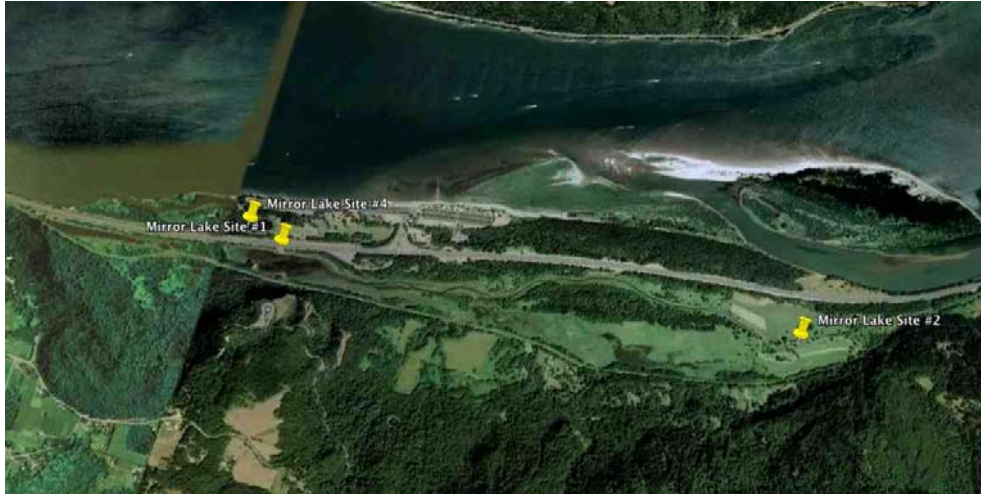
Figure 3-1 shows the three areas of focused fish sampling at the Mirror Lake project area. Site #1 (Lake) is on the open water part of the lake near the I-84 culvert (Figure 3-1, Figure 3-2A). The area is dominated by grasses from the high water mark to the low water edges, and by shrubs and blackberry vines along the bank above and at very high water levels. The lake substrate consists of consolidated to soft-packed mud, with aquatic vegetation later in the season. The lake is fed by waters from Latourell Creek and Young Creek. Its water level varies seasonally depending on the elevation of a beaver dam at its outlet and backwater from the Columbia River that inundates the site during spring runoff.

11Figure 3-1. Photo showing areas of fish collection at Mirror Lake in 2009. Photo provided by Google Earth.

Site #2 (Young Creek) is on Young Creek and is upstream of Site #1 (Lake) (Figure 3-1, Figure 3-2B). The creek varies from about 1.5 meters wide at low water levels to about 5 meters at high water. The riparian area is dominated by reed canary grass to the edge of the creek bed and immediate adjacent areas, with a steep drop (1.5 meters) from the edge of the creek bank. Bottom sediment is composed of very soft mud. From mid June to late summer, the creek banks are overgrown with tall grasses, which overhang the banks, provide shade, and cover for stream inhabitants. Between 2004 and 2007, before monitoring was initiated, a failing culvert (dam) at this site was replaced with a 70 ft bridge to give salmon species access to upstream spawning areas. Prior to restoration activities, very little large woody debris existed at this site and grasses provided the only available cover. To improve this situation, invasive plants along the creek were removed and native willows and cottonwoods were planted. In summer of 2008, large woody debris was added to Young Creek to improve salmon habitat.

Site #4 (Culvert) is located immediately below the I-84 culvert and adjacent areas opposite the boat launch and associated docks (Figure 3-1, Figure 3-2C,D). The area immediately below the culvert had very little to no vegetation associated with the banks or bottom. The banks were steep, and rocky, areas consisting of pebbles to small boulders. Bottom sediment was the same. The adjacent areas were dominated by grasses, with a steep bank (1.5 meter) that dropped off quickly. The bottom sediments were composed of very soft mud. In the summer of 2008, boulders were added to the culvert at I-84 to improve water flow for salmon passage.

Fish use of restoration sites was assessed by analysis of catch data. Fish were collected from April 2009 through September 2009. Due to variation in topography, accessibility, and water levels among the restoration sites, several types of gear were used to sample the Mirror Lake sites. Table 3-1 shows the coordinate of each site, and Figure 3-1 is a map detailing sampling site locations.

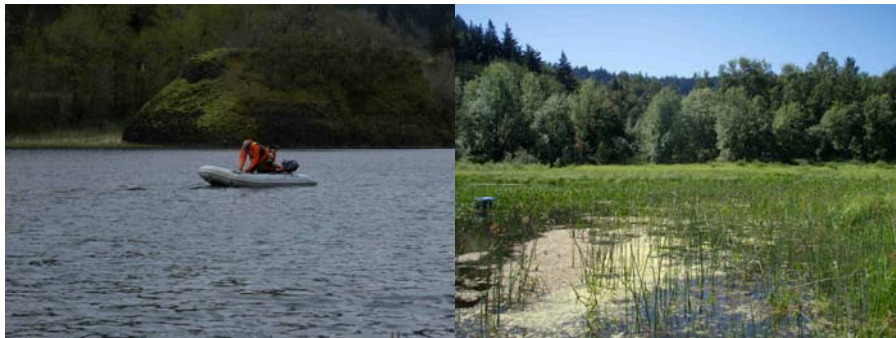
14Figure 3-4. Fishing at high water with PSBS (note the absence of vegetation in water) vs site at low water (full of vegetation)

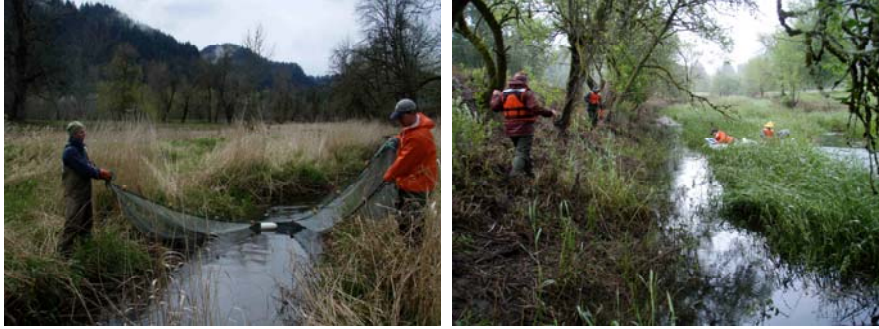
- Site #2 (Young Creek). This site is approximately two miles upstream of Site #1 (Lake), and followed a similar trend in water levels. The water level was so high in June that NOAA Fisheries could not use the MBN to fish this site (Figure 3-5).

15 **Figure 3-5.** Fishing with modified block net at lower water vs. sampling at relatively higher water levels (photograph from 2008).

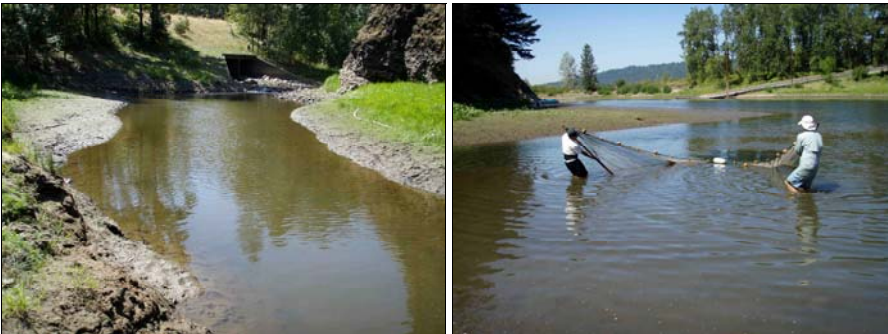
16 **Figure 3-6.** Low water level below the culvert, and fishing below the culvert using modified PSBS.

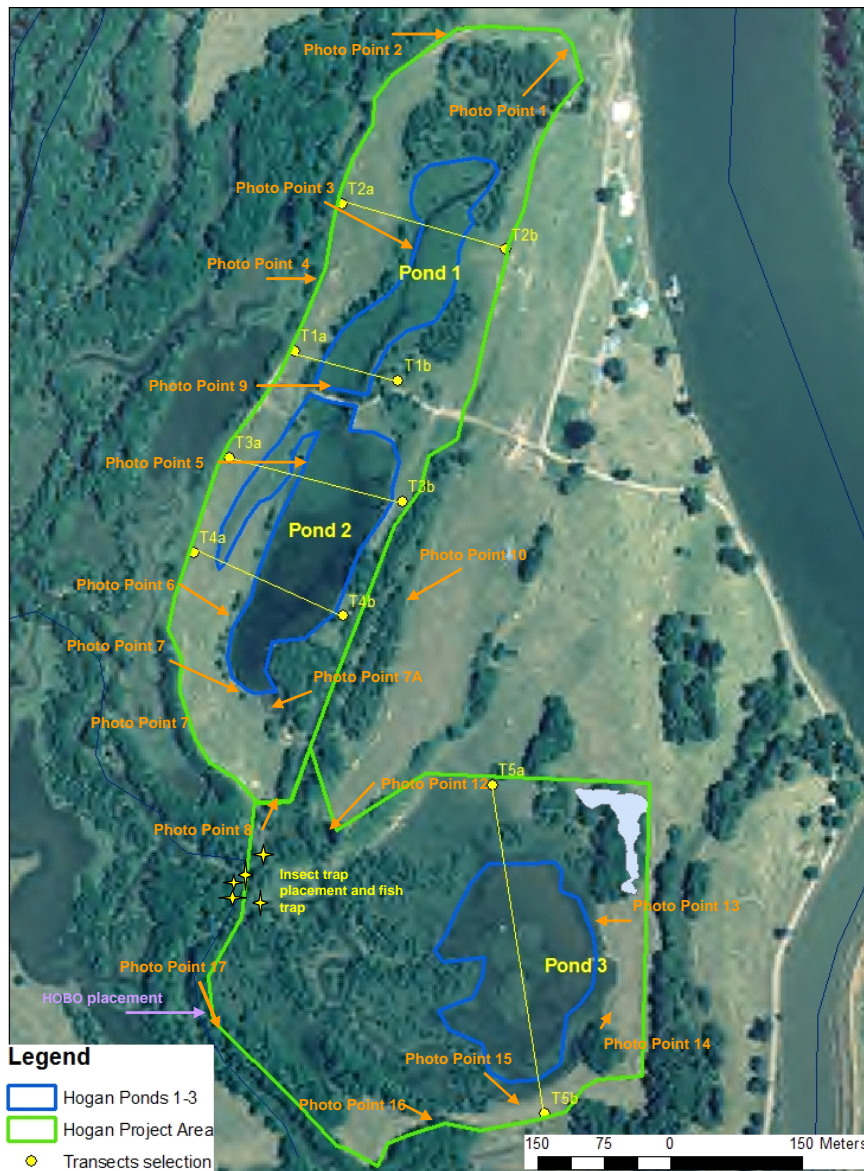
29 **Figure 5-2.** Locations of photo-point, vegetation transects, insect traps, fish sampling, and HOBO logger at Hogan Ranch.

SBWC established 5 photo points on April 11, 2007 at the Lower Scappoose Creek site (28Figure 5-1) and at the Hogan Ranch site, 15 photo points on July 28, 2004, with 2 more added in 2008 (29Figure 5-2). GPS coordinates were collected and archived for these photo point locations. Photos were taken at 90° intervals (4 pictures) at each location and once each season for a total of 4 times per year. SBWC established the photo point locations to track long-term environmental changes at this restoration site.

The composition of the vegetation communities at Hogan Ranch were examined to describe changes in plant community following ecological restoration activities in three tidal freshwater ponds. SBWC staff assessed vegetation communities along transects running across the ponds (Figure 5-2). On each transect, they identified the communities based on vegetation gradients. The simple basin topography of

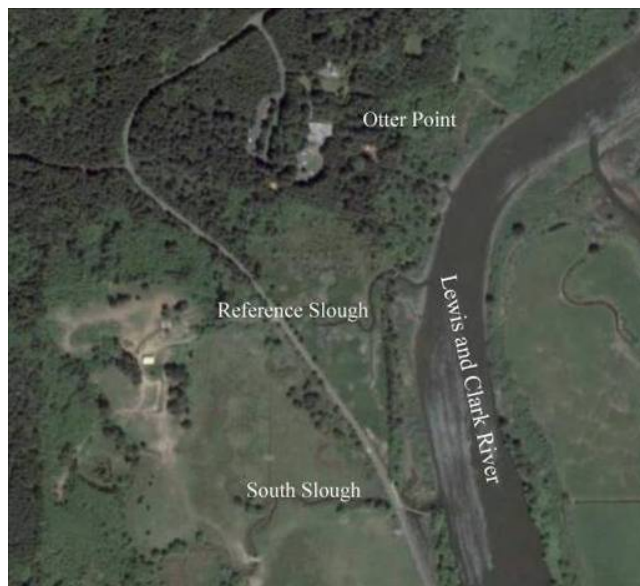
37Figure 6-2. Otter Point restoration site located on the mainstem Lewis and Clark River, including the Fort Clatsop restoration site ("South Slough") and nearby reference slough.

In 2007, LCREP reconnected 45 acres of diked pasture with the river and tide at Lewis and Clark National Historic Park's Fort Clatsop South Slough (Fort Clatsop restoration site) when they replaced a failing tide-gate with a bridge (37Figure 6-2). A standard culvert would have deterred fish by maximizing water velocity, while larger concrete versions would sink in the substrate. Unencumbered tidal-connectivity would maximize potential for estuarine habitat enhancement restoring opportunities for fish use and community enrichment.

The Fort Clatsop reference site was selected based on the proximity to the restoration site, a history of tidal connectivity, and having environmental conditions that could support salmonids (37Figure 6-2). Side channels yield space, surrounding spruce trees provide shade, riparian zones of native vegetation keep water in good condition, all of which should promote salmon usage. In 2008, monitoring efforts expanded beyond fish communities, to prey availability and utilization, to qualify salmonid feeding behavior. In 2009, CREST began to collect water quality data as well. These data will be directly compared to results from the restoration site.
