Action Effectiveness Monitoring for the Columbia River Estuary Habitat Restoration Program

Final Report to the Bonneville Power Administration

Project Number: 2003-011-00 Contract Number: 51120 Performance/Budget Period: September 15, 2010 – December 31, 2011 Annual Report

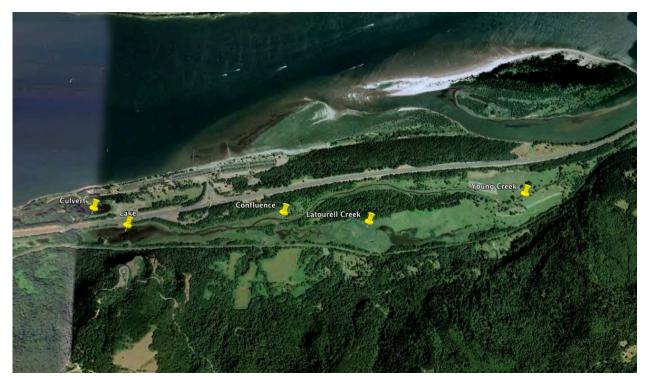
Figure 2. Photo showing areas of fish collection at Mirror Lake. Photo provided by Google Earth.

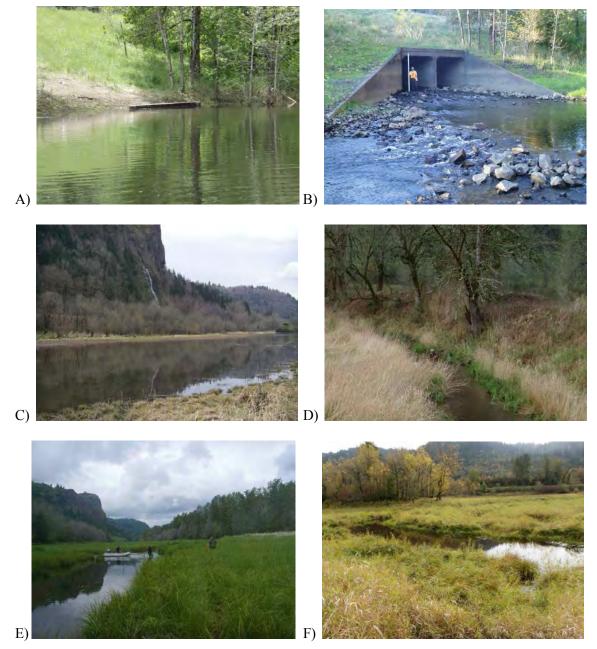
Figure 3. Photos of fish sampling sites at the Mirror Lake project area. A) Culvert at high water, B) Culvert at low water, C) Lake, D) Youngs Creek, E) Confluence and F) Latourell Creek.

Confluence and Latourell Creek: In 2011, these two new sites first sampled in 2010 were sampled again. Both sites were surveyed intermittently for salmon observation. The Confluence site (Figure 3 E) is located at the confluence of Latourell Creek and Youngs Creek, downstream of the Youngs Creek Site. Latourell Creek (Figure 3 F) is located 100 m downstream of Latourell Lake. Physical characteristics of both sites are similar to Youngs Creek. The bottom sediment is composed of very soft mud, and the banks are overgrown with tall grasses. The Confluence, which is slightly wider and shallower than Youngs Creek, was sampled in May, and July, and September, while Latourell Creek was sampled once in September.

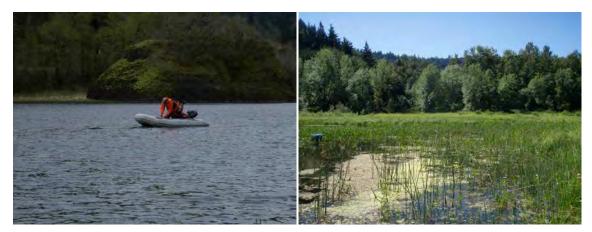
Figure 5. Fishing at high water with PSBS (note the absence of vegetation in water) vs site at low water (full of vegetation)

- Culvert. At mid to higher water, the area immediately below the culvert and two adjacent areas were sampled with the PSBS. At extreme low water, bottom substrate, which was comprised of very soft mud, prevented successful beach seining with the PSBS, and consequently no sampling was possible in September.
- Lake. This site was successfully fished in early and late May, June and July using the PSBS; from late August through December, water levels receded while the growth of aquatic vegetation increased. Low water levels and increased vegetation cover made site access difficult and prohibited the use of the PSBS (Figure 6), thus the MPSBS was used then to sample the site from late August through December.

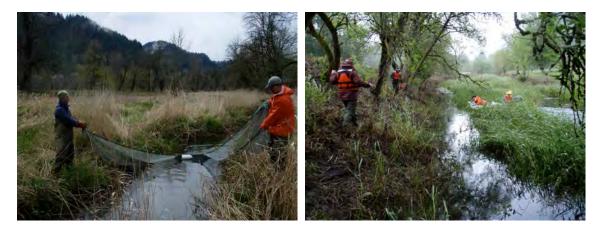
Figure 6. Fishing with modified block net at lower water vs. sampling at relatively higher water levels (photograph from 2008).

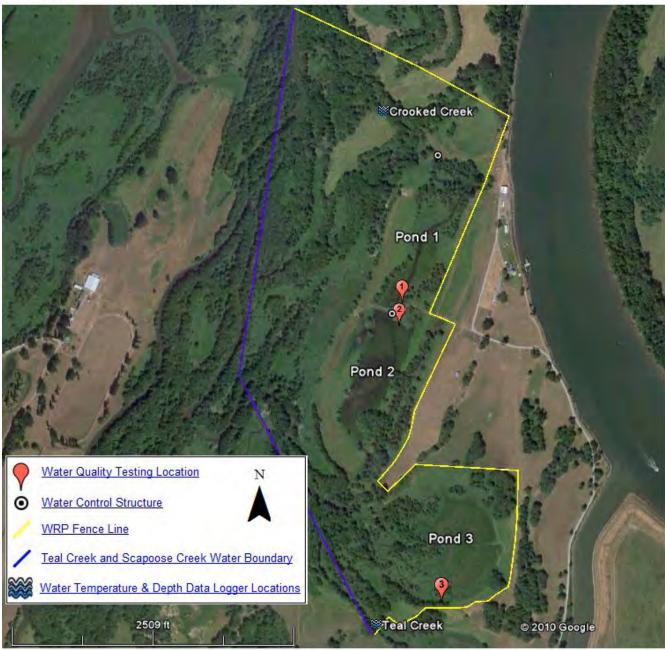
Figure 18. Location of restoration wetland Ponds 1-3, as well as location of water control structures, water quality grab sample sites, and data logger sites along Teal and Crooked Creek.

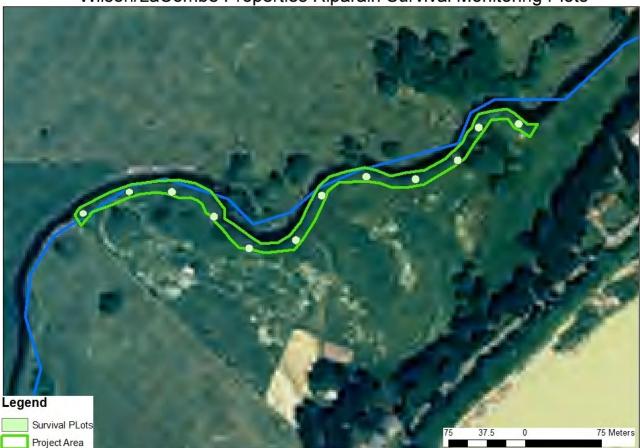
Wilson/LaCombe Properties Riparain Survival Monitoring Plots

Figure 21. Planted area and approximate location of survival monitoring plots 2008-2011 Wilson/LaCombe property, Scappoose Creek.

Survival monitoring was conducted in August of 2008-2011 after summer mowing. Sites are mowed once or twice a year to control the non-native reed canarygrass herbaceous layer between 2008-2011 on the Wilson/ LaCombe site and 2008-2010 on the Hogan Ranch site. In 2011 no funding was available for maintaining the plantings on Hogan Ranch, however extreme high water during April – July made mowing less important. Without mowing reed canarygrass can overgrow and suppress the plantings, causing poor planting vigor and mortality (Lavergne and Molofsky 2004, WRMWG 2009). At each site, we followed the current protocols recommended by the Estuary Partnership (Roegner et al. 2008) as closely as possible. The riparian planting site, Wilson/LaCombe, has plantings in a very narrow strip (4-5m) running along Scappoose Creek (Figure 21). The Wilson/LaCombe riparian plantings consisted of a dense mixture of riparian under and overstory plants (Appendix D). It was not possible to implement the monitoring protocol calling for a baseline and perpendicular transects at this site because of the size and shape of the planted area. We instead chose to place plots systematically from a random start in a path parallel to the creek. Property fence lines mark the starting and ending points of the planted area at this site. Plots were located every 50m along the length of the planted area (Figure 21), starting at the property line. The initial plot starting point was determined by choosing a number from a random number table. We assessed planting survival and vigor at a total of twelve plots (total area of 600 m^2 surveyed) on this site; the number of plots was chosen based on the guidelines in Roegner et al. (2008) for this.98 acres project site.

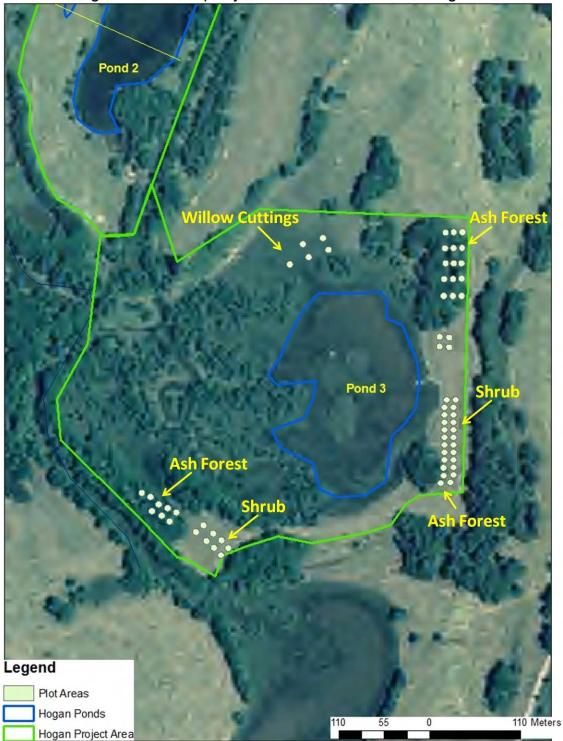
Hogan Ranch Property Wetland Survival Monitoring Plots

Figure 22. Approximate location of plots for monitoring vegetation survival on Hogan Ranch Pond 3 for 2009 and 2011.

At the second site, Hogan Ranch Pond 3, the planted area was wider, but irregularly shaped. We were able to use the condition and baseline transect sampling design for this area, but had to modify transect widths and locations along the baseline to conform to the planted area. On Hogan Ranch, plantings are composed of ash forest, willow, and shrub communities (Appendix D). We placed a baseline transect through each of the communities and constructed transects and plots systematically from a random start as much as was feasible. In total, we assessed planting survival and vigor at 62 plots (compared to 62 in 2009, 2010 and 54 in 2008) on this site (Figure 22); this met the recommendations in Roegner (2008) for this 16.67 acres planting area. The locations of the survival monitoring baseline transects were changed slightly from 2008 to 2009 which accounts for the additional 8 plots assessed in 2009-2011. This slight adjustment in location was done to establish a better representation of the larger planted area. In 2010 monitoring on Hogan Ranch were permanently marked with fence stakes for easier long-term identification and monitoring.

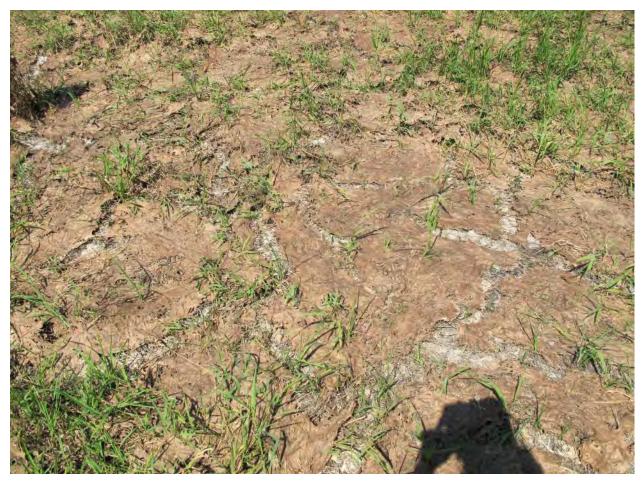
Figure 51. Taken in the Marshy Shore Plant Community of Pond 1 August 4, 2011.

Overall, the plant communities showed a significant shift in composition due to prolonged summer flooding (April through late July 2011). Extreme prolonged flooding in wetlands can result in plant die off, reduced germination and delayed plant growth (Casanova and Brock 2000). The reduction in reed canarygrass cover observed in the marshy shore and wetted area plant communities and the increase in reed canarygrass in the FACW plant community is a result of increased water depth and period of inundation (as compared to recent levels) in these plant community zones (Jenkins et al. 2008). In the wetted area and marshy shore depths were likely higher than reed canarygrass 'tolerance range while in the FACW plant community the depth was more optimal for reed canarygrass than other less flood tolerant species. Other species such as colonial bentgrass (*Agrostis capillaris*, introduced) in the FACU plant community and water purslane (*Ludwigia palustris*, native) in the wetted area plant community showed significant declines compared to previous years. In places where declines in plant species abundance (cover) were observed an increase in dead organic matter ground cover was observed (Figure 51).

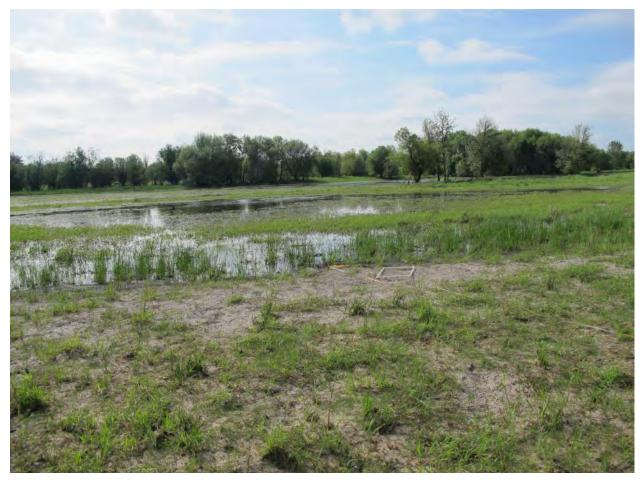
Figure 58. West side of Pond 2 Looking East Along Transect 3, Notice the Lack of Vegetation in the Marshy Plant Community.

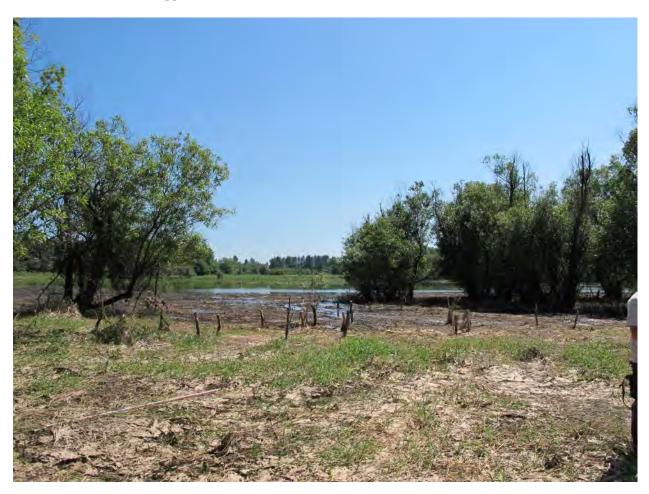
Figure 67. North End of Pond 3 Looking South Along the Vegetation Transect Line August 4, 2011.

Overall, Pond 3 has shown a shift from a plant community dominated by jointed rush (*Juncus articulates*, native) (31%), American speedwell (*Veronica americana*, native) (25%), and reed canarygrass (9%) in 2004, to a plant community dominated by reed canarygrass (25%), wapato (64%) and creeping spike rush (10%) in 2010 (see Report 2010). The 2011 total cover comparisons are not included in this report because this year's plant survey does not represent the true plant community composition of this pond due to the impacts of extreme high water during the typical wapato growing season (Figure 67). However it is expected that the plant community will be similarly (2010 data) dominated by wapato, creeping spike rush and reed canarygrass when normal hydrology is returned. Community based plant cover data for 2004-2011 is located in Appendix B.

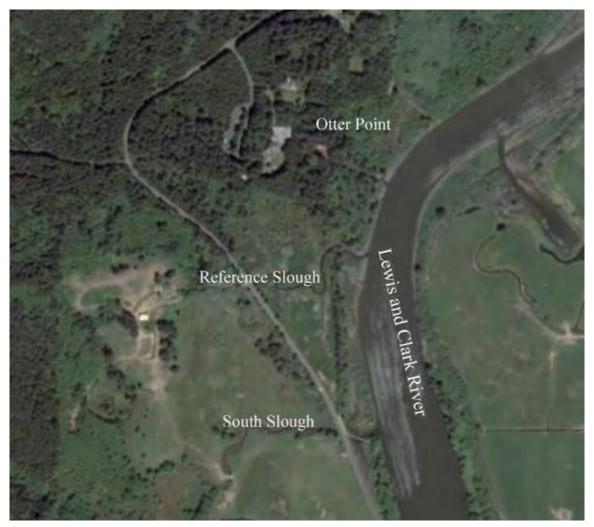
Figure 71. South Slough tidegate removal/bridge installation site, located on the Lewis and Clark River mainstem, including the nearby reference slough (Alder Creek) and current dike breach site, Otter Point.
