Examining the Functions and Forms of Restored Channel Outlets in Floodplains of the Lower Columbia River Estuary

Curtis Loeb, PE

Wolf Water Resources, Inc. | Portland, Oregon

Columbia River Estuary Conference

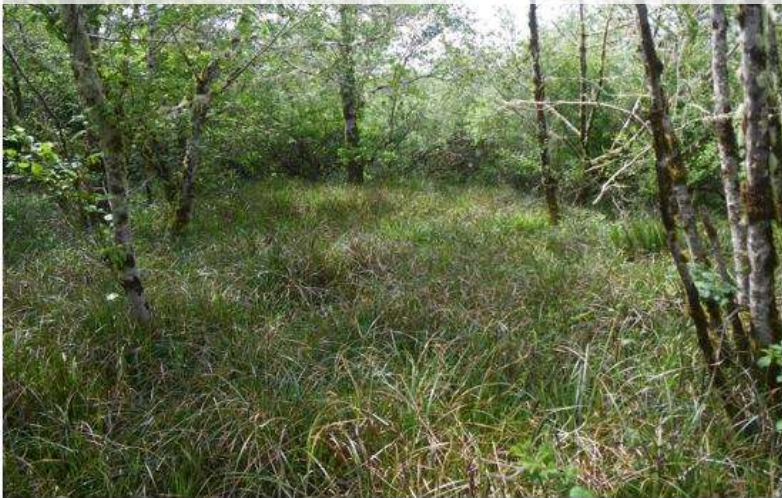
Not visible on aerials / LiDAR

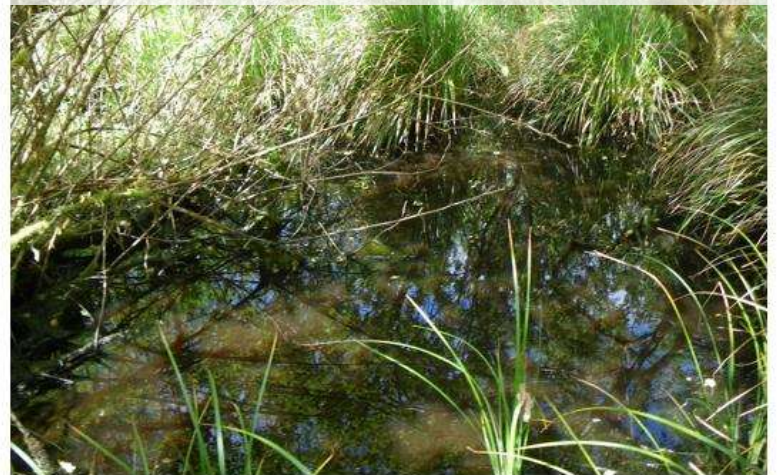
Numerous small flow paths

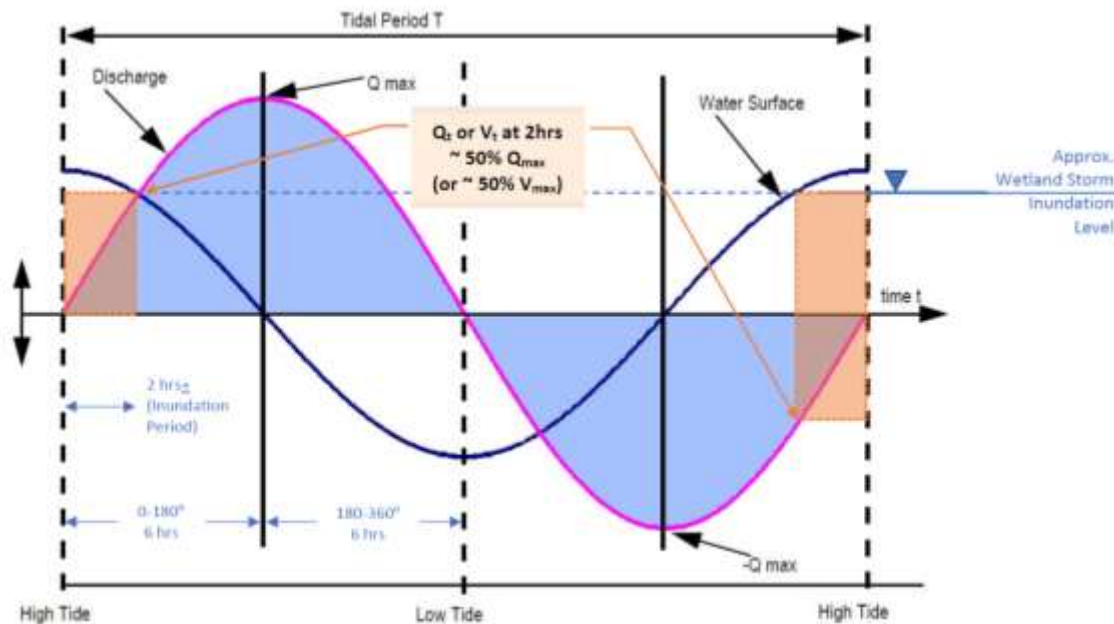
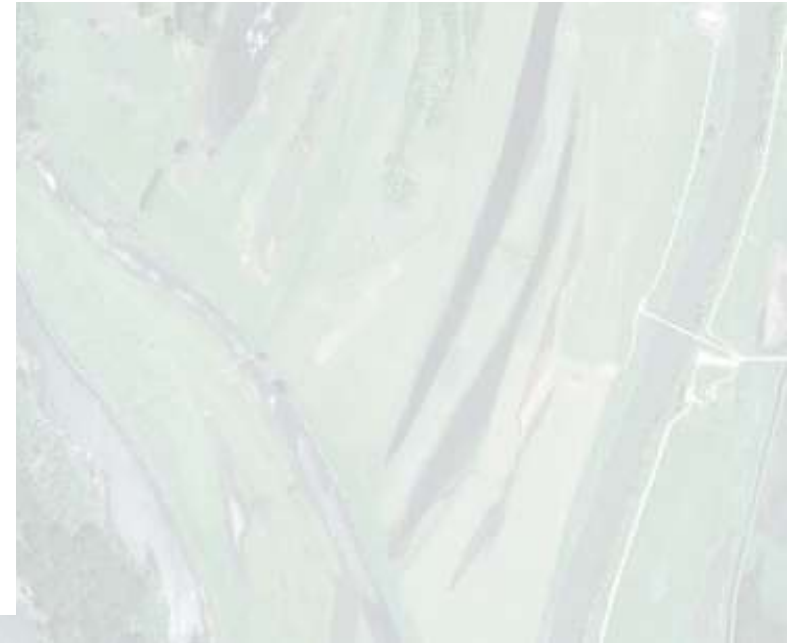
Hydraulic evaluation of erosion

- Tidal prism approach - max. theoretical flow (USFHA 2004, HEC-25)

$$Q_{max} = \frac{\pi Vol}{t}$$

where:

Q_{max}	=	Maximum discharge during a tidal cycle (cfs)
π	=	Constant, 3.1416
Vol	=	Volume of tidal prism (inundated volume) (ft ³)
t	=	Time between successive high tides (sec.)
