Effectiveness of a Channel Habitat Reconnection in Tidal Freshwater of the Columbia River: Sandy River Delta

GARY E. JOHNSON AND NICHOLE K. SATHER

Pacific Northwest National Laboratory, Coastal Ecosystems Research Team

Columbia River Estuary Conference, Astoria, Oregon May 2016

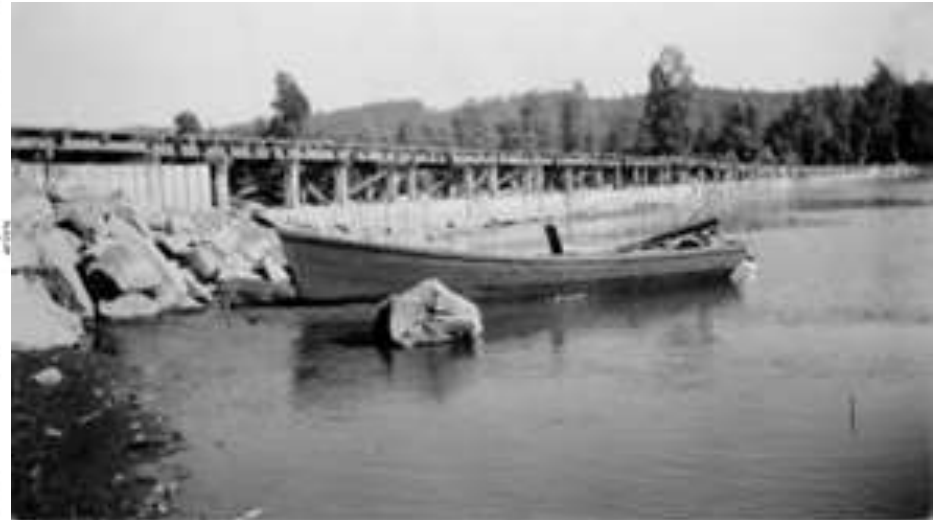
At the Sandy River delta, a dam was installed in the 1930s to concentrate flows of two main distributaries into one to enhance smelt and salmon migrations upstream into the Sandy River.

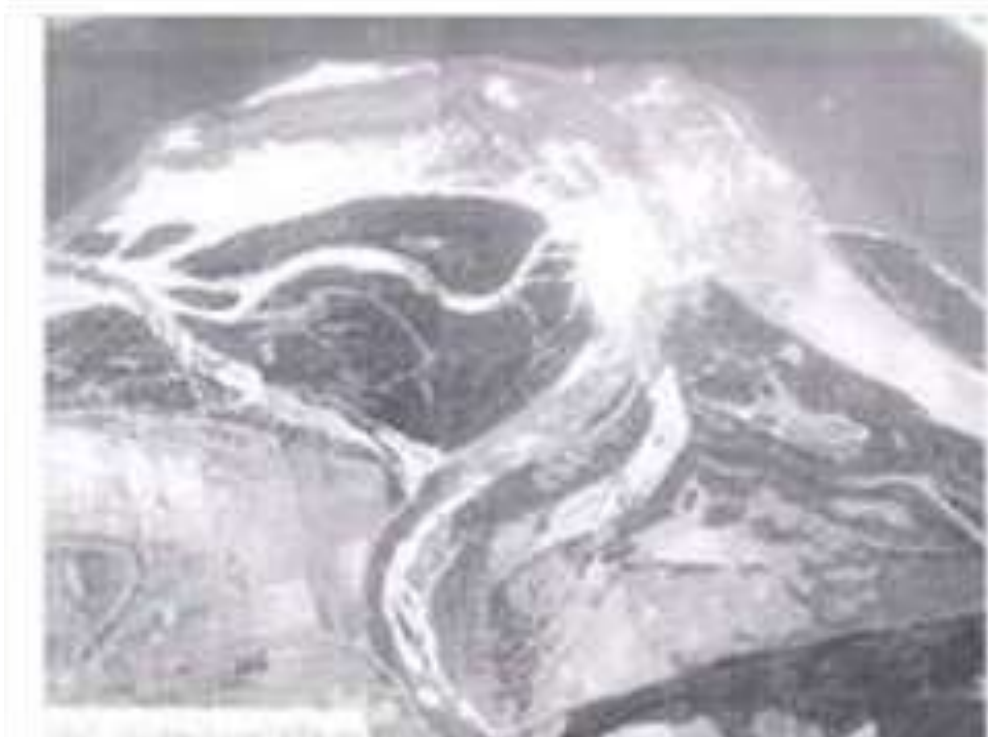
Aerial View -- Pre-Restoration

The dam altered the flow regime and reduced the quantity and quality of rearing habitat for juvenile salmon migrating down the Columbia and Sandy rivers to the ocean.

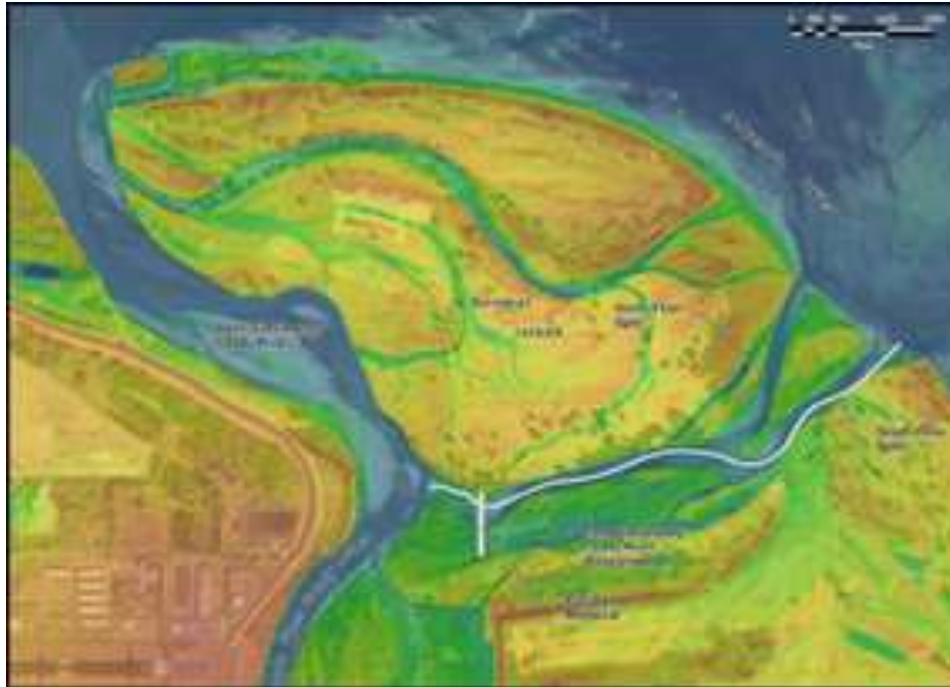
The restoration action involved removing the dam to return the river to its natural channel form, processes, and connection to the Columbia River.

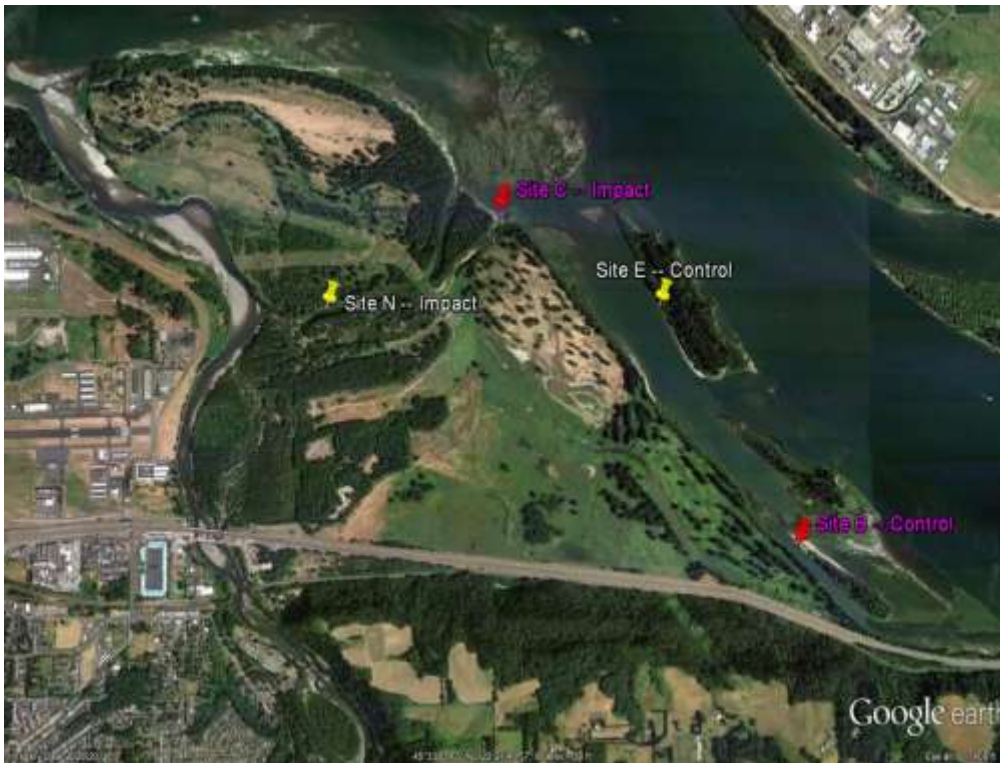
We implemented a before-after-control-impact design with two pairs of control/impact sampling sites.

This presentation includes data from **Sites C and N.**

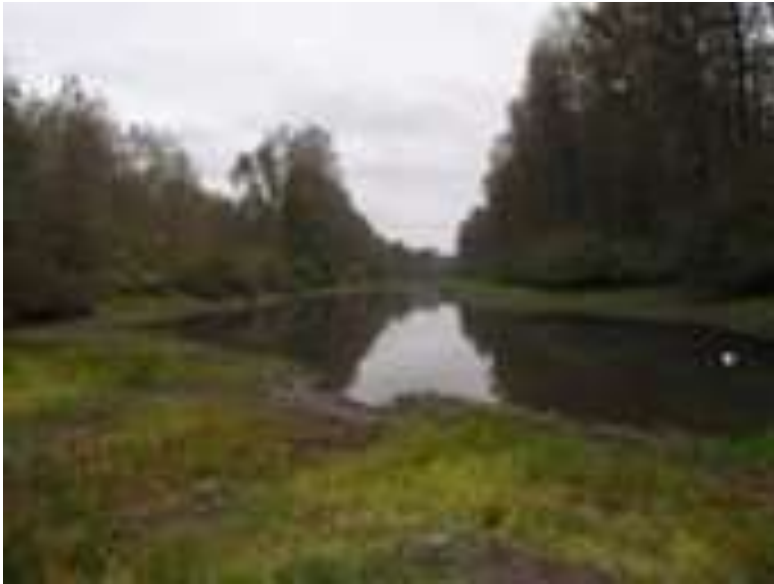
Pre-construction, Oct 2012

The rechannelization produced dramatic physical changes to the historical river channel at the confluence with the Columbia River, changing from backwater to riverine habitat.
