# Elevation is the Surrogate for Everything

*Columbia River Estuary Conference*  
*Astoria, Oregon*

# Plas Newydd Farm Investing in Wapato Valley Mitigation and Conservation Bank

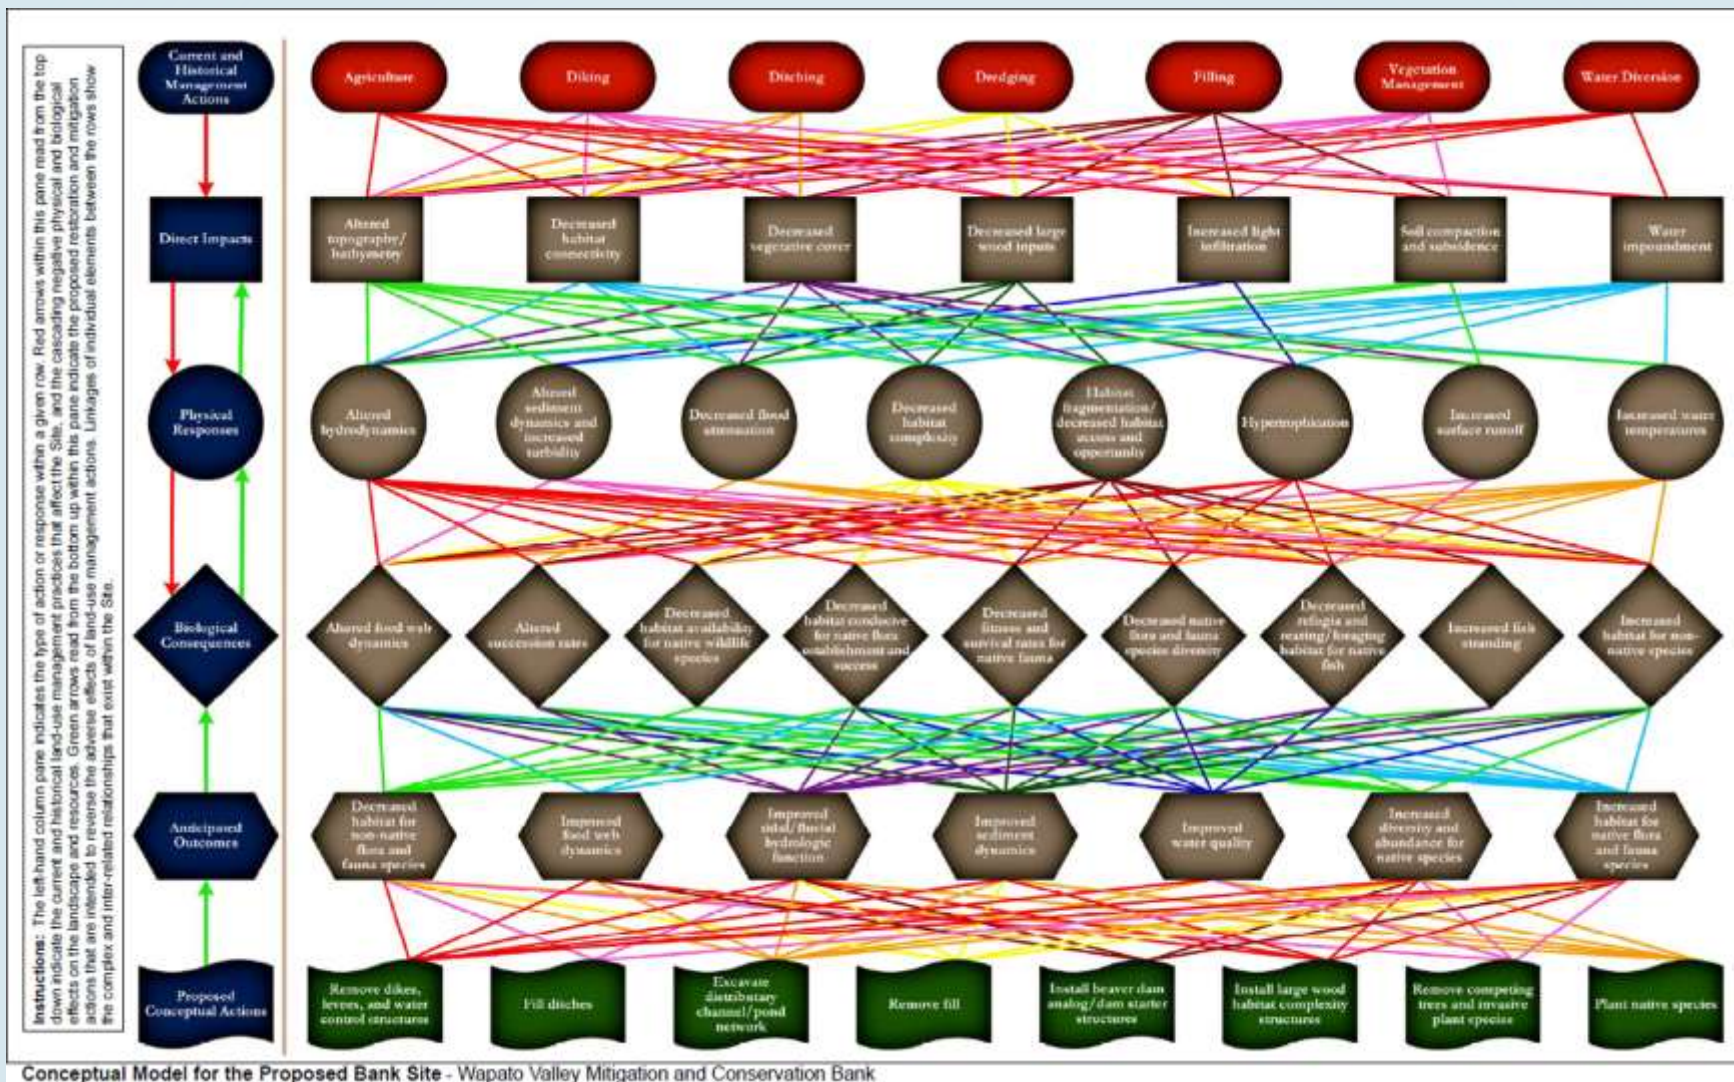
Conceptual Model for the Proposed Bank Site - Wapato Valley Mitigation and Conservation Bank

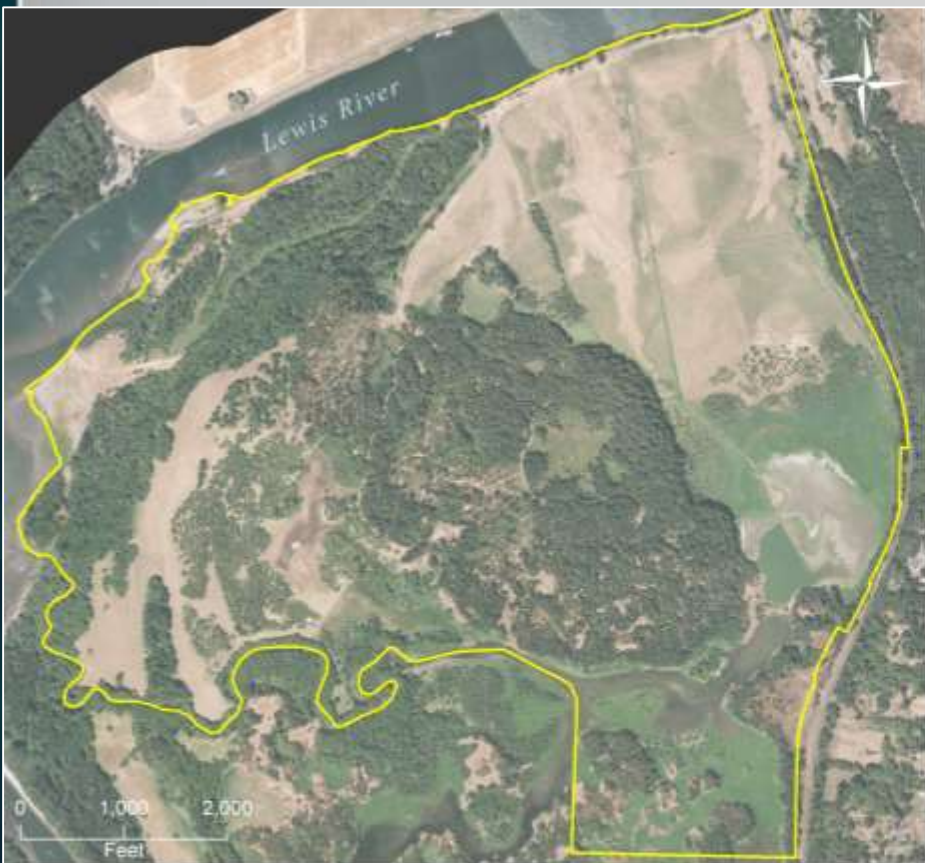
**Low Water Aerial**  
**WSE 7.3 NAVD88**  
**August 2015**

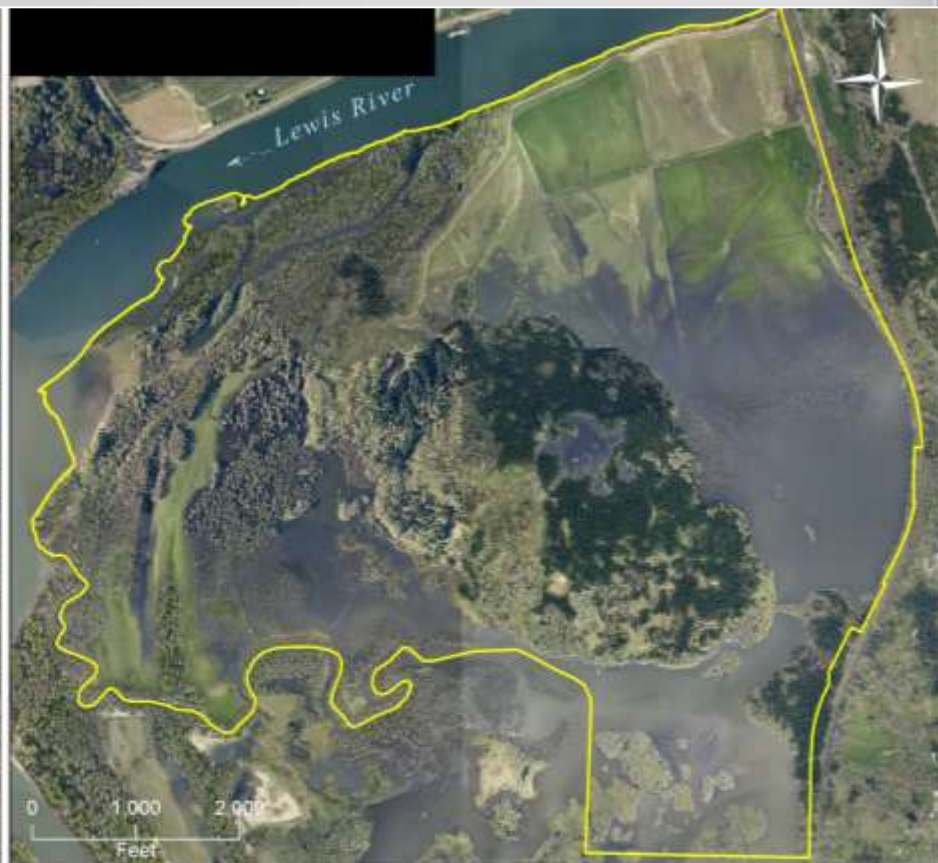
**High Water Aerial**  
**WSE 15.8 NAVD88**  
**April 2012**

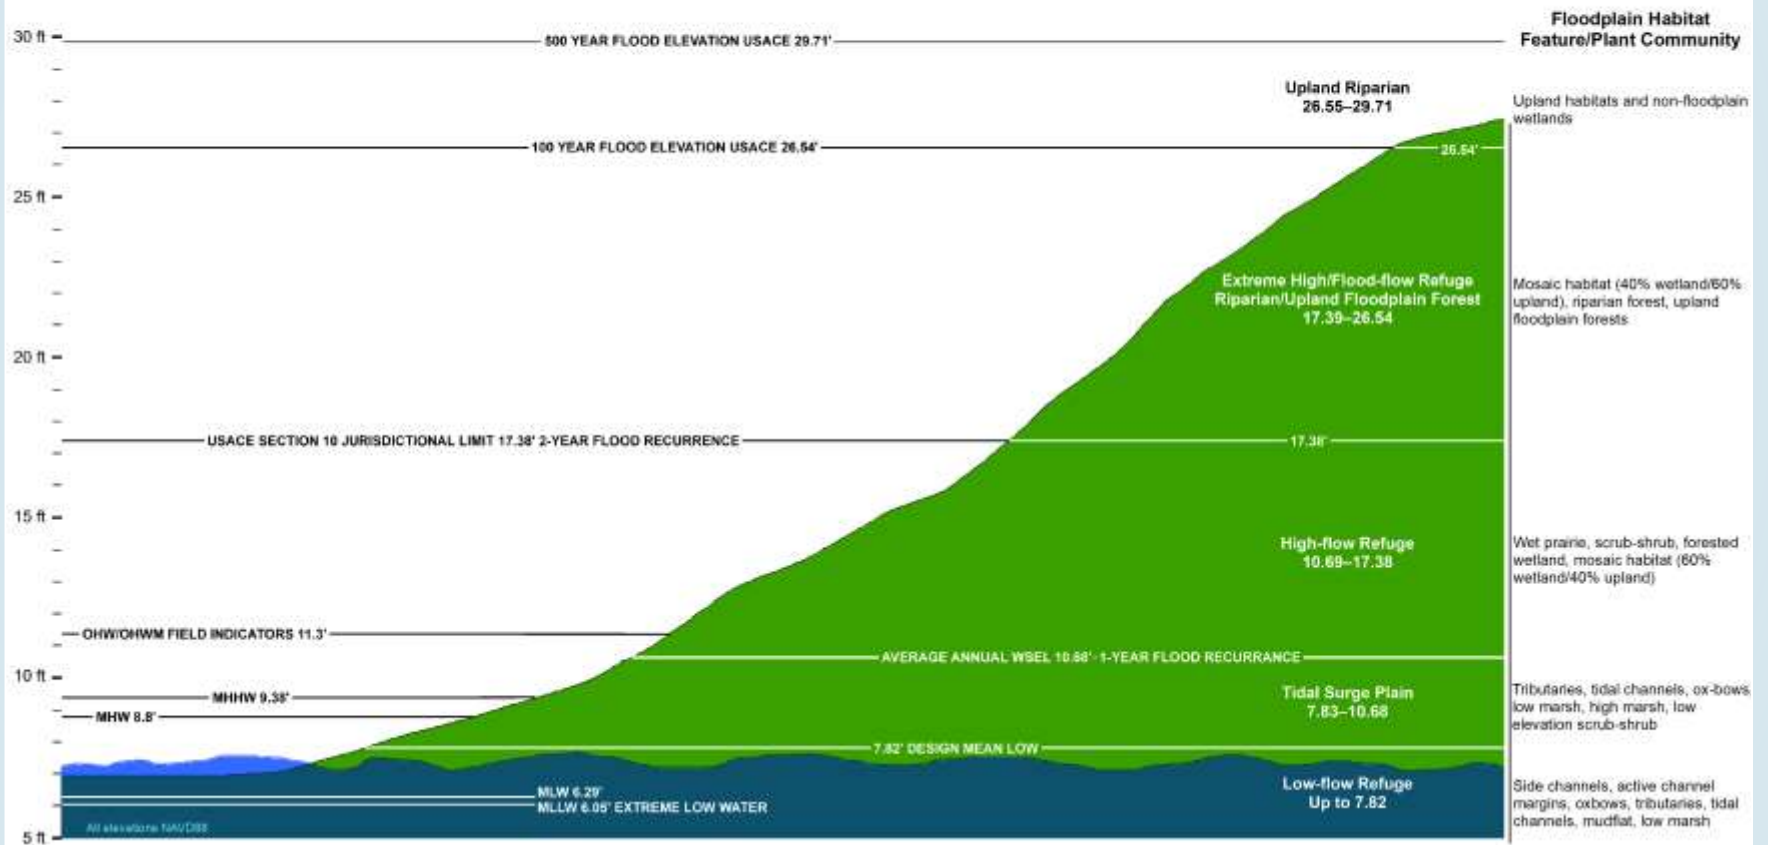
## Lower Columbia Functional Habitat Types for RM 87/Reach E

Habitat Type	Elevation (ft) (NAVD88)	Flood Recurrence	Floodplain Habitat Feature/Plant Community
Low-flow Refuge	Up to 7.82	Extreme low water (ELW) to MLW*	Side channels, active channel margins, oxbows, tributaries, tidal channels, mudflat, low marsh
Tidal Surge Plain	7.83–10.68	MLW to average annual WSEL (AAWSEL) (1-year floodplain)	Tributaries, tidal channels, oxbows, low marsh, high marsh, low elevation scrub-shrub
High-flow Refuge	10.69–17.38	AAWSEL to 2-year floodplain**	Wet prairie, scrub-shrub, forested wetland, mosaic habitat (60% wetland/40% upland)
Extreme High-/Flood-flow Refuge Riparian/Upland Floodplain Forest	17.39–26.54	2-year to 100-year floodplain	Mosaic habitat (40% wetland/60% upland), riparian forest, upland floodplain forests
Upland Riparian	26.55–29.71	100-year to 500-year floodplain	Upland habitats and non-floodplain wetlands
