## Carr Slough Preservation and Tidal Wetland Restoration

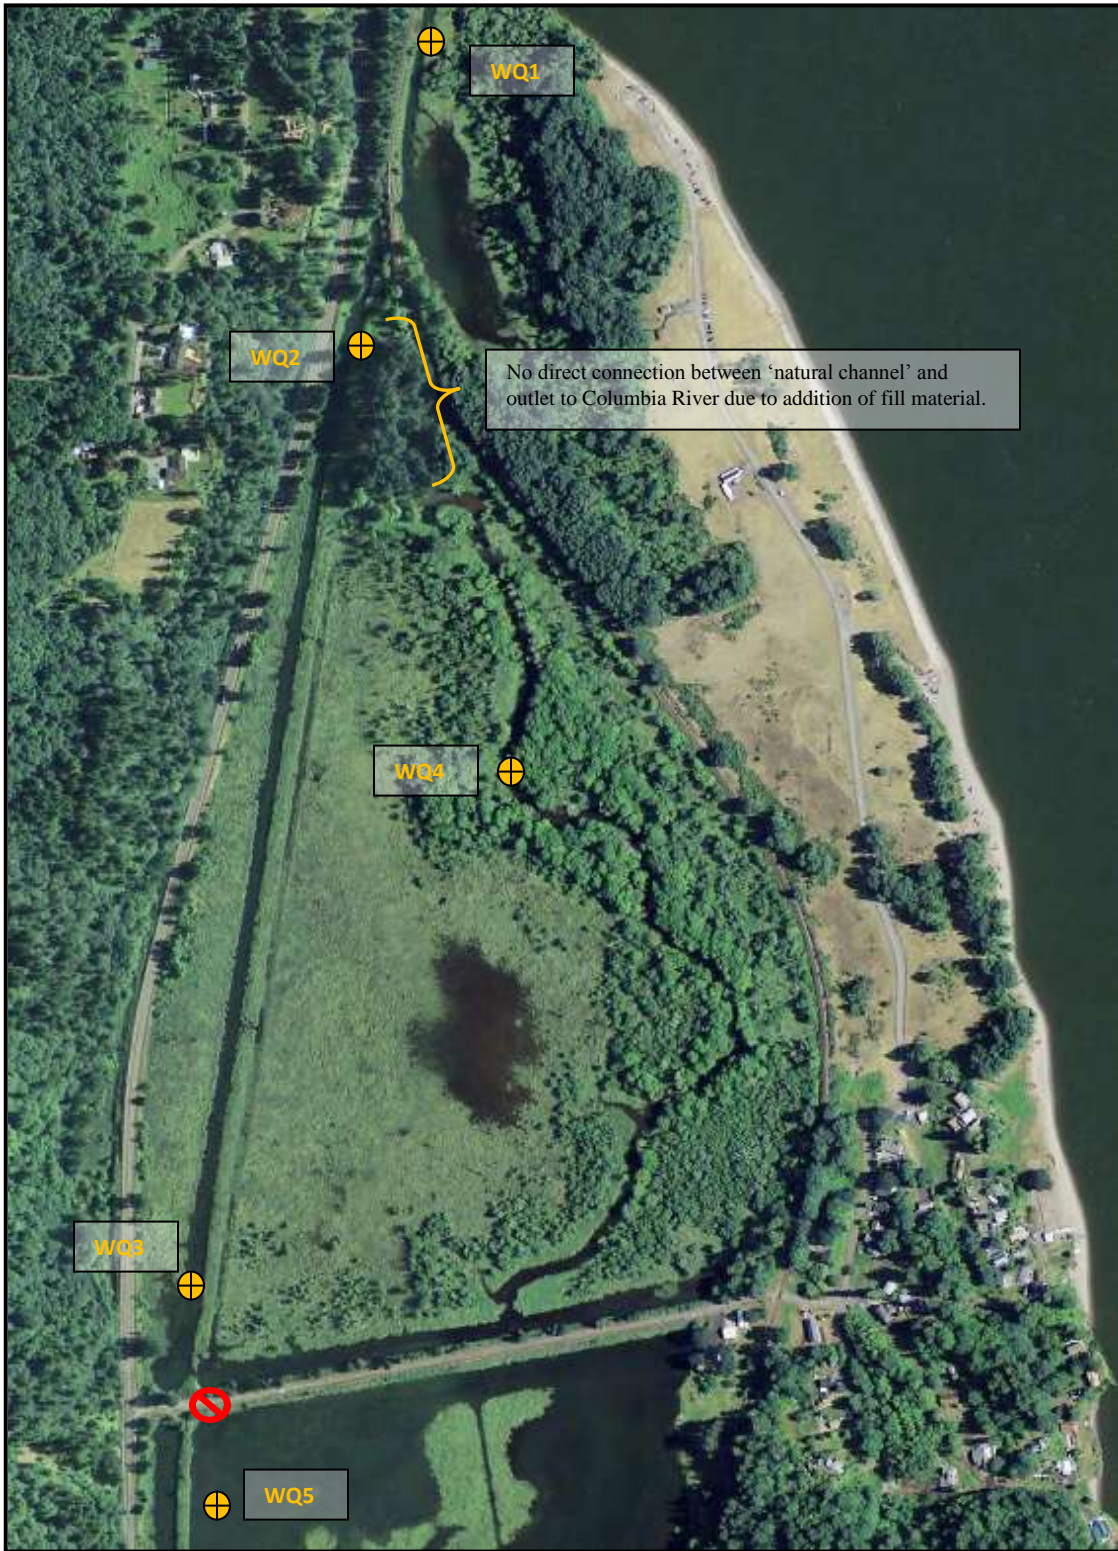
The connection point between Carr Slough and the Mainstem River feeds directly into the ditched channel section that parallels Highway 30. There is no direct connection from the inlet to the more natural meandering section of slough channel (Figure 2). It appears that there was a historic connection which has been cut off by fill material. At the south end of the property, there is a culvert with an old degraded tide gate affixed that connects Carr Slough to the open water lacustrine habitat that is presumable owned by Portland General Electric (PGE) (Figure 2, Photo 4). The flap on the tide gate appears to be rusted and likely has impaired functions, leaving the pipe partially open.

Figure 2. Aerial Photograph of Carr Slough Showing Current Site Conditions. Potential water quality sampling sites are noted in orange. The current tide gated culvert connecting Carr Slough to the adjacent parcel is indicated in red.

- Would reconnecting the natural meandering slough channel directly (i.e., removal of fill within the slough indicated on Figure 2) have potential to increase direct flows, influence water quality, and provide more direct access for fish to slough habitat?

Connection of the meandering slough directly to the Columbia River via removal of fill should be explored. This would provide juvenile fish accessing the site from the mainstem with more direct access into the complex portions of the slough which currently have better canopy, some large wood, and more natural habitat conditions. Evaluation of the water quality data will be useful in determining the potential benefit of this action. Reconnecting the channel directly could provide an increased outflow of nutrients, invertebrates, and detritus that would add to the local food web and provide foraging benefits to juvenile fish on the Mainstem Columbia River margins.

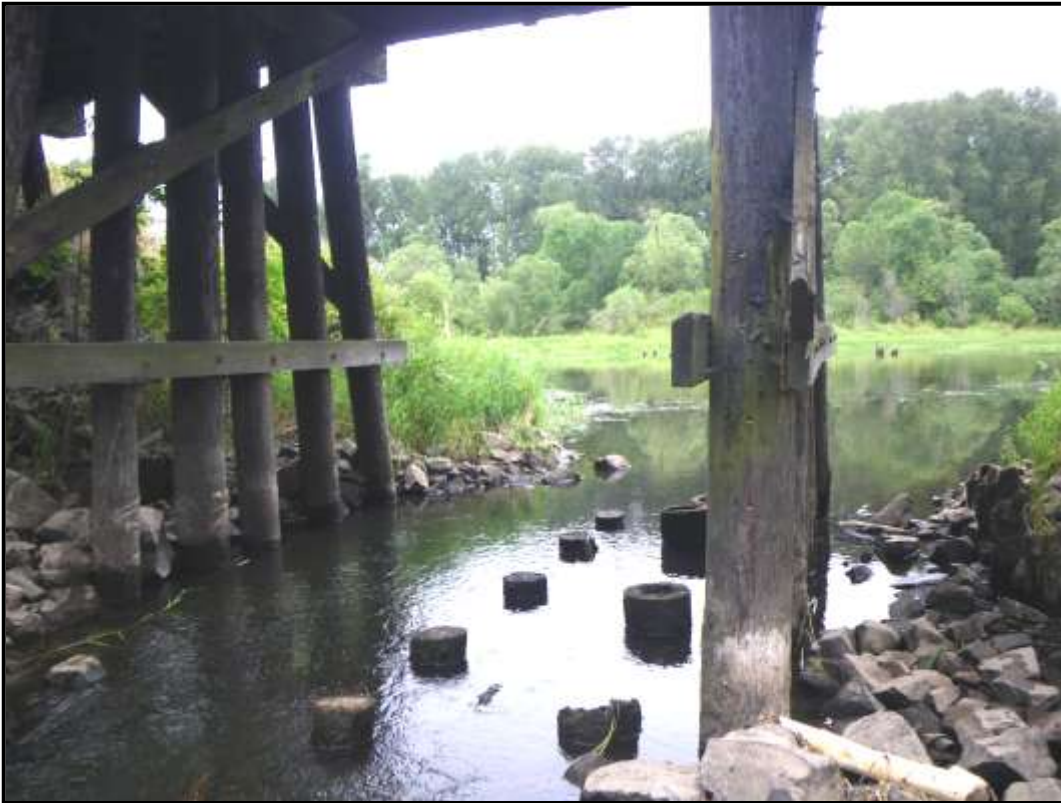
*Fish Access and Juvenile Rearing of ESA Listed Salmonids* – Carr Slough has direct connectivity with the Columbia River via an approximately 12 foot wide channel (Photo 1) beneath the railroad trestle. The channel gradient is fairly flat (approximately 1.5%) and flows out through a county-owned wetland complex and directly connects to the mainstem Columbia River (Photo 2). Inspections of the connection indicate that the channel is likely fully passable under a variety of flows for a wide variety of salmonid species and life-history forms. Species that could use the site include Federally threatened Lower Columbia River stocks of Coho, Chinook, steelhead, and chum as well as species of concern coastal cutthroat trout and perhaps lamprey

Photo 1| Connection of Carr Slough to the Columbia River under the railroad trestle.

*Improved Channel Complexity and Connectivity*—Large wood is currently lacking at Carr Slough. The ditched section has no canopy cover and no large wood present. The meandering slough section has good canopy cover, but limited large wood. Historically, natural processes would have likely delivered some large wood into this floodplain wetland habitat from the hill slope above, however, the construction of Highway 30 and agricultural development has cut off this process. Additions of complex large wood structures would provide juvenile salmonids with cover and invertebrate substrate. Evaluations of the tidal amplitude should be considered in determining structure location and configuration as well as the size, type, and dimensions of wood to use. Potential to integrate vertical members into the wood structures to reduce potential for mobilization would be evaluated relative to the tidal fluctuation. The key infrastructure concern at this site is the railroad trestle which is insufficiently wide to pass large wood.

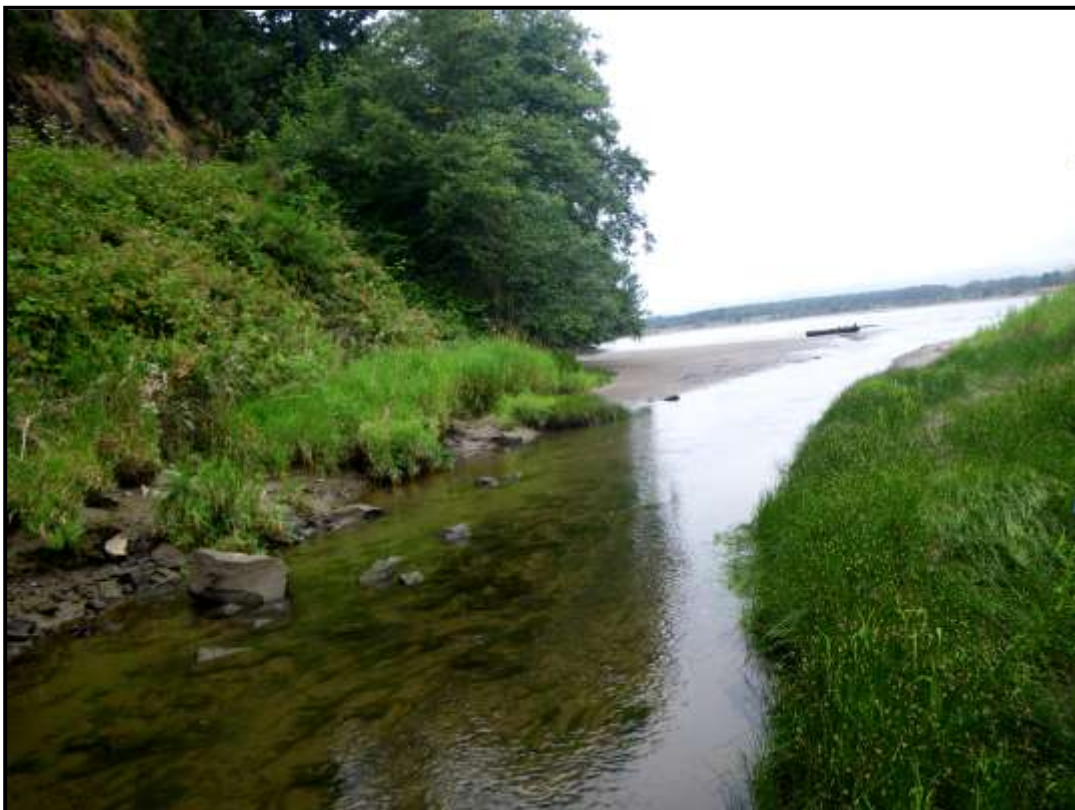
Photo 2. Below rail road trestle looking toward mainstem Columbia River.

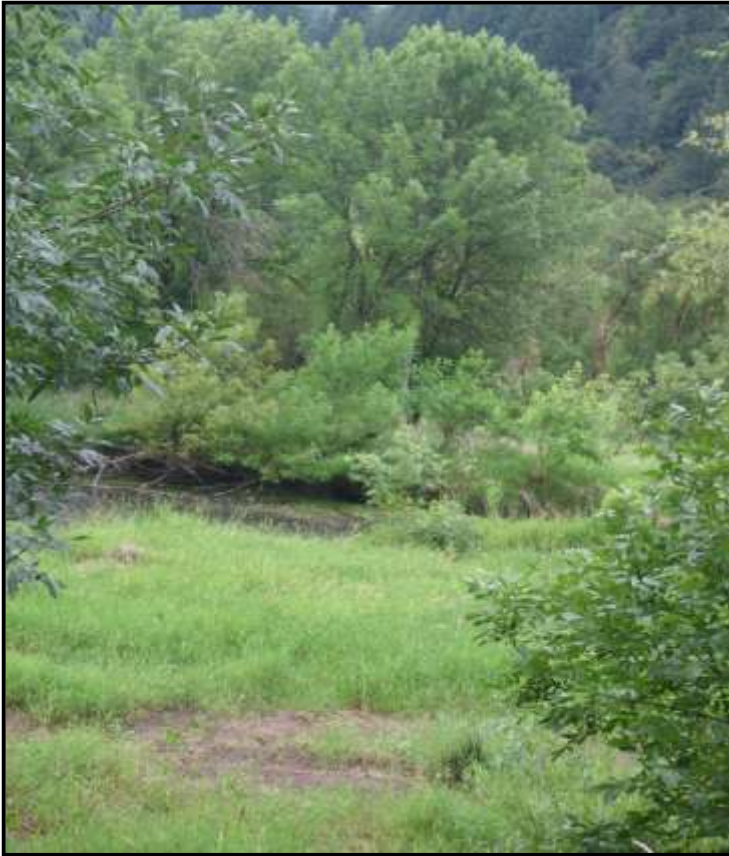
Migratory Songbird Use – Carr Slough has a mixed species variety of shrubs and trees growing in a mosaic fashion over approximately 45% of the land surface (Figure 2, Photo 3). Species present include ash, willow, dogwood, Douglas spirea, alder, and oak. Other cover types present are open water/channel with the dominant land cover being primarily invasive reed canary grass. Formal bird surveys have not been conducted at this site, but per on site observations and bird occurrences in similarly located areas with similar habitat conditions, this site is likely to support foraging and / or nesting for a variety of songbird species. Typical species may include willow flycatcher (*Empidonax traillii*) pacific-slope flycatcher (*Empidonax difficilis*), rufous hummingbird (*Selasphorus rufus*), tree swallow (*Tachycineta bicolor*), northern rough-winged swallow (*Stelgidopteryx serripennis*), barn swallow (*Hirundo rustica*), black-capped chickadee (*Poecile atricapillus*), golden-crowned kinglet (*Regulus satrapa*), yellow warbler (*Dendroica petechia*), common yellowthroat (*Geothlypis trichas*), Wilson's warbler (*Wilsonia pusilla*), song sparrow (*Melospiza melodia*), and others.

Photo 3. General vegetation composition at Carr Slough.

*Vegetation: Improved Native Tree and Shrub Composition & Invasive Species Control*—The portions of the site which are not under shrub or tree cover or in open water conditions tend to be dominated by reed canary grass. It would be extremely difficult and management intensive to shift the reed canary to other non-woody plant communities. Evaluation of the basic hydrologic information (i.e., tidal amplitude) to determine the likelihood of successful survival of shrubs and trees in these areas, and in particular along the ditch, would be a key first step. Next would be the development of a planting plan that incorporates rigorous site preparation and several years of post-planting establishment follow-up. Additional coverage by shrubs and trees would probably not increase the avian or aquatic species diversity, but could increase the habitat quality for these species over a larger proportion of the site.

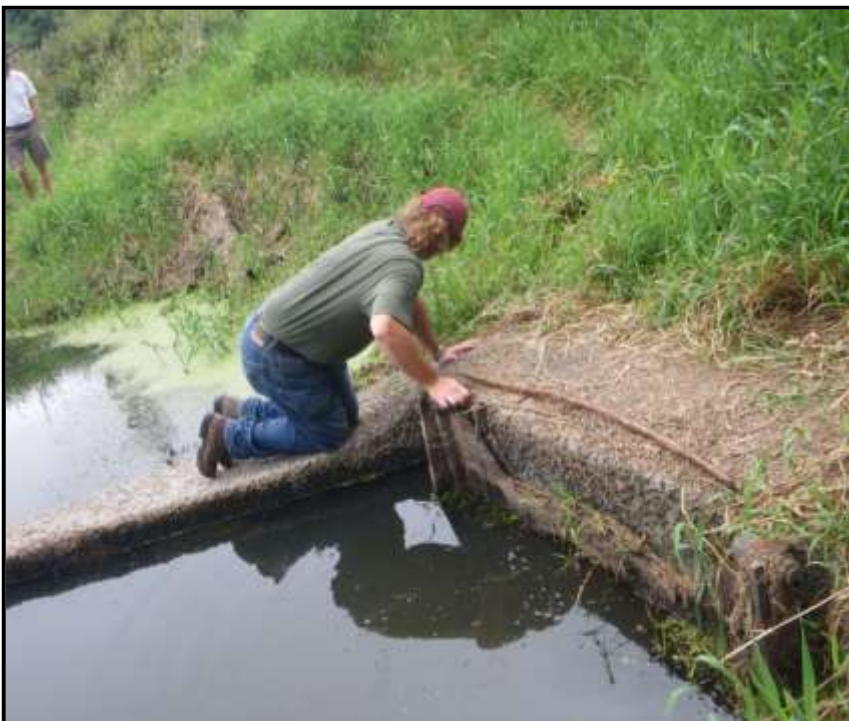
Photo 4. Location of culvert/ failed tide gate connecting Carr Slough with the PGE site.

Consideration should be given to the effects of the failed culvert / tide gate between Carr Slough and the PGE site on both water quality within Carr Slough and also movement of fish, in particular exotic predator fish. The connection may have limited effect on Carr Slough.
