# ***Fort Clatsop Restoration Project Summary Report***

*Report written by the Columbia River Estuary Study Taskforce*

*October, 2007*

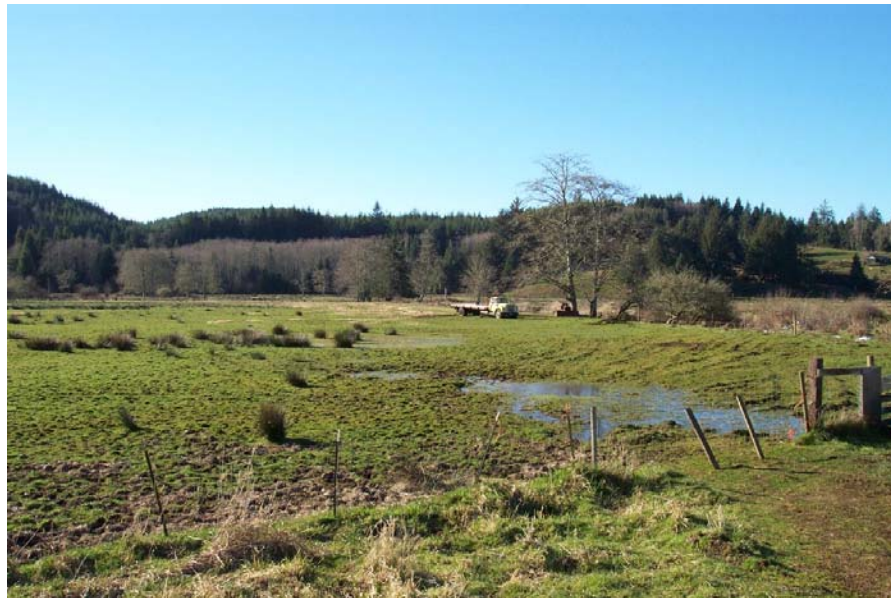
Figure 2. Pre-restoration conditions: Diked Pasture

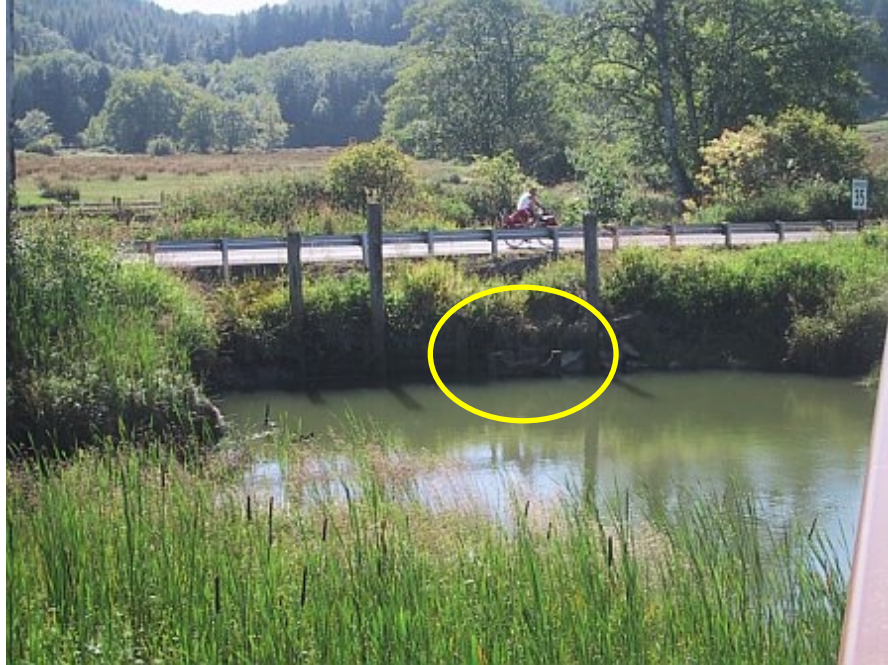
Figure 3. Pre-restoration conditions: Tidegate Structure

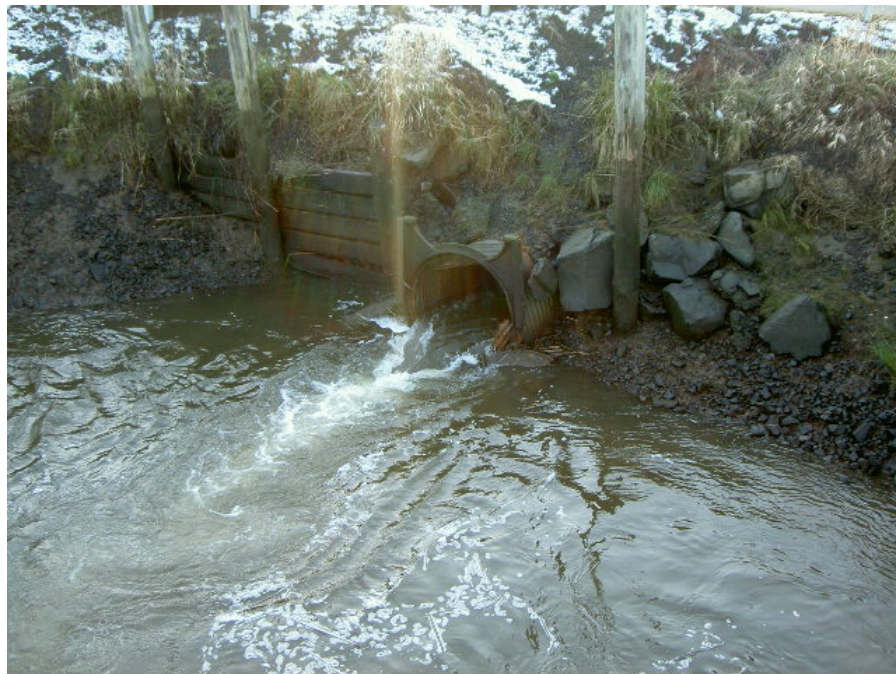
Figure 4. Pre-restoration conditions: Failing Tidegate Structure

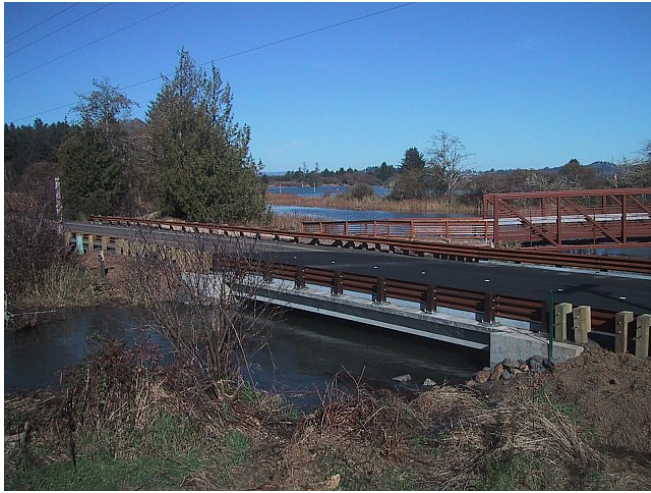
Figure 5. New structure demonstrating established tidal signature (looking northeast)

Currently estuarine habitat forming processes (figures 5-7) have manifest on the site passively providing opportunities for the propagation of native marsh plant communities. These historic habitat types are known to perform multiple functions for a variety of species in the Columbia River Estuary. These functions encompass both physical and biological functions such as habitat refugia and production of detritus valuable for supporting estuarine food web structures of multiple biotic communities (i.e. phytoplankton, zooplankton, benthic and epibenthic infauna).

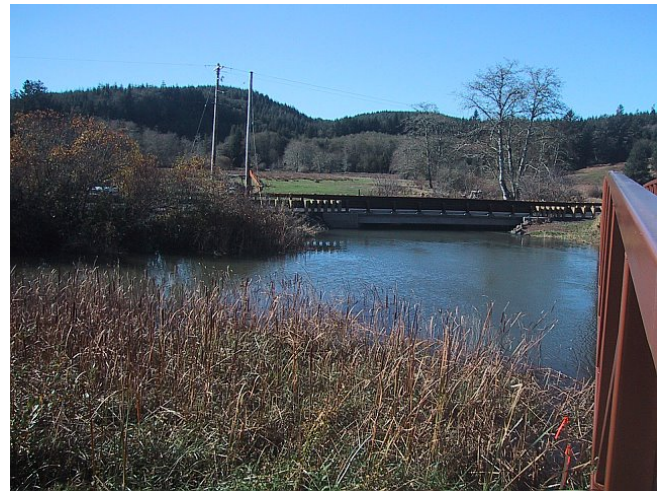
Figure 6. Tidal processes at high tide entering pasture (looking west)

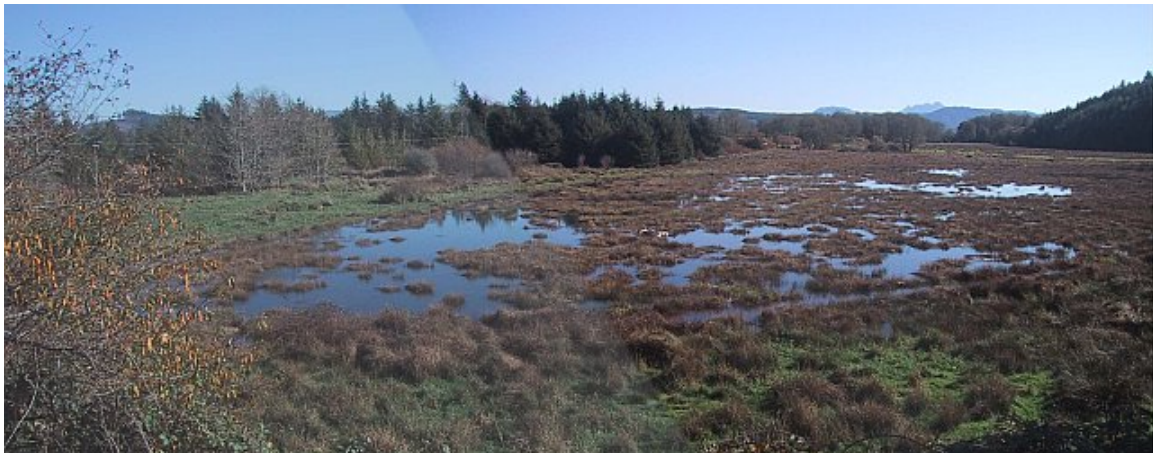
Figure 7. Initial extent of tidal inundation from restoration treatment (looking southeast)
